**Air Accidents Investigation Branch**

**Report on the incident to  
Airbus A340-642, registration G-VATL  
en-route from Hong Kong to London Heathrow  
on 8 February 2005**

Published 4 September 2007

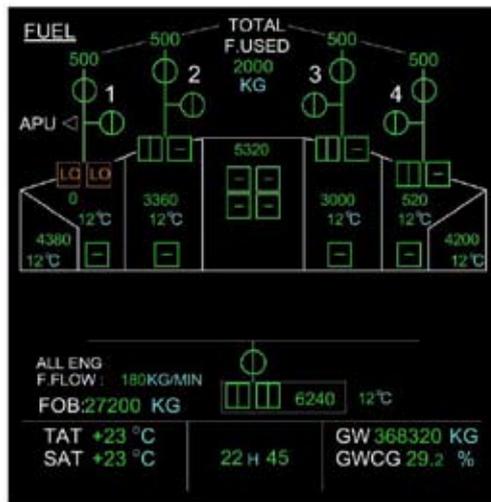
**Figure 16**

The DMC normally receives data from the master FCMC for the display of the fuel system status on the SD. However, in this situation, the DMC is not receiving any data from the master FCMC and so it selects the SDAC as the data source for the status of the centre tank fuel pumps, main and standby engine fuel pumps, trim tank fuel pumps, engine LP fuel valves, cross feed valves, cross feed pipe and jettison system. Although fuel quantity data is available from the slave FCMC, it is presented without the amber warnings of low contents in the collector cells and the tank, which can only be generated by the master FCMC. Also, without data from the master FCMC, the fuel transfer arrows would not be displayed when fuel transfer was taking place. However, in this scenario, the engine fuel pump and standby engine fuel pump low pressure data to the DMC is provided by the SDAC. Therefore, an amber LO indication should have been displayed on the fuel page for the number 1 main and standby pumps.

A hypothetical interpretation of the display presented to the flight crew on G-VATL

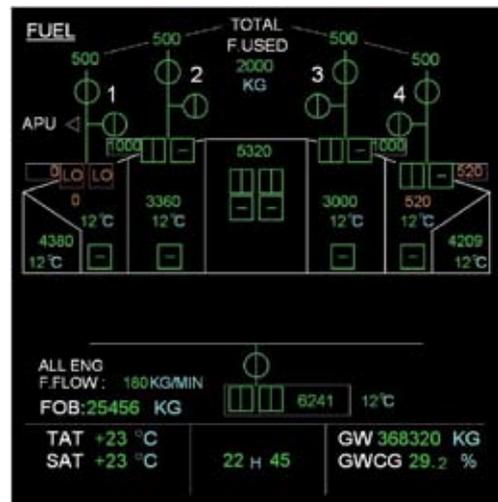
**Figure 17**

Interpretation of what the flight crew should have seen at the engine rundown
