ACCIDENT

Aircraft Type and Registration:	CASA 1-131E Series 1000 Jungmann, G-JUNG	
No & Type of Engines:	1 ENMA Tigre G-IV-A2 piston engine	
Year of Manufacture:	1952	
Date & Time (UTC):	24 May 2009 at 1413 hrs	
Location:	Staunton Caundle, Dorset	
Type of Flight:	Private	
Persons on Board:	Crew - 1	Passengers - 1
Injuries:	Crew - 1 (Fatal)	Passengers - 1 (Serious)
Nature of Damage:	Substantial	
Commander's Licence:	Private Pilot's Licence	
Commander's Age:	63	
Commander's Flying Experience:	Estimated 980 hours Last 90 days - Unknown Last 28 days - Unknown	
Information Source:	AAIB Field Investigation

Synopsis

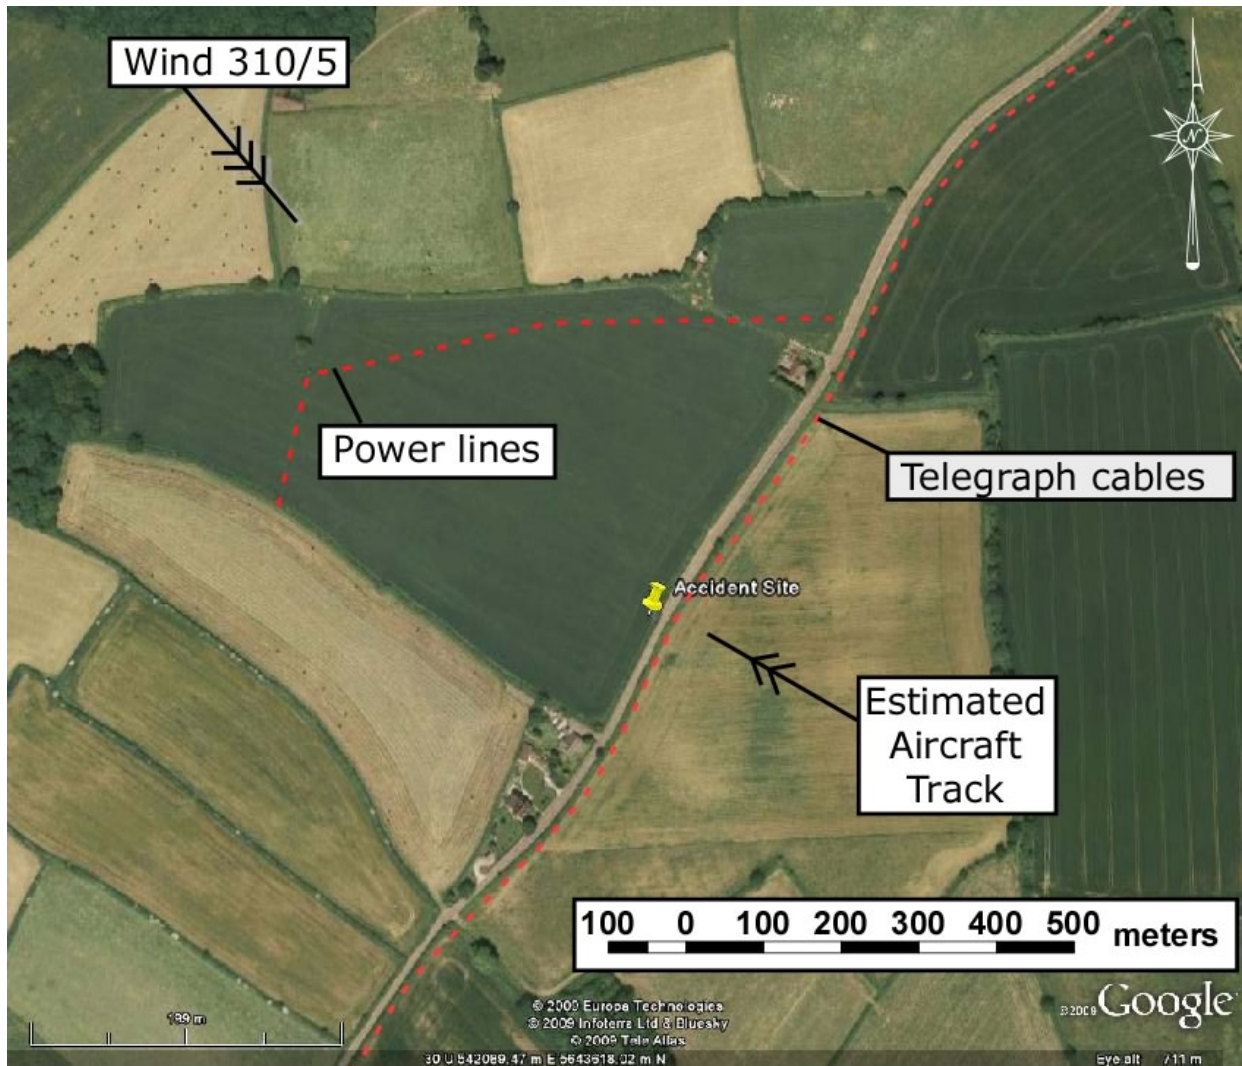
Figure 1

The aircraft had come to rest inverted just inside the hedgerow of a field of light crops to the north of the village of Stourton Caundle. The only ground mark had been made by the spinner of the propeller, which indicated an impact angle of 45° beyond the vertical.

A set of telegraph cables ran alongside the Stourton Caundle to Stalbridge road; this road ran parallel to the hedgerow boundary of the accident field. The cables consisted of several small wires wrapped in a black insulation material and supported by a steel rod; the diameter of the cable was 10 cm. Telegraph poles, spaced at 50 m intervals, supported two sets of the telegraph cables which were mounted on the poles at a height of 6.5 m (22 ft) above the ground. The cables were in parallel, with one wire in front of the pole and the other

behind. When struck by the aircraft, the telegraph cables had separated from the pole closest to the accident site; this pole had remained standing. The telegraph poles, both north and south of the accident site, had been uprooted. The cables had stretched to the extent that they were found lying on the hedgerow that bounded the accident site field. There was visible damage to the cable insulation and the internal wires.

Accident location

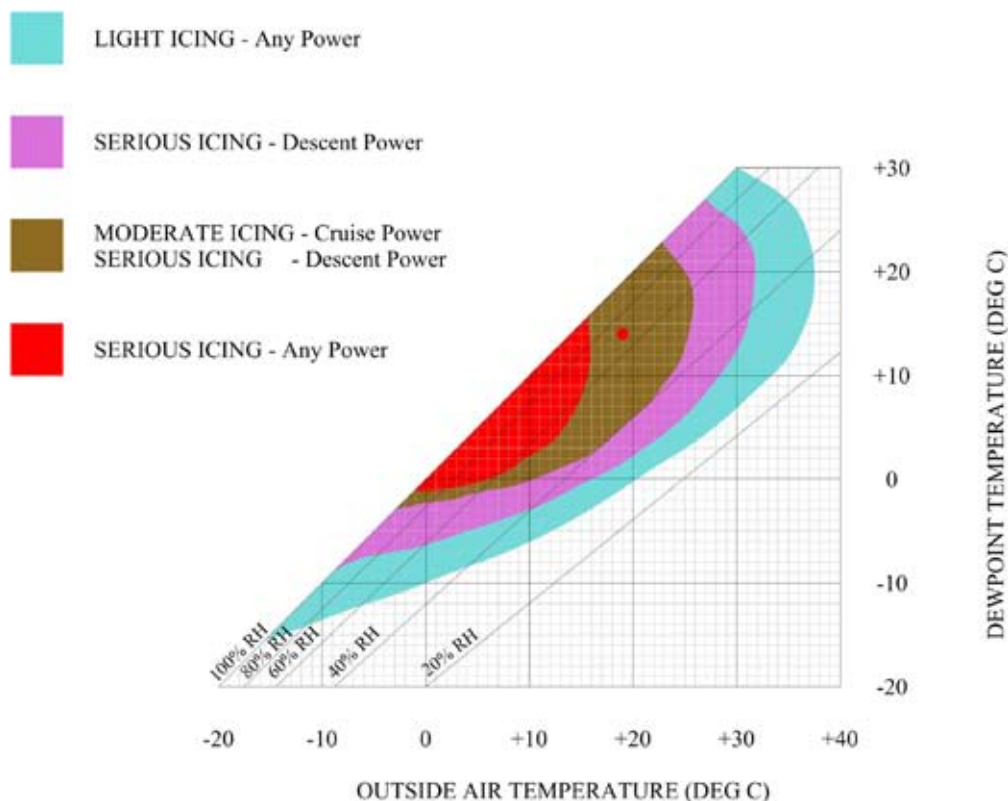
Figure 2
Carburettor icing prediction chart

The weather conditions at the time were such that carburettor icing could have been a possibility with moderate icing at cruise power and serious icing at descent power, Figure 2. The carburettor heat control was found in the COLD position.
