ACCIDENT

Aircraft Type and Registration:	1) Mooney M20J, G-JAST 2) Vans RV-4, G-MARX
No & Type of Engines:	1) 1 Lycoming IO-360-A3B6D piston engine 2) 1 Lycoming O-320-E3D piston engine
Year of Manufacture:	1) 1980 2) 1996
Date & Time (UTC):	4 September 2010 at 1600 hrs
Location:	Near Ryde, Isle of Wight
Type of Flight:	1) Private 2) Private
Persons on Board:	1) Crew - 1 Passengers - 1 2) Crew - 1 Passengers - 1
Injuries:	1) Crew - 1 (Fatal) Passengers - 1 (Fatal) 2) Crew - 1 (Minor) Passengers - 1 (Minor)
Nature of Damage:	1) Destroyed 2) Extensive damage to landing gear and right wing
Commander's Licence:	1) ATPL(A) 2) CPL(A)
Commander's Age:	1) 73 years 2) 32 years
Commander's Flying Experience:	1) 17,500 hours (of which 100 were on type) Last 90 days - 28 hours Last 28 days - 8 hours 2) 2,000 hours (of which 126 were on type) Last 90 days - 57 hours Last 28 days - 25 hours
Information Source:	AAIB Field Investigation

Synopsis

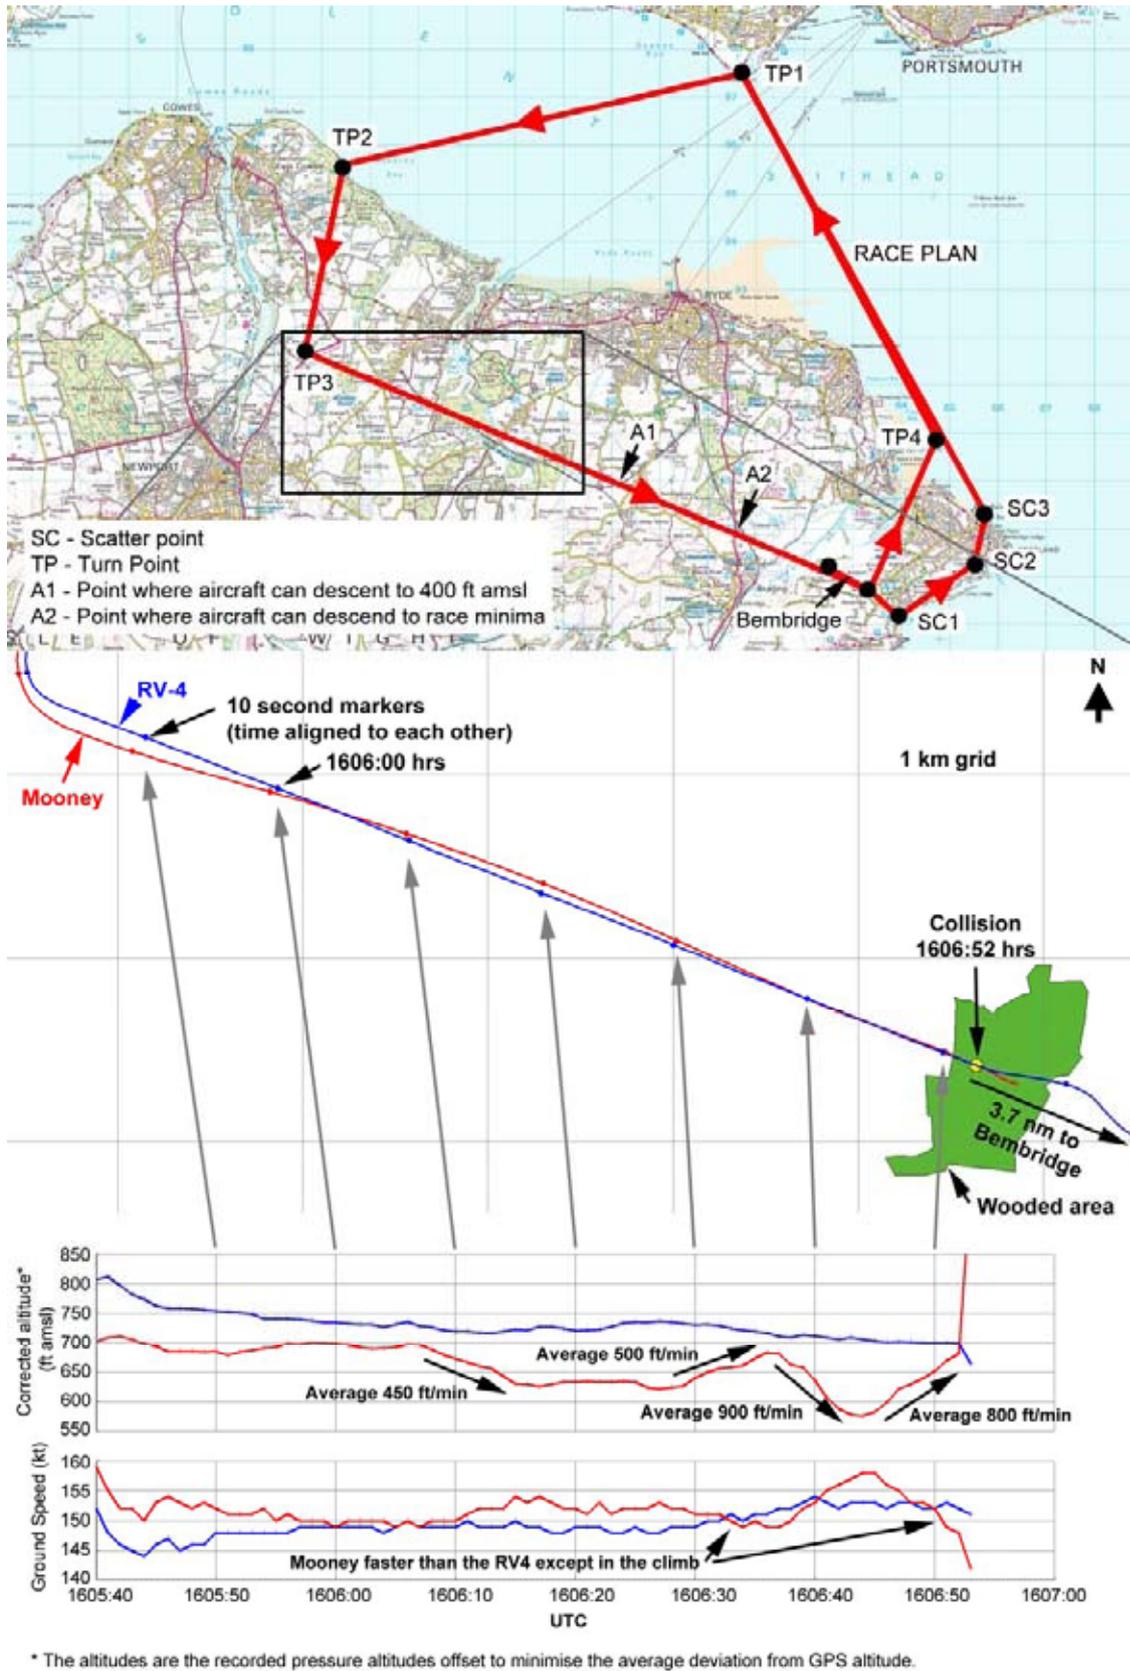
Figure 1
Relative motion of the two aircraft leading up to the impact

After the last turn on to the final straight of the fifth and final lap, the Mooney was below and to the rear and right of the RV-4. Figure 1 shows their relative positions and speeds. The RV-4 flew with a relatively stable speed and track, in a slow descent. Whilst

remaining below the RV-4, the Mooney tracked from the right side of the RV-4 to the left of its track. As it passed beneath the path of the RV-4, the Mooney started a descent, levelling off 70 ft lower. In doing so, it picked up speed and started to pass the RV-4 whilst below and to its left. The Mooney then started to climb and drifted to the right, losing speed, bringing it back to the right of the RV-4 but still beneath. This, in combination with a shallow descent and associated increase in the speed of the RV-4, resulted in a period of approximately seven seconds where the RV-4 was faster than the Mooney. The Mooney then drifted to the left of the RV-4, once more, while descending at a rate of approximately 900 ft/min, resulting in an increased speed and it pulling ahead of the RV-4. After losing 100 ft, it entered a climb, averaging about 800 ft/min, reduced speed again and climbed to the right closing on the RV-4 until the aircraft collided. The collision occurred at 1606:52 hrs at an altitude of about 675 ft amsl, over Rowlands Wood, approximately 3.7nm to the west of the Runway 12 threshold at Bembridge Airport.

The impact disrupted the still air environment inside the cockpits of both aircraft, making the pressure altitude readings unreliable, which explains the upward trace of the Mooney's altitude after the collision in Figure 1.

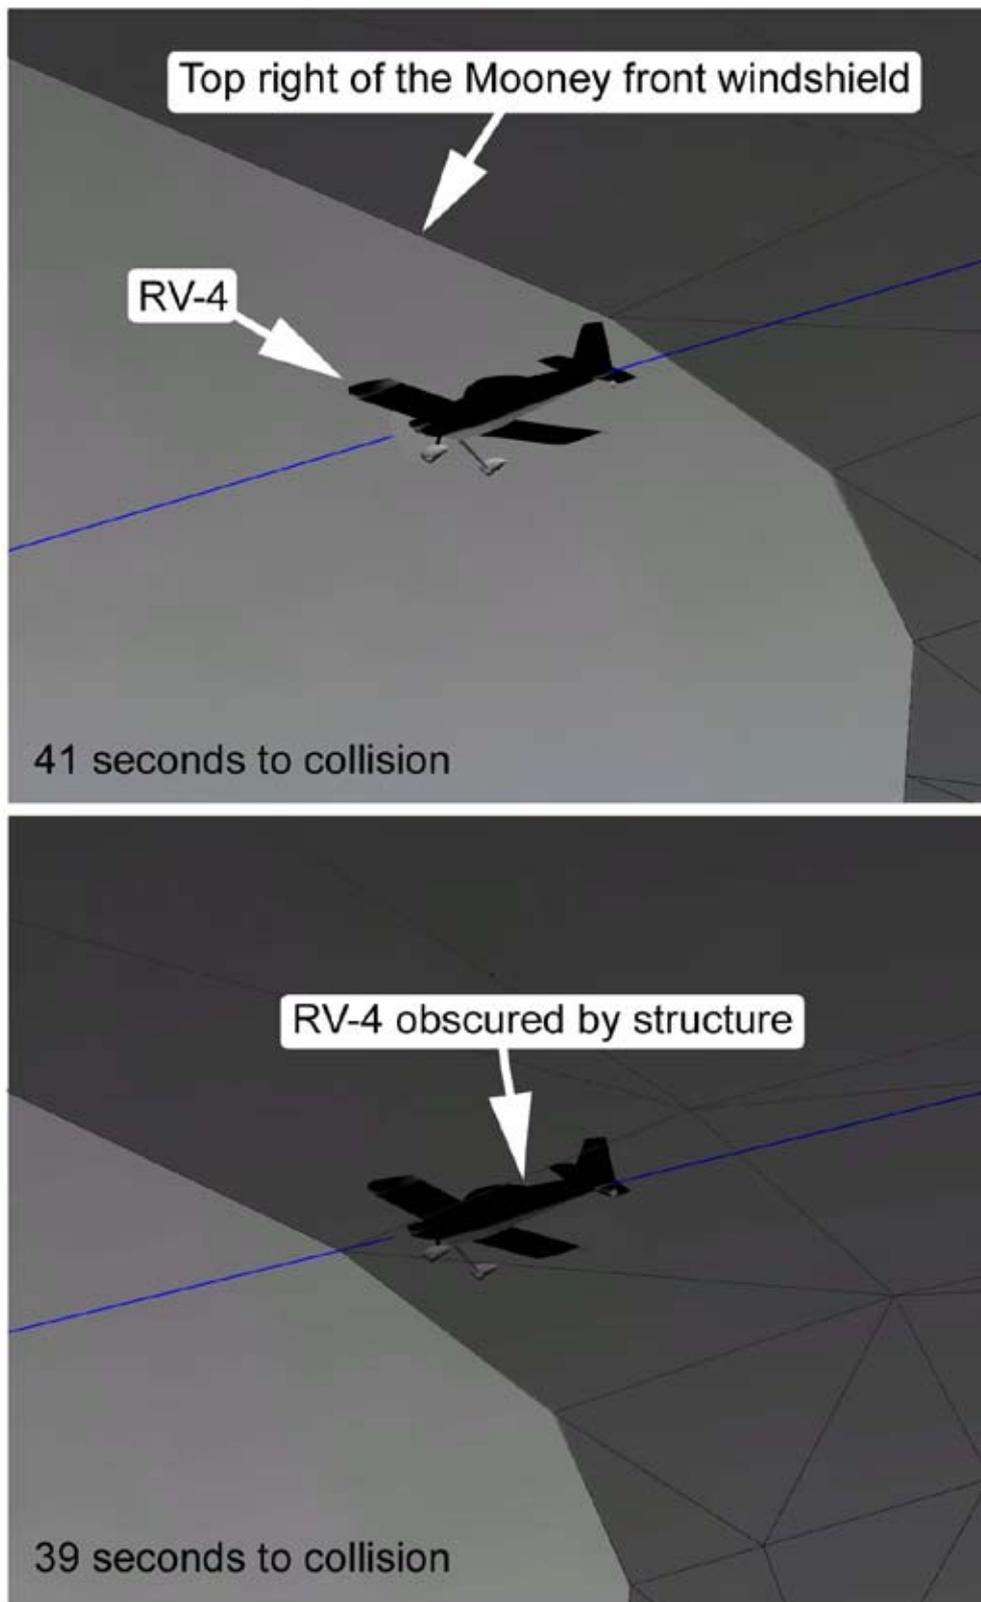
Figure 2

The results indicate that the RV-4 would not have been visible from the nominal Mooney pilot's position for 39 seconds before the collision (see Figure 2). Varying the parameters to account for modelling errors changed this result to between 37 and 44 seconds.

Illustration of the loss of line of sight of the RV-4 from the Mooney pilot's nominal eye position

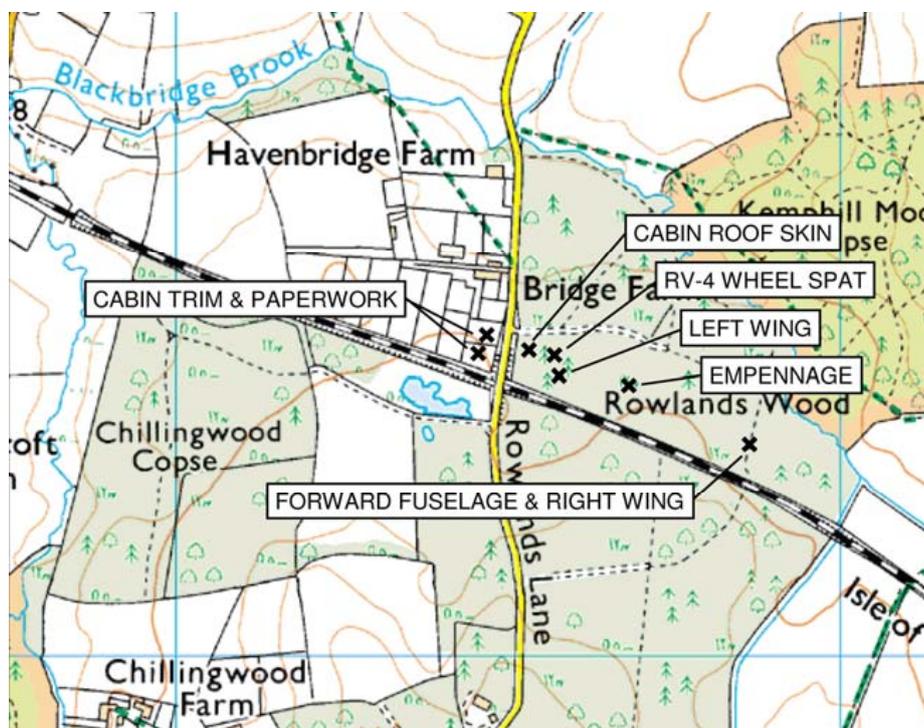
Figure 3
Wreckage plot

wind conditions which, combined with the relatively low height of the collision, resulted in little off-axis drift of the lighter wreckage (Figure 3). The wreckage trail was composed of the Mooney, broken into three major sections and many smaller pieces, and fragments of the forward section of the RV-4's right mainwheel spat. The majority of the wreckage came to rest in woodland, with a small quantity of lightweight material from the cabin of the Mooney being blown downwind into open fields immediately to the west of the wooded area.

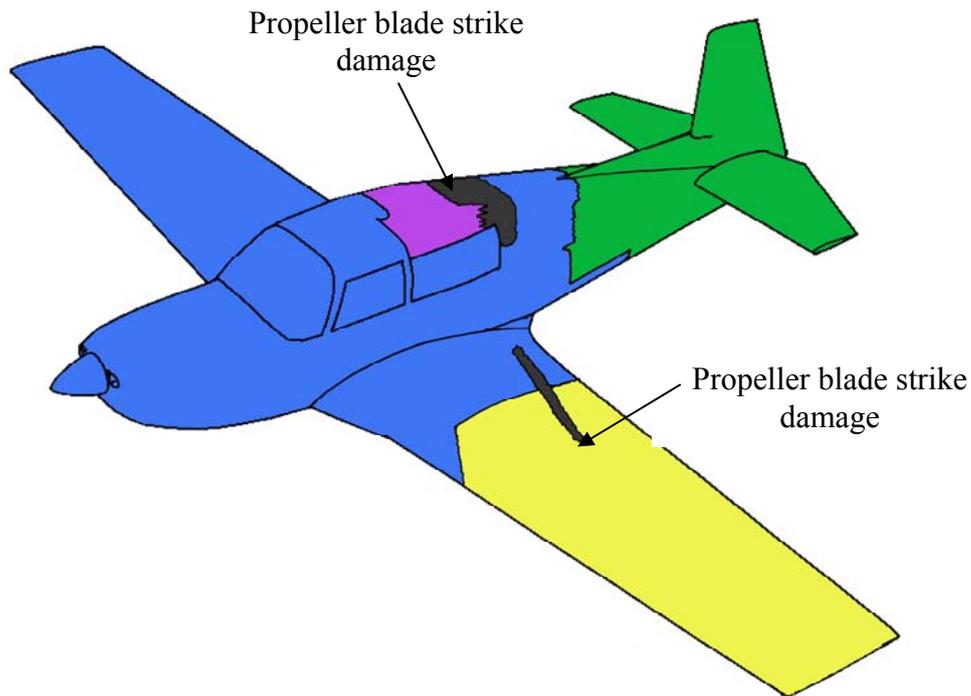
Figure 4

The Mooney had broken into three major sections:

- The right wing and fuselage, from the spinner rearwards to approximately 1.0 m behind the wing trailing edge and the inboard 0.9 m section of the left wing

- The empennage and rear fuselage section
- The left wing, which had separated at about 0.9 m outboard from the left fuselage side

Main sections of Mooney wreckage
