ACCIDENT

Aircraft Type and Registration:	Extra EA300L, G-DUKK	
No & Type of Engines:	1 Lycoming AEIO-540-L1B5 piston engine	
Year of Manufacture:	2000	
Date & Time (UTC):	19 June 2010 at 1501 hrs	
Location:	Methley Bridge, Castleford, West Yorkshire	
Type of Flight:	Aerial Work	
Persons on Board:	Crew - 1	Passengers - None
Injuries:	Crew - 1 (Fatal)	Passengers - N/A
Nature of Damage:	Aircraft destroyed	
Commander's Licence:	Airline Transport Pilot's Licence	
Commander's Age:	31 years	
Commander's Flying Experience:	3,600 hours (of which 70 were on type) Last 90 days - 33 hours Last 28 days - 13 hours	
Information Source:	AAIB Field Investigation

Synopsis

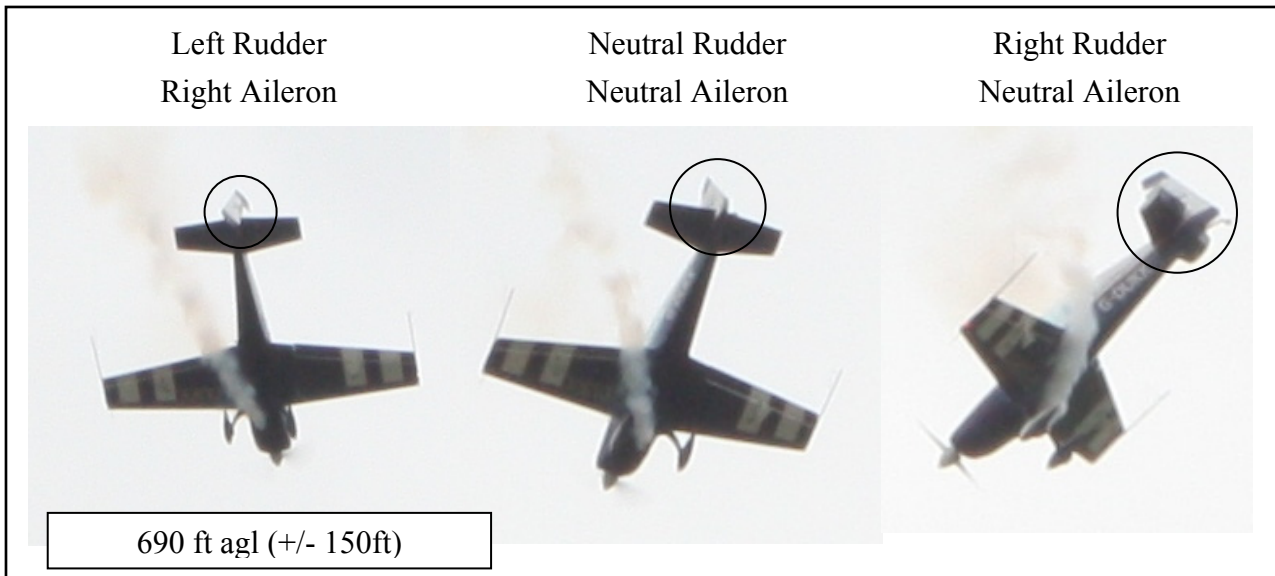
Figure 2

A sequence of photographs showed the aircraft in a flat spin, showing when pro-spin control inputs² were removed and the correct spin recovery control inputs (right rudder and neutral aileron) were made (Figure 2). The NIEC established that the aircraft was at a height of 690 ft (\pm 150 ft) when the spin recovery was initiated.

G-DUKK spin recovery initiation from a left turning flat spin
 All three pictures taken within one second
 (photographs courtesy Paul McCormick)

The pilot's DA approved a minimum aerobatic display height of 300 ft. Flight observations in a similar aircraft showed consistently that 1,000 ft was required to recover the aircraft to level flight from a flat spin. Therefore, to achieve this, the pilot would have needed to initiate the recovery from the spin at a height of 1,300 ft. Photographic evidence indicated that the recovery was initiated at 690 +/-150 ft agl.

From this height flight observations indicated a safe recovery would not have been possible.

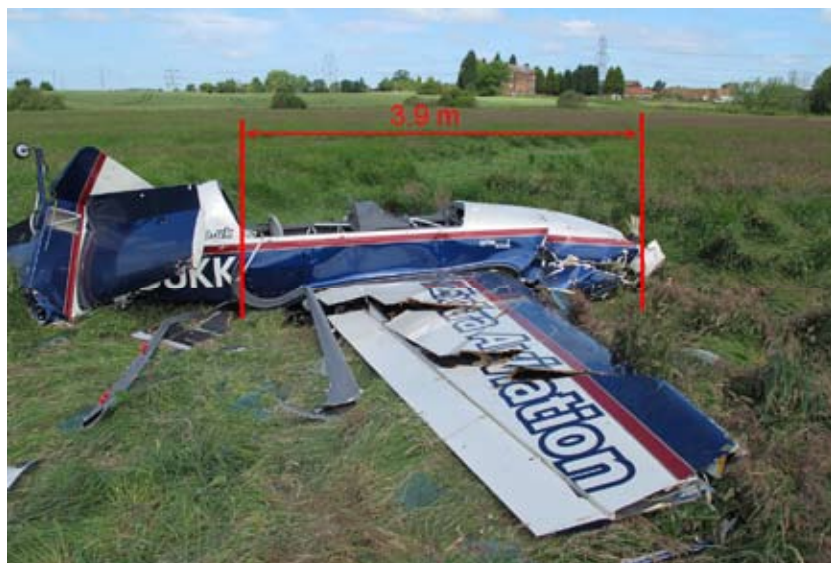
Figure 3

The wreckage of the aircraft was found upright in a flat field of tall grass, approximately 200 m north-east of Methley Bridge, Castleford (Figure 3). The aircraft had travelled a distance of just 3.9 m from its initial impact point to its final resting point, indicating a steep nose down impact, consistent with the video and still imagery. All three propeller blades had separated near their roots indicating that they had a high rotational energy at impact. The steel-tube airframe had sustained numerous overload failures, and the composite wing upper and lower surfaces were destroyed. The empennage had failed in bending overload due to the inertial forces at impact. There was no evidence of any pre-impact separations.

Aircraft wreckage – the distance from nose impact point to nose resting point was 3.9 m.

The evidence from the accident site revealed that the aircraft had come to rest in a horizontal distance of just 3.9 m. The evidence from the video analysis indicated a final impact speed of at least 100 kt. This would have resulted in an overall deceleration during impact of at least -339 m/s^2 , which is equal to 34.6 g. The peak g at impact would probably have been approximately double this value. This is considerably in excess of the 9g certification requirement for the EA300 and also in excess of the current 26g requirement for emergency landing conditions.

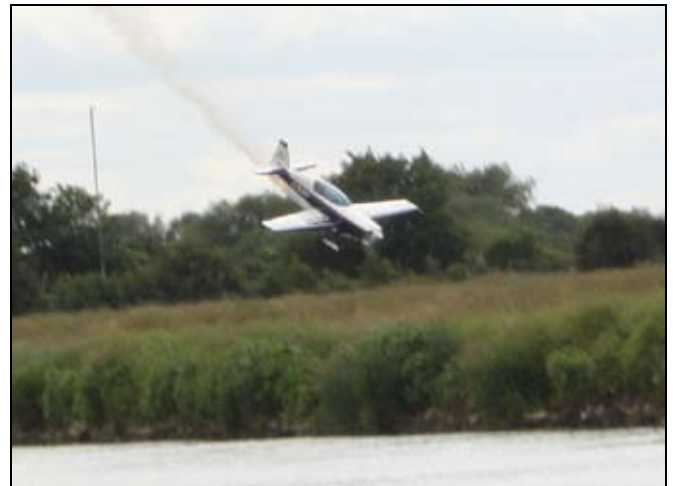
Figure 4

Video evidence of the aircraft just prior to impact revealed that at approximately 100 ft agl it was in a nose-down attitude of $-40^\circ (\pm 5^\circ)$, with a flight path angle of $-53^\circ (\pm 5^\circ)$ and a groundspeed of at least 100 kt (120 ± 20 kt). The last available still image of the aircraft (Figure 4) shows the aircraft in a nose-down

attitude of -25° ($\pm 5^\circ$) just prior to impact. This image also revealed that the aircraft's smoke system was active until impact.

G-DUKK moments before impact – nose-down pitch angle estimated at 25° ($\pm 5^\circ$)
