AAIB Bulletin No: 1/94

Ref: EW/G93/09/13

Aircraft Type and Registration: Denney Kitfox Mk 3, G-BUDR

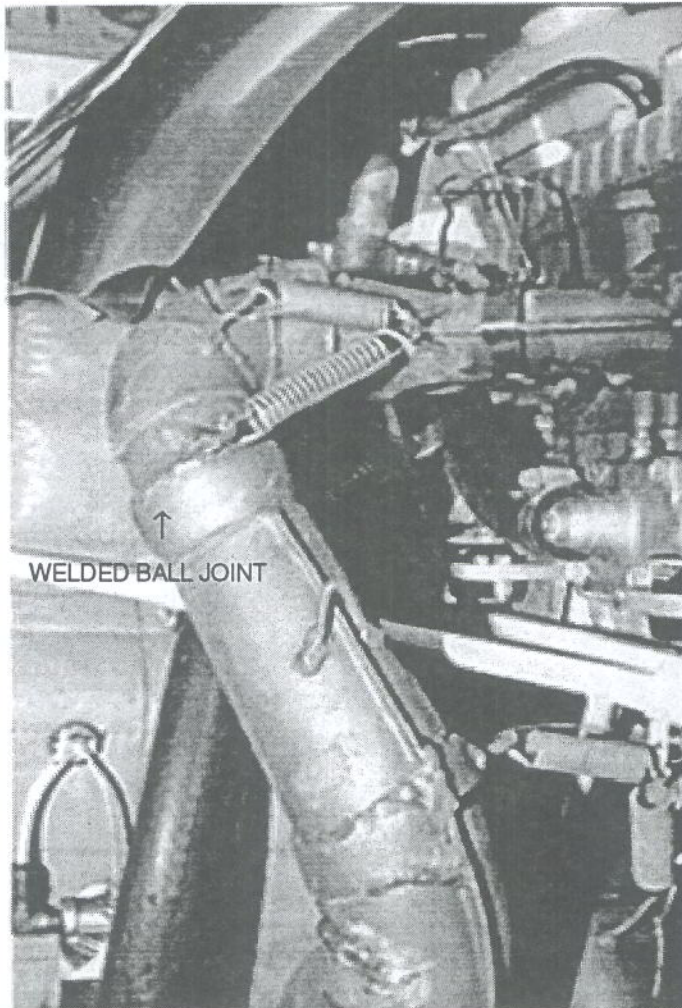
The original design of the exhaust pipe between the manifold and the exhaust box included one ball joint to reduce the transmission of movement and vibration to the exhaust system. The single ball joint allowed simple installation, but it was found that the exhaust system life was too low due to vibration. Consequently a double ball jointed system was introduced to improve exhaust component lives.

On 'DR' the ball joints were originally located by two diametrically opposed springs located at positions around the joint, and experience showed that these springs were unable to stop the joint vibrating apart. The lower ball joint was therefore welded, effectively returning the exhaust to the original state of one ball joint, and the springs on the remaining joint were doubled up to provide more positive location.

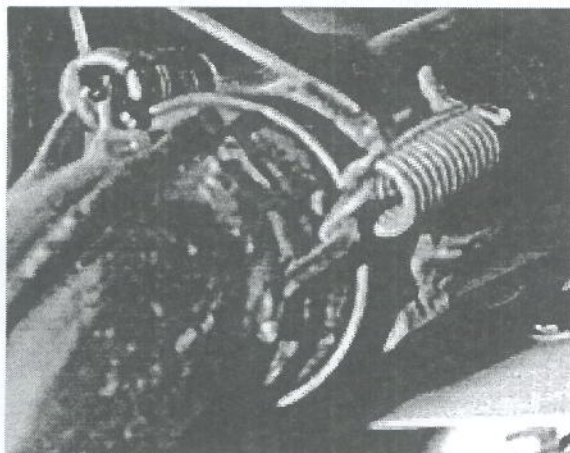
A Rotax Service Information publication requires that all ball joints should be lubricated regularly with heat resistant grease, however the remaining ball joint on 'DR' was dry when inspected by the AAIB.

The UK engine distributor strongly recommends the use of three springs to retain each ball joint and stated that engine kits supplied to the aircraft manufacturers had three springs per exhaust joint, but that the suspension hooks are supplied loose, not welded onto the pipes, allowing individual aircraft types to specify different hook locations.

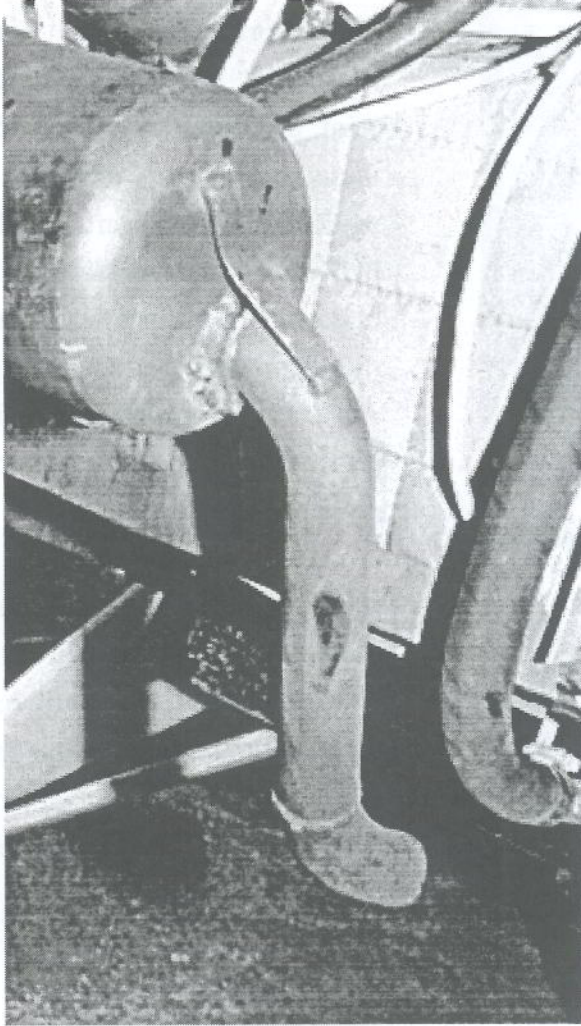
Extension to exhaust pipe

Faced with continued fumes in the cockpit the owner consulted the PFA who liaised with the distributor. The problem was ascribed to too short an exhaust pipe allowing fumes to enter the cockpit through gaps in the cabin door.

The solution agreed upon by all three parties was to extend the exhaust pipe with a welded-on pipe. This change was embodied, but the pipe was found to vibrate excessively, possibly exacerbated by the effects of the welded lower ball joint. For this reason the extended tail pipe was subsequently shortened by 3 to 4 inches.

A further problem then appeared when the outlet face of the exhaust box failed just above the weld locating the outlet pipe, this was repaired by welding with the addition of a bracket to stiffen the joint.

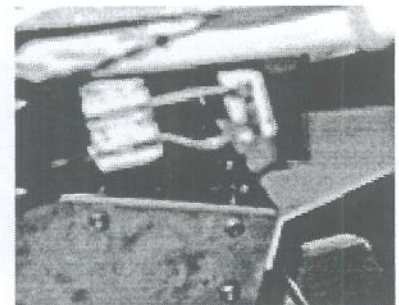
After the accident a kink in the oil control cable at the throttle bellcrank between the nipple and the outer sleeve was discovered, it was not determined whether the kink was caused by the oil valve sticking, or whether the kink caused the oil valve to remain in the open position. However this may have made the fumes entering the cockpit more noticeable.
