ACCIDENT

Aircraft Type and Registration:	i) Airbus A340-313, 6Y-JMP ii) Boeing 777-222, N781UA
No & Type of Engines:	i) 4 CFM56-5C turbofan engines ii) 2 Pratt & Whitney PW4000 turbofan engines
Category:	1.1
Year of Manufacture:	i) 1992 ii) 1996
Date & Time (UTC):	14 July 2004 at 1254 hrs
Location:	Runway 27L Holding Area, London Heathrow Airport
Type of Flight:	i) Commercial Air Transport (Passenger) ii) Commercial Air Transport (Passenger)
Persons on Board:	i) Crew - 4 Passengers - 273 ii) Crew - N/K Passengers - N/K
Injuries:	i) Crew - N/K Passengers - N/K ii) Crew - None Passengers - None
Nature of Damage:	i) Damage to left winglet ii) Damage to right wing tip
Commander's Licence:	i) N/K ii) Air Transport Pilot's Licence
Commander's Age:	i) N/K ii) 47 years
Commander's Flying Experience:	i) N/K ii) 20,000 hours (of which 806 were on type) Last 90 days - 230 hours Last 28 days - 60 hours
Information Source:	AAIB Field Investigation

Synopsis

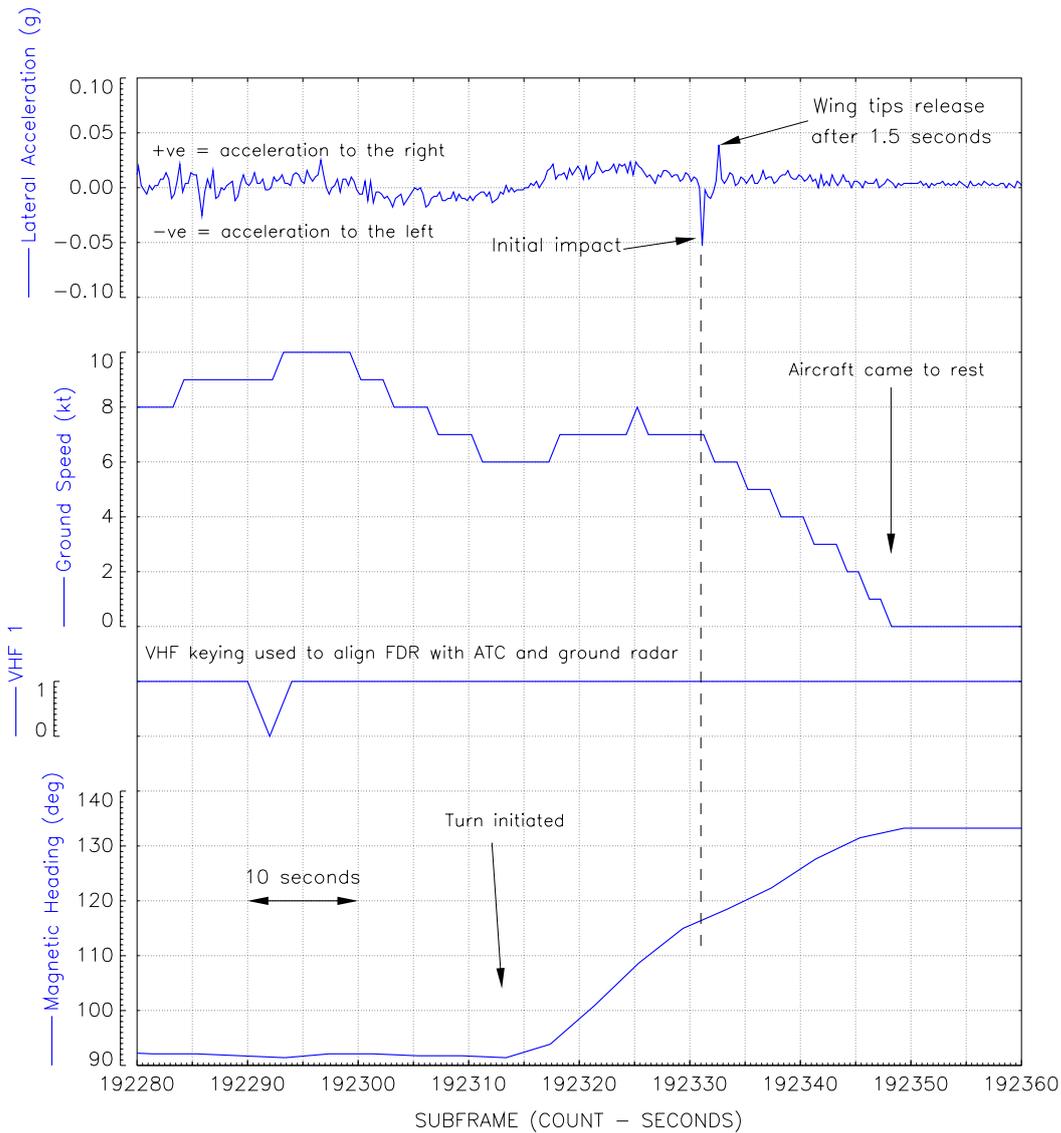
Figure 3
Key FDR parameters from the B777.
Accident to N781UA / 6Y-JMP on 14 July 2004 at Heathrow

The data confirmed that the B777, which was crossing behind the stationary A340, was turning to take up a heading parallel to the A340 on its right. At the time the B777's right wingtip struck the rear of the A340's left wingtip, it was travelling at approximately 7 kt, and turning right, resulting in a wingtip speed of approximately 2.7 kt. The wingtip impact generated a lateral acceleration (g) of 0.05g to the left and, after the B777's wingtip rubbed along the A340 wingtip for approximately 1.5 seconds, a spike

of 0.04g to the right. At this point the aircraft's speed was recorded as 6 kt and its magnetic heading samples either side of the initial impact g spike were recorded as 115°M and 118.5°M.
