No: 4/87

Aircraft type and registration: Bensen B8-V Gyrocopter G-BIOT

Date and time (UTC): 27 November 1986 at 1200 hrs

Location: 1/2 nm north of runway 18 at Dunkeswell airfield

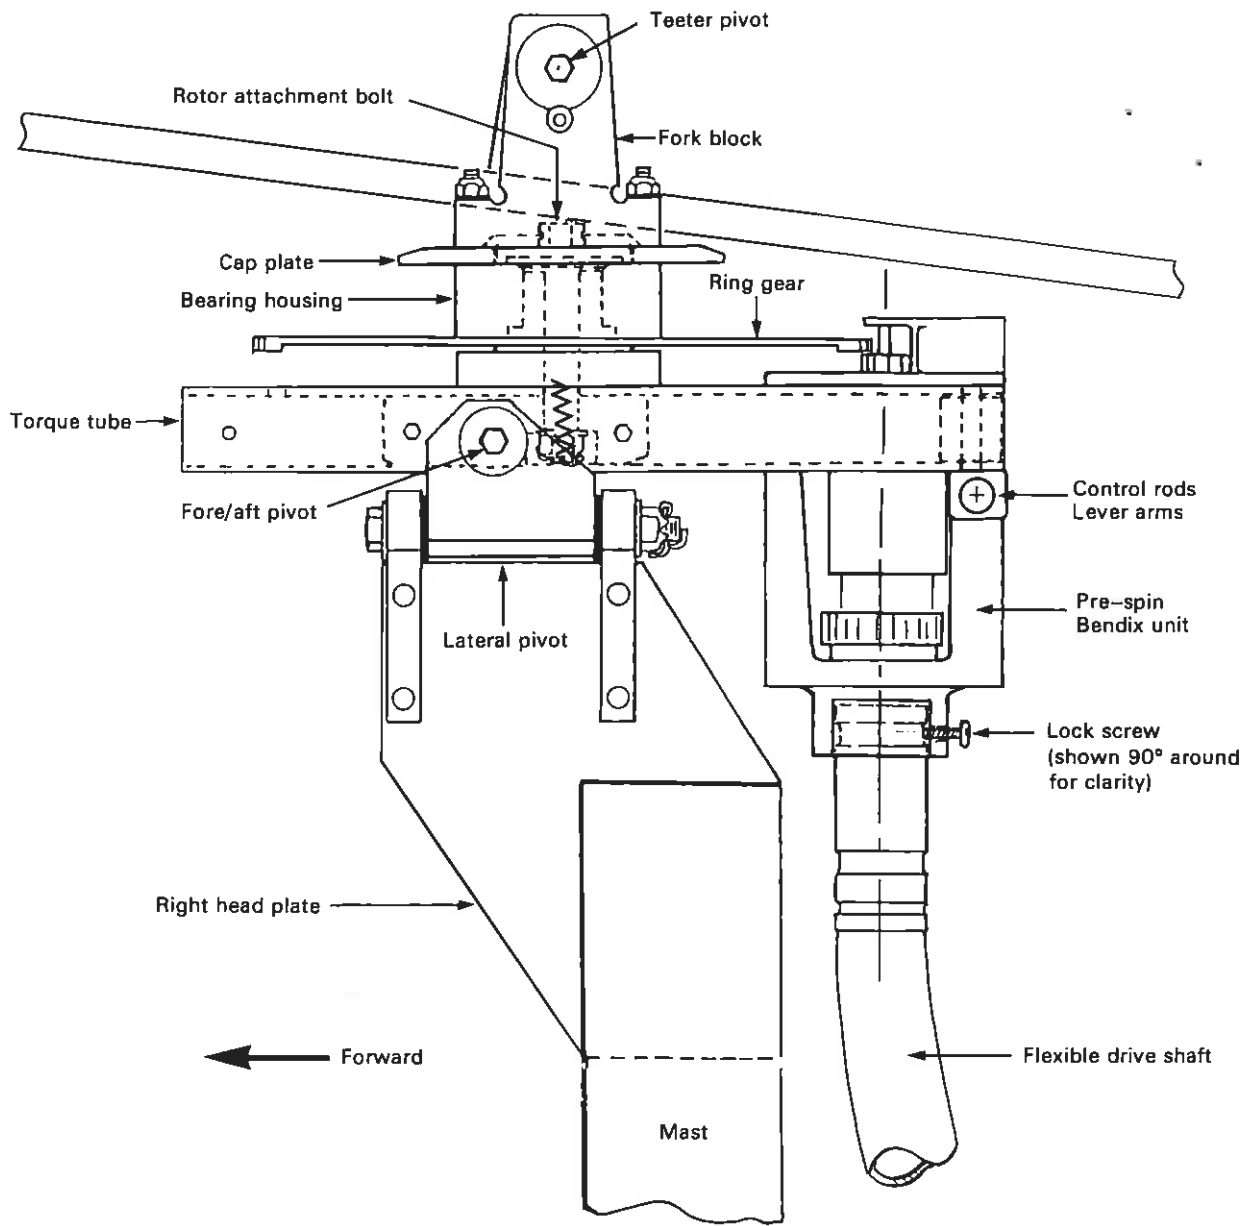
It was quickly established that all the flying control linkages and cables were intact and that the autogyro's main structure had been intact prior to impact. However, when the area of the mast head was excavated during the recovery, it immediately became apparent that a major failure had occurred in the rotor control system, in particular to the component known as the torque tube, see Fig.1.

This tube, which is made from extruded square section aluminium alloy, acts as the main support for the rotor assembly. It is pivoted to provide the fore and aft lateral control for the rotor and, at the rear, mounts the operating arms for the control rods. In addition in this area is mounted the Bendix unit, which is part of the rotor pre-spin system. A counterbored alloy block, which provides one half of the fore/aft control stop and local re-inforcement for the rotor attachment bolt, is positioned into this tube through a cutout in its lower surface.

GENERAL ARRANGEMENT OF ROTOR HEAD
 SHOWING POSITION OF FAILURE (Σ)

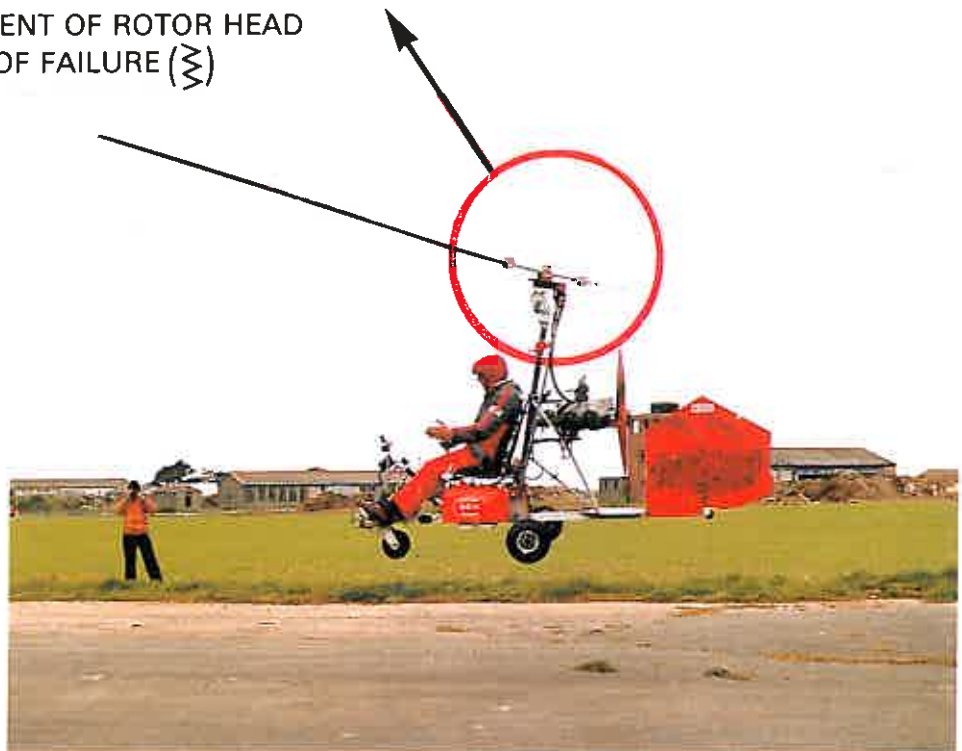
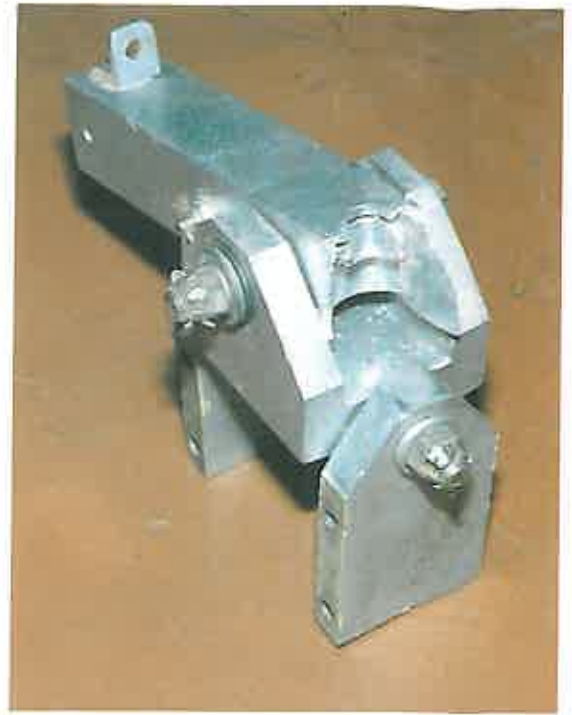
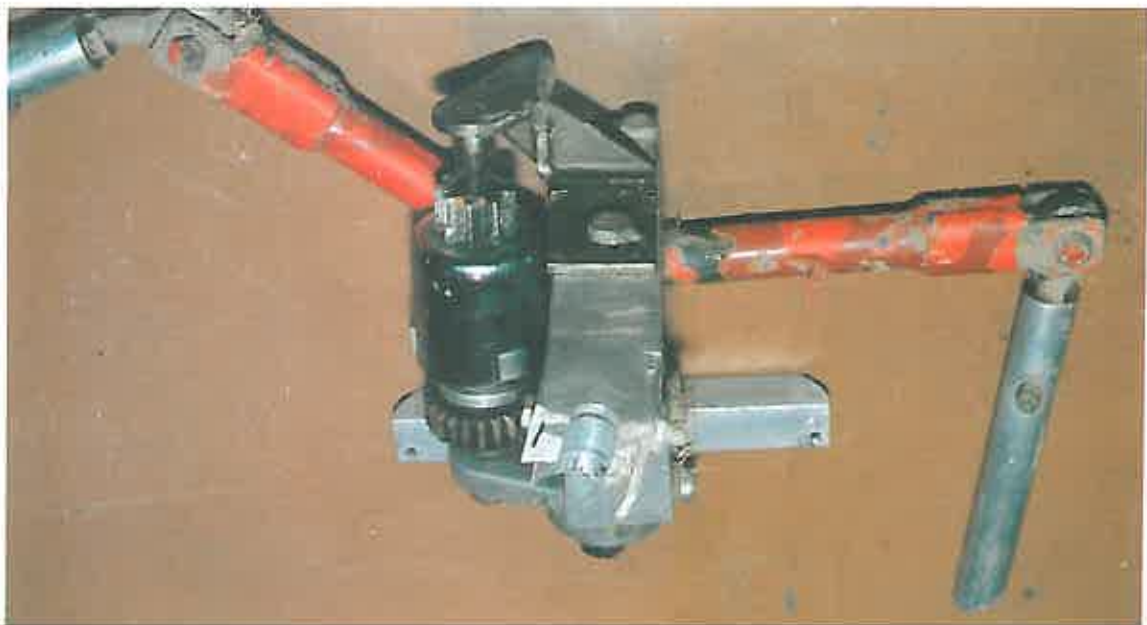
FIGURE 2

Detailed examination of this component revealed its dimensions and material strength not to be in question, and that the mode of failure was predominantly one of torsion, see Fig.2. It was apparent that high torsional load had been experienced from the rear end of this tube upto the position of the rotor bolt attachment hole, sufficient to cause failure at a section through this hole and gross distortion of the material in the region of the central cutout. The sense of this torque was clockwise when seen from the rear. Little or no damage was present on the tube forward of the rotor bolt hole, but some was present, however, on all of the control head stops.

After contacting the propeller, it would therefore seem that the flexible drive shaft was rotated with some force about its upper attachment point, causing the control head torque tube to twist and fail, in turn leading to rotor detachment.

FORWARD SECTION OF
TORQUE TUBE

VIEWS OF TORQUE TUBE SHOWING FAILURE
AND DISTORTION OF AFT SECTION

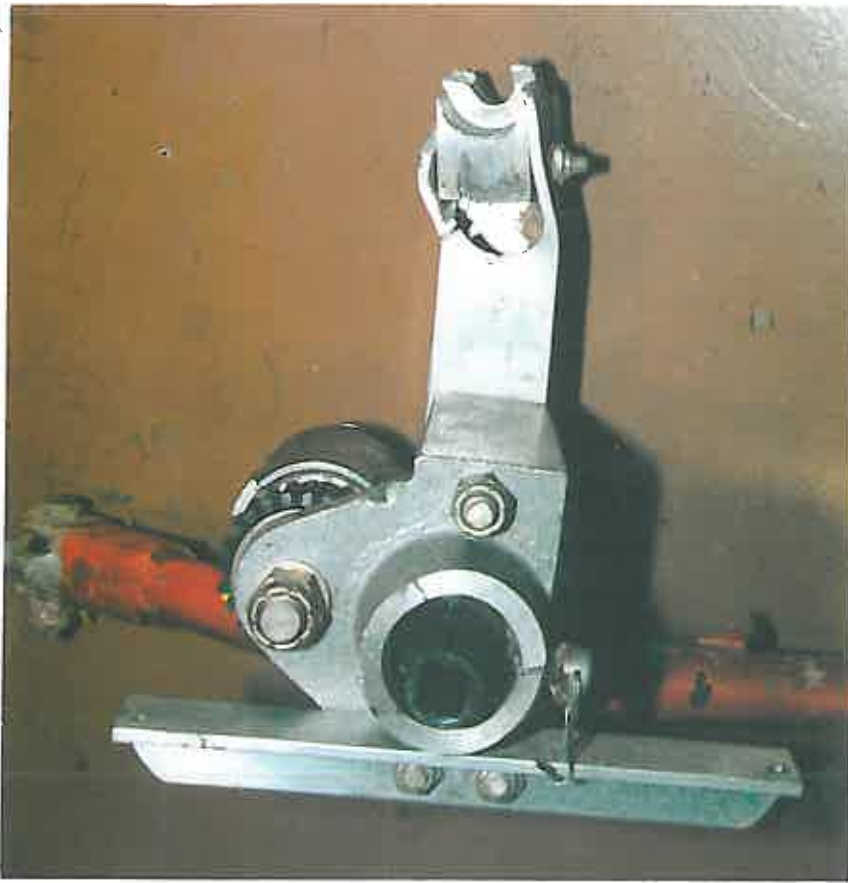
Examination of this drive shaft revealed that a significant amount of surface damage was present at a position several inches up from its lower end which was co-incident with a sharp kink of the whole shaft. When loosely re-assembled onto a re-construction of the wreckage it became apparent that a hard contact had occurred between the propeller and this shaft, the propeller blade failing against the direction of rotation but in the plane of rotation. Examination of the upper attachment of the shaft revealed the sleeve to have been forcibly rotated in the socket against the locking screw in a direction consistent with propeller contact and that the walls of this socket were split as a result of overload. By comparison, the walls of the lower

VIEW OF UNDERSIDE – SHOWING DAMAGE TO SOCKET
