Aircraft Type and Registration:	Cessna 310Q, G-EGEE	
No & Type of Engines:	2 Continental IO-470-VO piston engines	
Year of Manufacture:	1969	
Date & Time (UTC):	18 May 1994 at 1406 hrs	
Location:	Norwich Airport, Norfolk	
Type of Flight:	Private	
Persons on Board:	Crew - 1	Passengers - None
Injuries:	Crew - None	Passengers - N/A
Nature of Damage:	Left main landing gear, left wingtip under surface and aileron, dorsal fin, left tailplane and elevator, left propeller and engine	
Commander's Licence:	Private Pilot's Licence with IMC and Night Ratings	
Commander's Age:	44 years	
Commander's Flying Experience:	2,609 hours (of which 560 were on type) Last 90 days - 3 hours Last 28 days - 2 hours	
Information Source:	Aircraft Accident Report Form submitted by the pilot and inspection by the AAIB

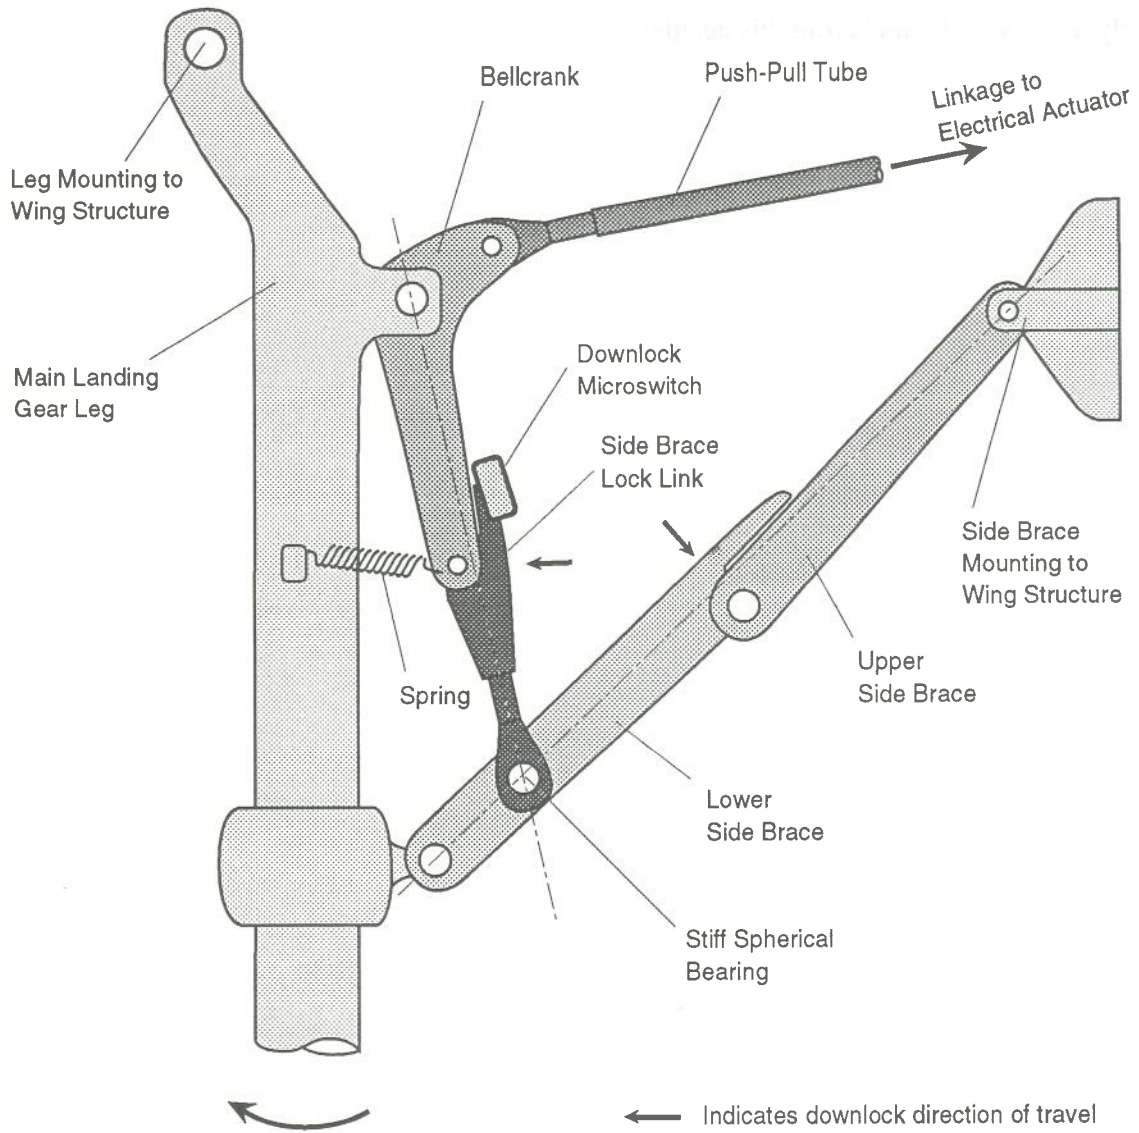
Fig 1

Inspection of the left main landing gear revealed failures of the bellcrank pivot bolt, one of the bellcrank pivot bolt lugs and the side brace lock link on the threaded portion of the eye-end (see Fig 1). Examination of the fractures indicated that all of the failures had resulted from overload and no evidence of any pre-existing defect was found. The failures were consistent with the locking mechanism having been subjected to gear side loads on landing due to the upper and lower side braces not having been overcentred.

The downlock microswitch is activated to illuminate the gear down green light indication by the side brace lock link overcentring and this could occur with the side brace not overcentred if the landing gear were not correctly rigged. The component failures precluded a post-accident check of the left main gear rigging. The main landing gear rigging had not been disturbed as part of the C of A renewal and the last work on the main landing gear recorded in the aircraft log book took place in January 1991, approximately 300 flying hours before this accident.
