**ACCIDENT**

<b>Aircraft Type and Registration:</b>	Fokker F27-500 Friendship, G-BVOB
<b>No &amp; Type of Engines:</b>	2 Rolls-Royce Dart 532-7 turbo prop engines
<b>Category:</b>	1.1
<b>Year of Manufacture:</b>	1968
<b>Date &amp; Time (UTC):</b>	22 March 2005 at 1140 hrs
<b>Location:</b>	Runway 27, Guernsey Airport, Channel Islands
<b>Type of Flight:</b>	Public Transport (Cargo)
<b>Persons on Board:</b>	Crew - 2                      Passengers - None
<b>Injuries:</b>	Crew - None                Passengers - N/A
<b>Nature of Damage:</b>	Damage to left landing gear, wheels and brakes
<b>Commander's Licence:</b>	Airline Transport Pilot's Licence
<b>Commander's Age:</b>	58 years
<b>Commander's Flying Experience:</b>	10,611 hours (of which 8,231 were on type) Last 90 days - 32 hours Last 28 days - 20 hours
<b>Information Source:</b>	Aircraft Accident Report Form submitted by the pilot and additional AAIB enquiries

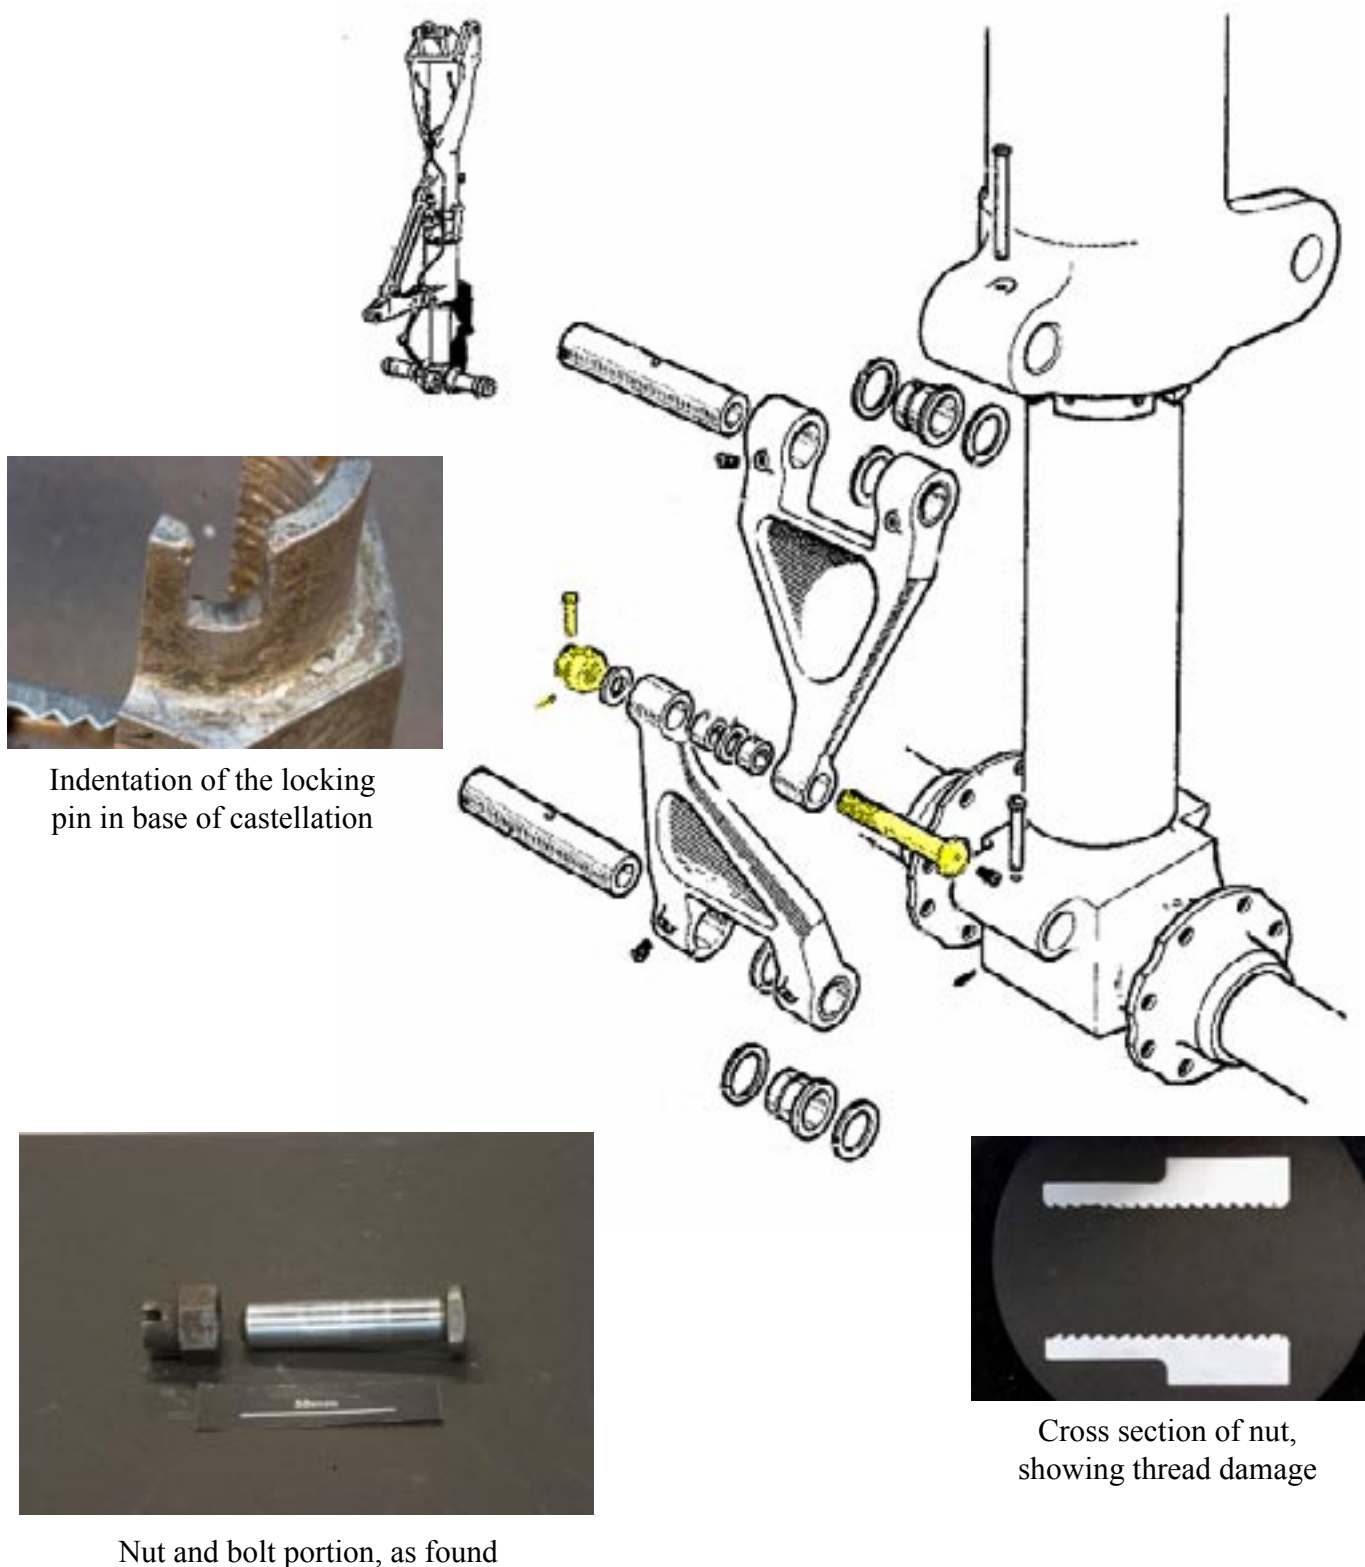
**Figure 1**

An illustration of the main landing gear torque link assembly is shown at Figure 1, where it can be seen that the centre torque link bolt is retained by the castellated nut together with a headed locking pin and a split pin. The last two items were also not recovered, and it was considered likely that, assuming they had been present at the time of the incident, they had remained with the missing portion of the bolt.

The bolt had failed at the run-out of the threaded section, and examination under a scanning electron microscope revealed the presence of ductile dimples, which are a characteristic of ductile overload, across the entire fracture surface. There was no evidence of progressive crack growth, such as fatigue, and there was no evidence of bending. It was concluded that the observed features were consistent with the failure occurring as a result of an axial tensile overload.

Inside the nut, the threads had been severely damaged, consistent with an axial load having been applied in a direction away from the head of the bolt. The metallurgical examination observed that although the crests of the threads had been flattened, they did not appear to have been stripped.

It was noted that the bottom of two opposite castellations showed evidence of witness marks that indicated that the locking pin had been present at least at some stage during the life of the nut.

Main landing gear layout, showing details of torque link components
