INCIDENT

Aircraft Type and Registration:	Lockheed L1011-385-1-14 Tristar, G-BBAH
No & Type of Engines:	3 Rolls-Royce RB211-22B turbofan engines
Year of Manufacture:	1974
Date & Time (UTC):	20 June 1995 at 1645 hrs
Location:	32°50' North 014°20' West
Type of Flight:	Public Transport
Persons on Board:	Crew - 14 Passengers - 401
Injuries:	Crew - None Passengers - None
Nature of Damage:	Rupture of rear pressure bulkhead
Commander's Licence:	Airline Transport Pilot's Licence
Commander's Age:	48 years
Commander's Flying Experience:	7,000 hours (of which 2,000 were on type) Last 90 days - 110 hours Last 28 days - 58 hours
Information Source:	AAIB Field Investigation

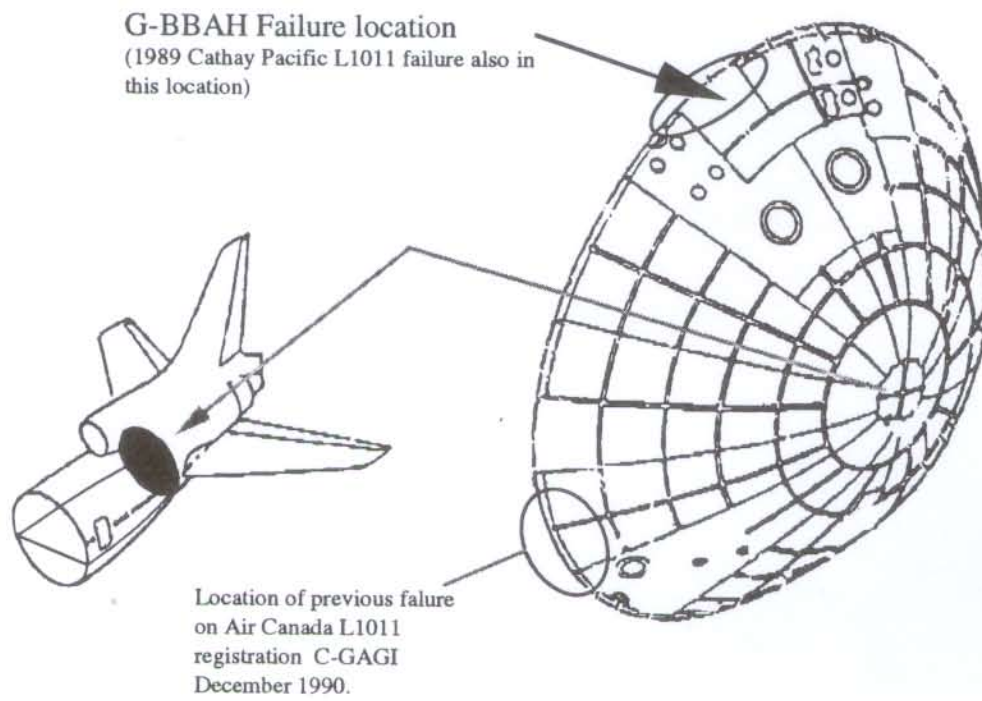
Figure 1

The rear pressure bulkhead is a thin shell structure comprising a series of 1 mm (0.040 inch) thick gore panels lapjointed to form a dome-shaped pressure membrane of approximately hemispherical profile, overlaid with a network of doublers and anti-tear straps as shown in Figure 1.

The sudden decompression was caused by a partial failure of the rear pressure bulkhead at the location shown in Figures 1 and 2.

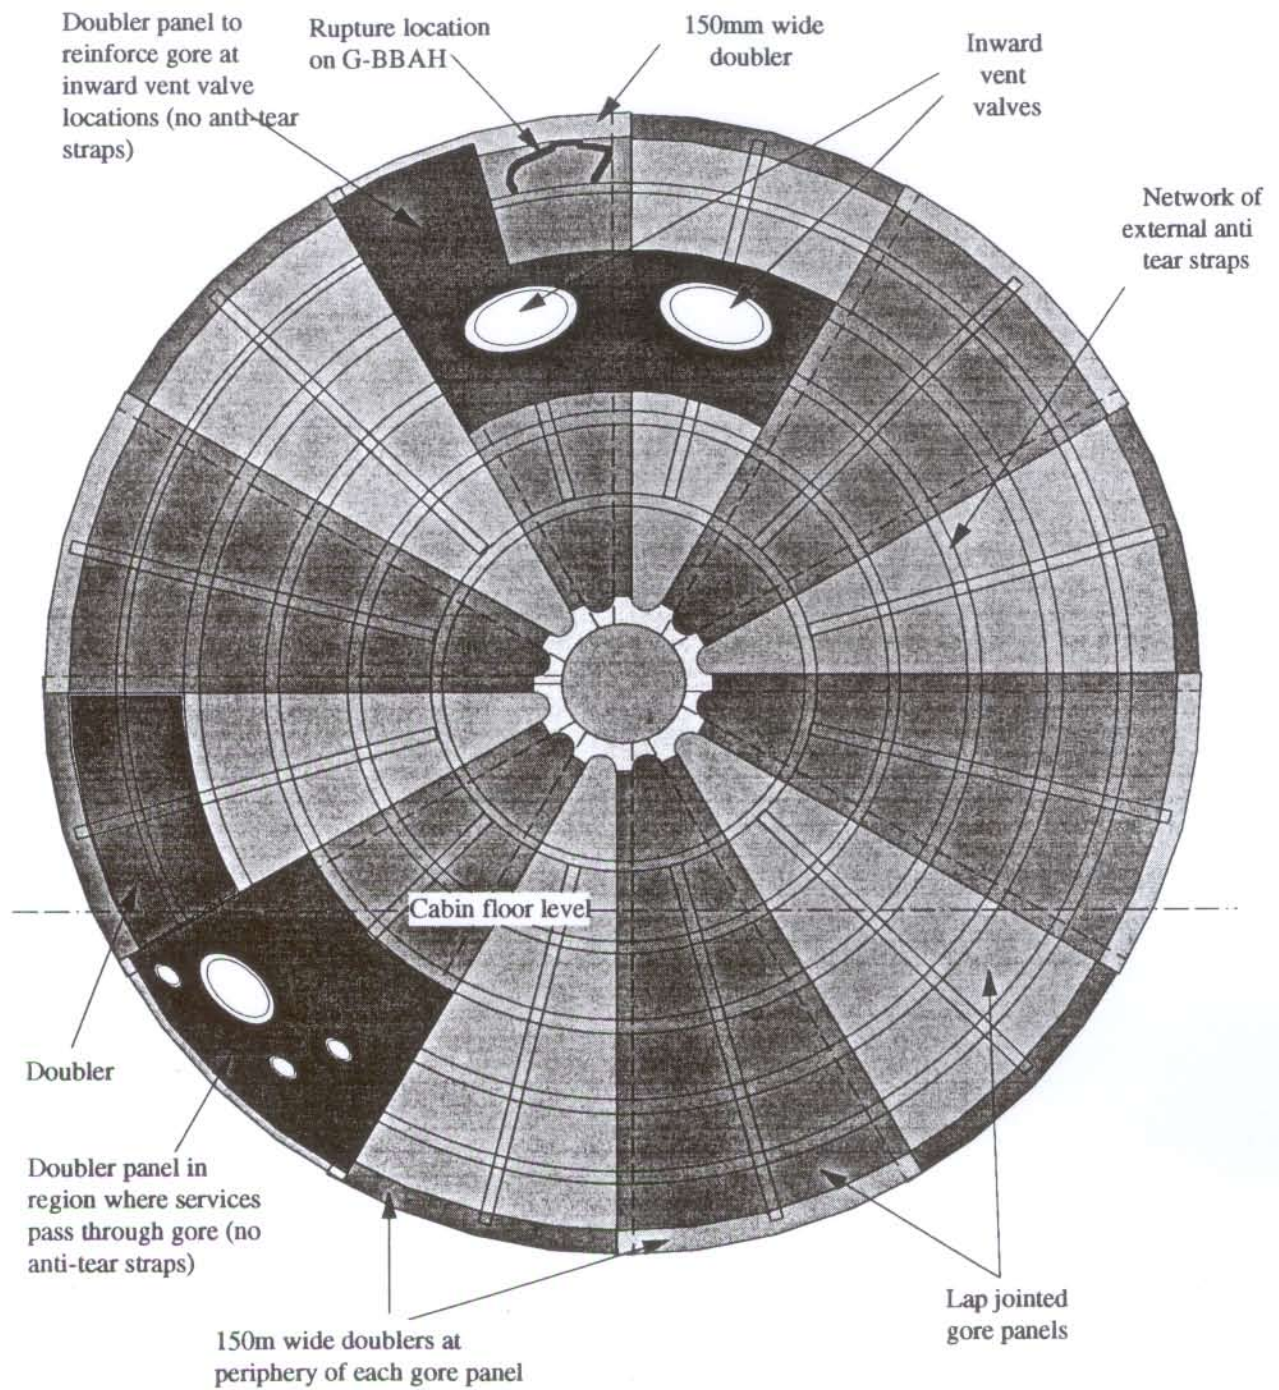
Figure 2

Constructional details are shown in Figure 2. The gore panels are lap-jointed alternately on the forward and aft sides of the nominal membrane surface, producing a 'handed' form of construction. A series of radial and circumferential anti-tear straps, bonded in a *waffle* pattern to the aft face of the bulkhead, subdivide each of the gore panels into ten elements of approximately rectangular shape. The purpose of the anti-tear straps is to limit the size of any rupture which might occur by encouraging tears to turn away from the anti-tear straps, resulting in a 'U' shaped *flap* which can blow outwards safely, venting the differential pressure across the bulkhead and inhibiting further propagation of the failure.

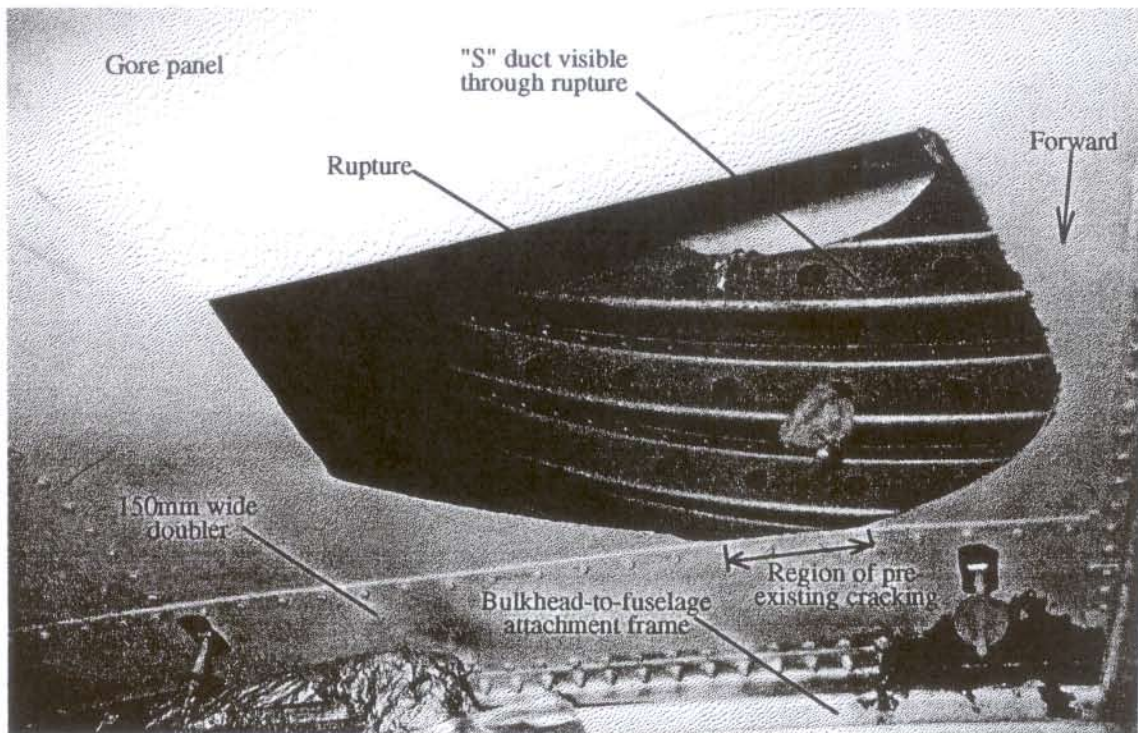
The failure comprised a 394 mm (15.5 inches) by 292 mm (11.5 inches) *letterbox* rupture of the pressure membrane at the top of the bulkhead just to the left of the aircraft centreline, immediately inboard of the 150 mm wide doubler which runs around the outer periphery. Figure 3 shows the rupture viewed from a position inside the pressure hull, looking forward and upward; the edge of the doubler is clearly visible. Figure 4 is a view from aft of the bulkhead on the left side, showing the rupture flap jammed up against the 'S' duct.

The failure had developed from a 100 mm (4 inches) long region of pre-existing circumferential cracking in the membrane gore panel adjoining the inboard edge of the doubler, (see Figure 3). The rupture subsequently propagated as rapid tears from either end of this pre-existing crack region. The rapid tears initially ran in an approximately circumferential direction before turning radially downwards (ie toward the centre of the bulkhead), due almost certainly to stiffness changes in the gore panel itself as the tears propagated, and the influence of radial frames and stiffeners. Having started to run radially inwards, toward the centre of the *dome*, both tears were then arrested by the first of the circumferential anti-tear straps which they encountered.

It was noted that the nominally circular (circumferential) profile of the edge of the 150 mm doubler was deformed inward slightly at a position just outboard of the pre-existing crack region, as though the bulkhead had been 'panted' inward (ie 'oil-canned') at some time in the past. This deformation is shown schematically in Section B-B in Figure 5, and is just discernible in the *line* of the edge of the

doubler visible in Figure 3. Measurements of the deformation profile were made using a long straight edge held against the internal surface of the bulkhead in line with the edge of the doubler. These measurements suggested that the maximum depth of the dent was approximately 6 mm, at a point approximately 200 mm outboard of the end of the pre-existing crack region. The circumferential extent of the deformed region was difficult to quantify, but it appeared to cover an area from the outboard end of the pre-existing crack to a position about 900 mm outboard of that location.

Figure 3
View looking up and forward from inside pressure hull

- 95-38:** The Civil Aviation Authority and the Federal Aviation Administration, in conjunction with Lockheed should:
1. Review existing maintenance and inspection requirements, and if necessary instigate an in-service inspection of Lockheed L1011 aircraft aft pressure bulkheads, capable of reliably detecting:

- i) fatigue cracking on the bulkhead structure
 - ii) *oil-can* deformations and other bulkhead abnormalities which could result in abnormal flexural modes in response to cabin pressure changes

2. Ensure that the attention of maintenance staff is drawn to the risks of subtle forms of damage being caused to the bulkhead structure, particularly in relation to the difficulty of gaining access to the aft face of the bulkhead and the risk of introducing *new* damage whilst carrying out inspections.

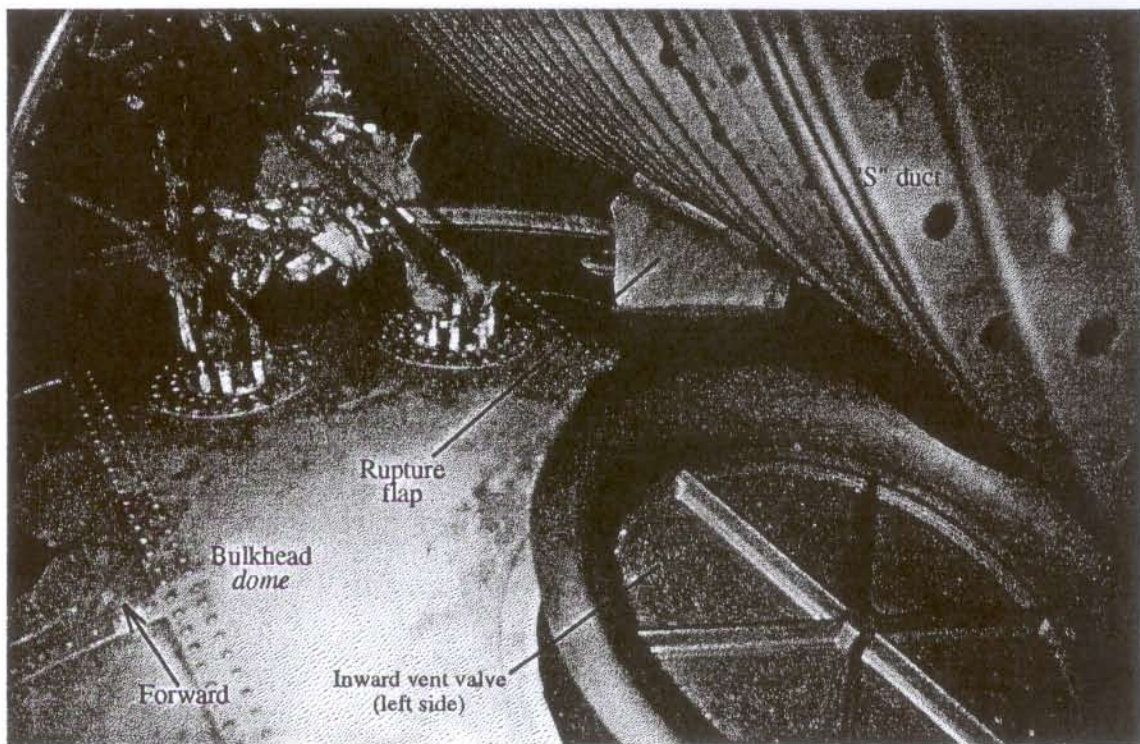
Figure 4
View forward onto aft face of bulkhead

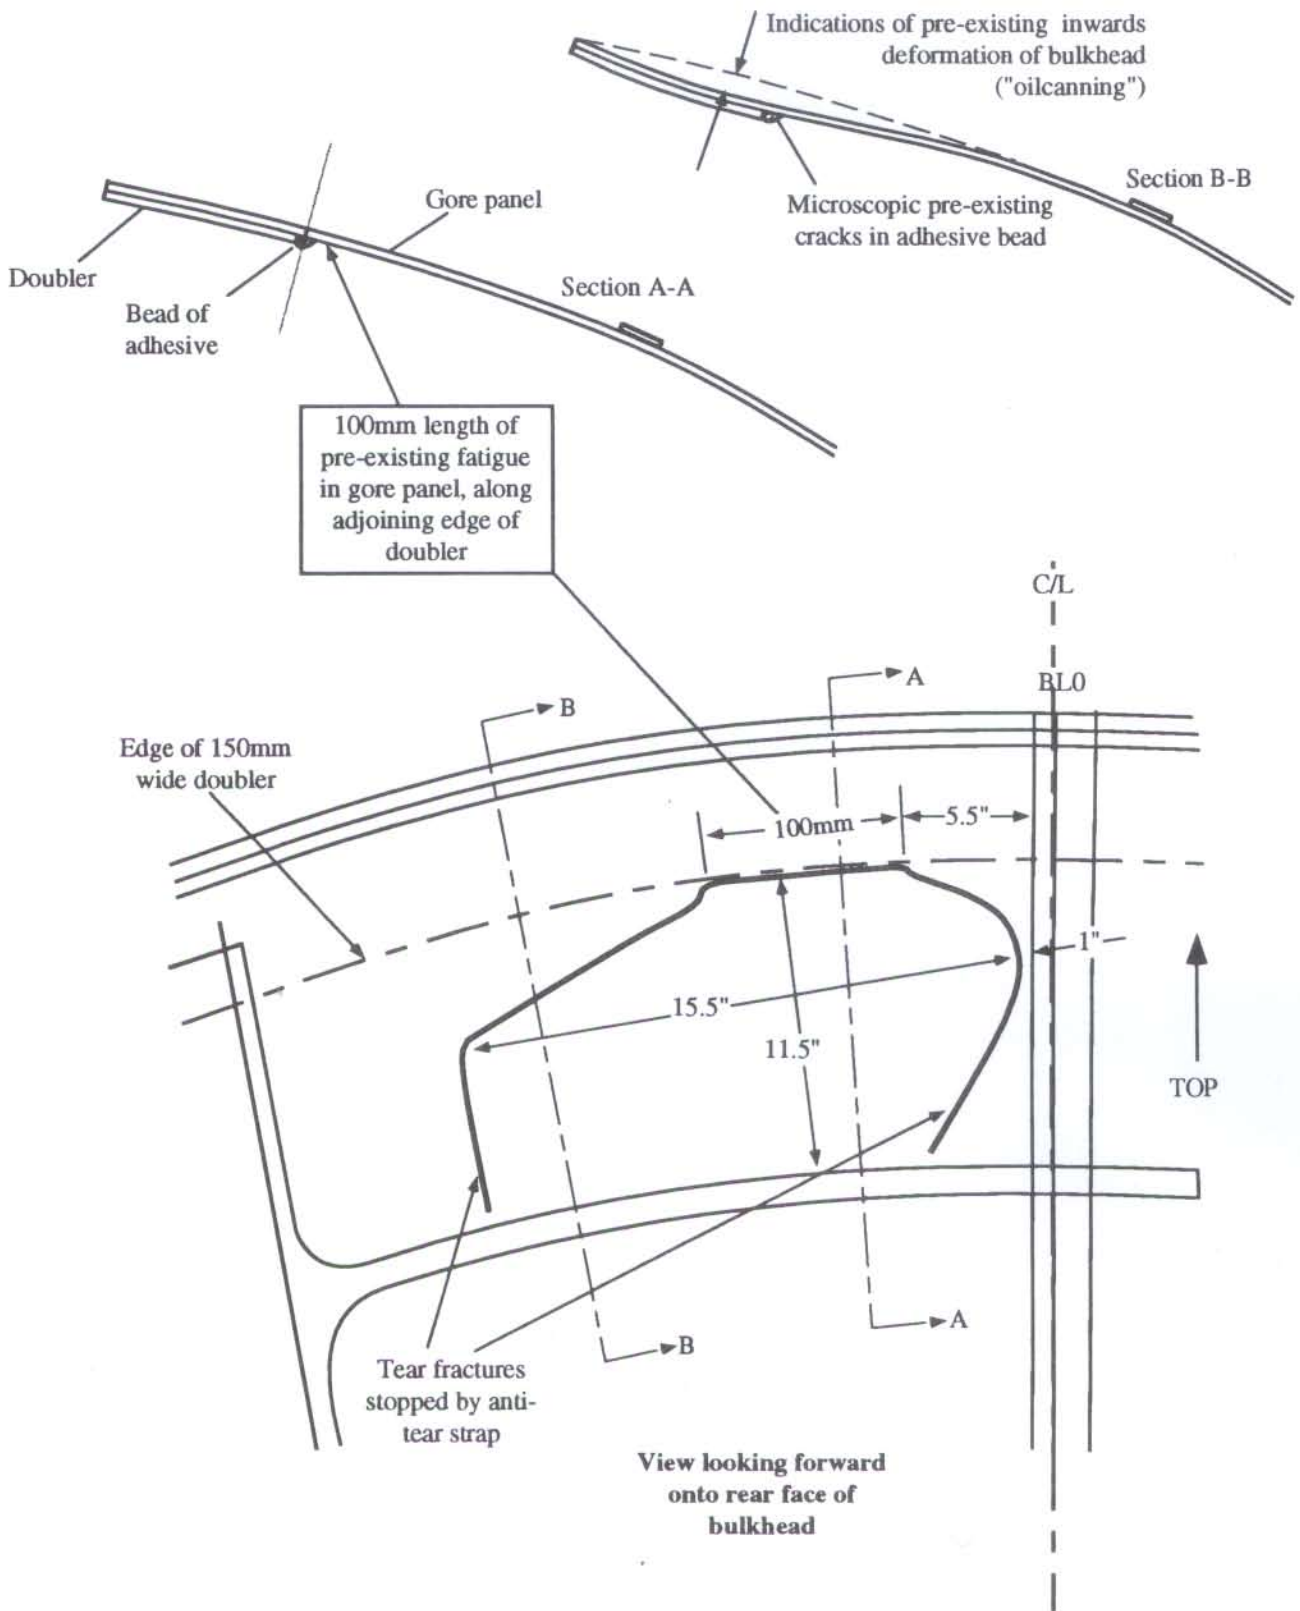
Figure 5

A sketch of the failure, giving approximate sizes and other details, is shown at Figure 5.
