**MANUFACTURERS CUSTOMER SERVICE NOTES & BULLETINS RELATING TO
ROTOR BRAKE OPERATION**

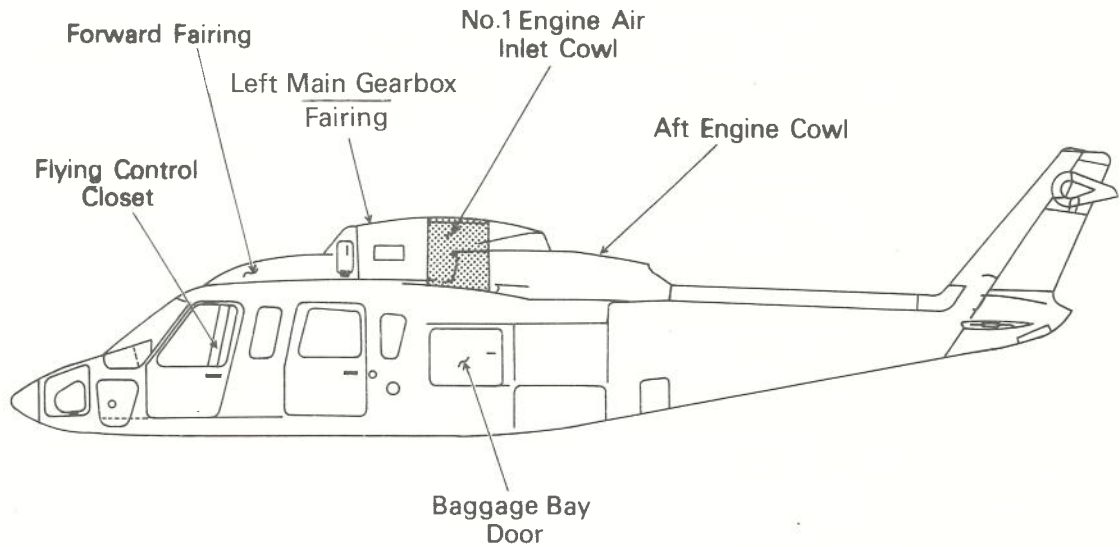
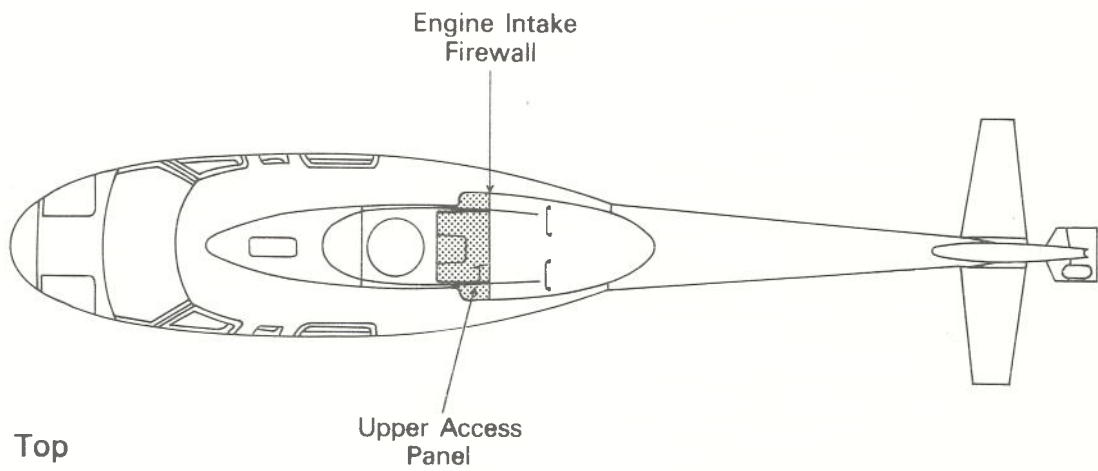
General Arrangement of Aircraft Panels

Shaded Areas Indicate Location of Intake Plenum
