No: 12/90

Ref: EW/G90/07/37

Aircraft Type and Registration: McDonnell Douglas DC-9-32, G-PKBM

Nature of Damage: Left outer landing gear door detached; minor damage to left main flap

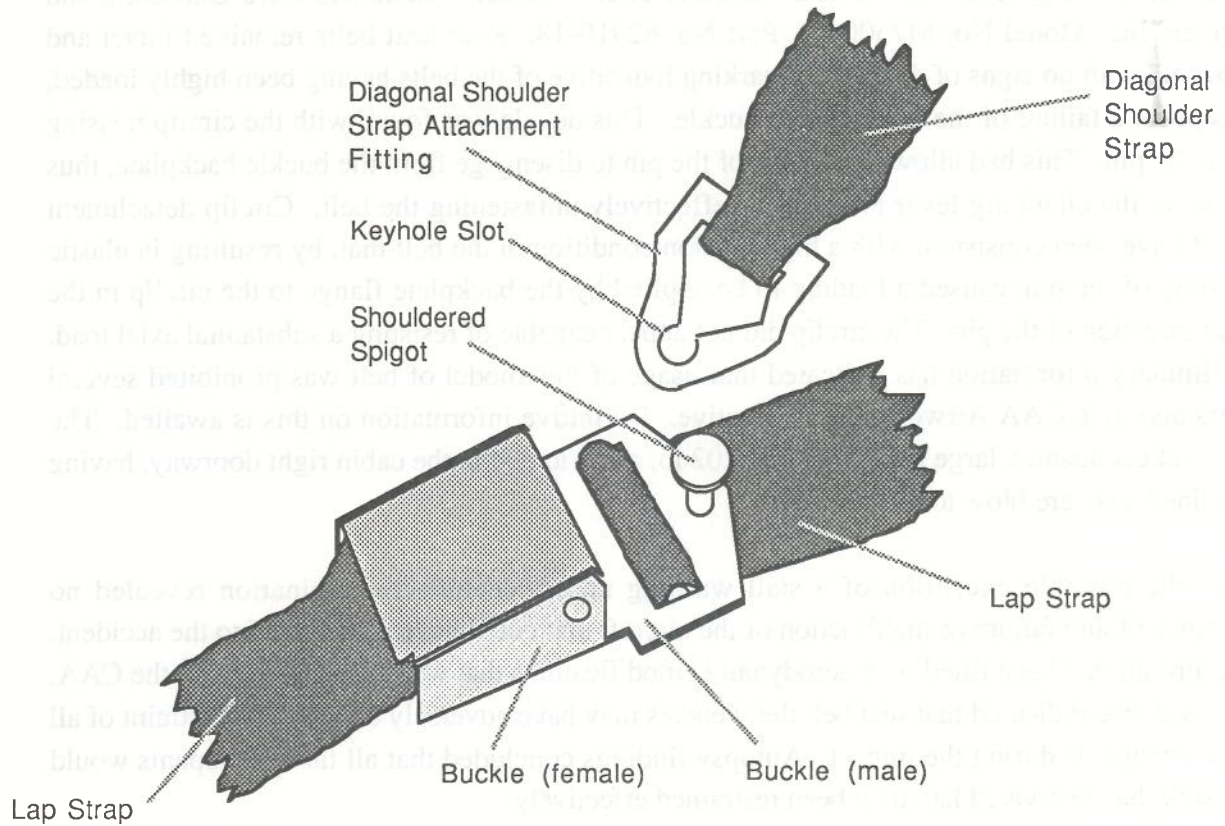
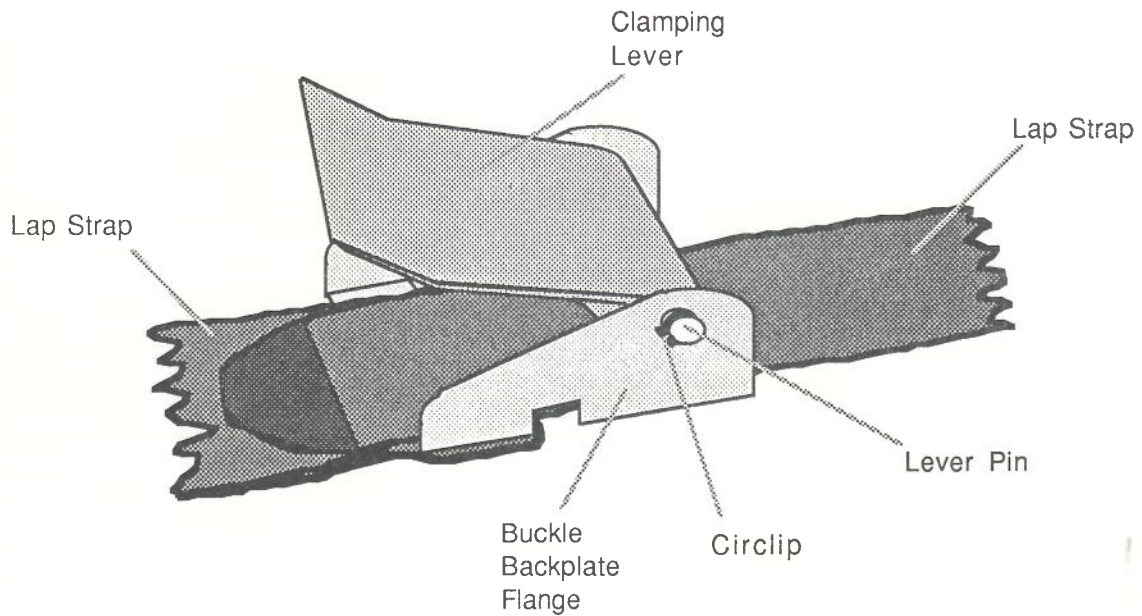
SEAT BELT SCHEMATICS

circumferential groove formed near the other end. The belt assemblies were Cumming and Sanders Inc. Model No. M7500-S2, Part No. 62910-18. Rear seat belts remained intact and attached, with no signs of distress or marking indicative of the belts having been highly loaded, except for a failure of the left seat belt buckle. This buckle was found with the circlip missing from the pin. This had allowed one end of the pin to disengage from the buckle backplate, thus allowing the clamping lever to displace, effectively unfastening the belt. Circlip detachment could have been consistent with a high tension condition in the belt that, by resulting in elastic bending of the pin, caused a loading to be applied by the backplate flange to the circlip in the axial direction of the pin. The circlip did not appear capable of resisting a substantial axial load. Preliminary information has indicated that usage of this model of belt was prohibited several years ago by a CAA Airworthiness Directive. Definitive information on this is awaited. The rear seat occupant, a large man weighing 202 lb, came to rest in the cabin right doorway, having sustained a severe blow to the chin.
