**AAIB Bulletin No:** 11/94

**Aircraft Type and Registration:** Sportavia RF5B Sperber, G-SSWV

**Date & Time (UTC):** 18 August 1994 at 1715 hrs

**Location:** Camphill Airfield, Derbyshire

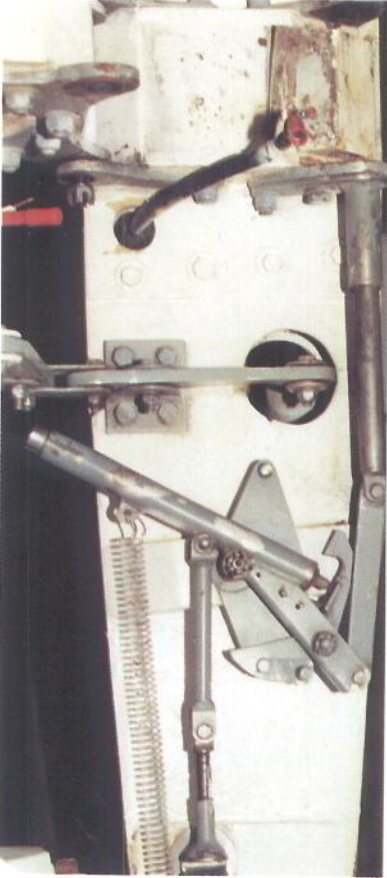
The pilot subsequently found that the right wingtip was unlocked. He had understood that it was not possible to fit the wing joint fairing in position if the locking mechanism was not fully in the locked position.

**FIG.1 WING JOINT MECHANISM UNLOCKED**

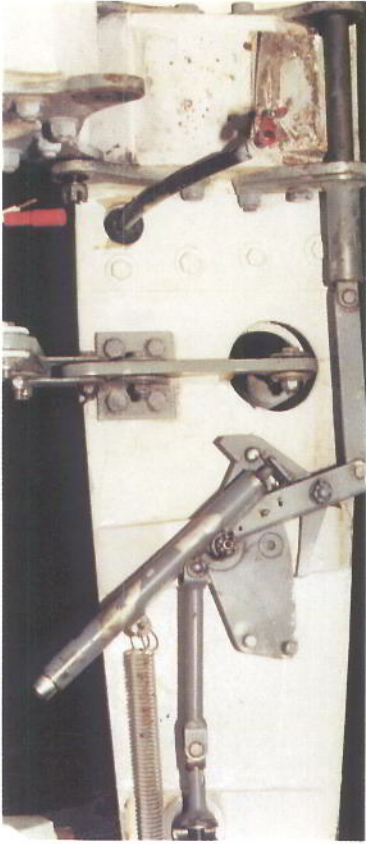
**FIG.2 WING JOINT MECHANISM LOCKED**

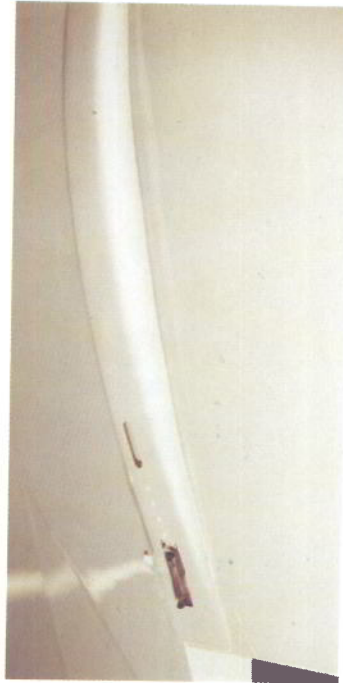
**FIG.3 WING JOINT FAIRING UNLOCKED**

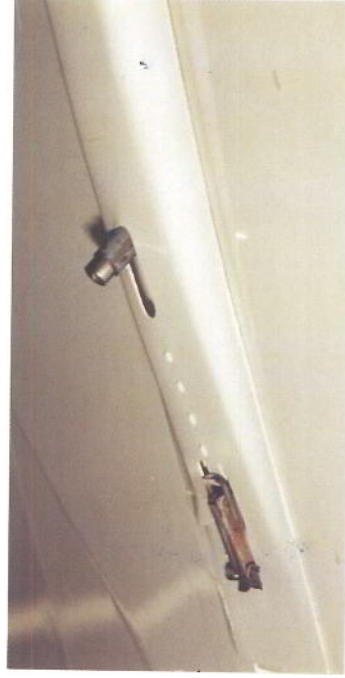
**FIG.4 WING JOINT FAIRING LOCKED**

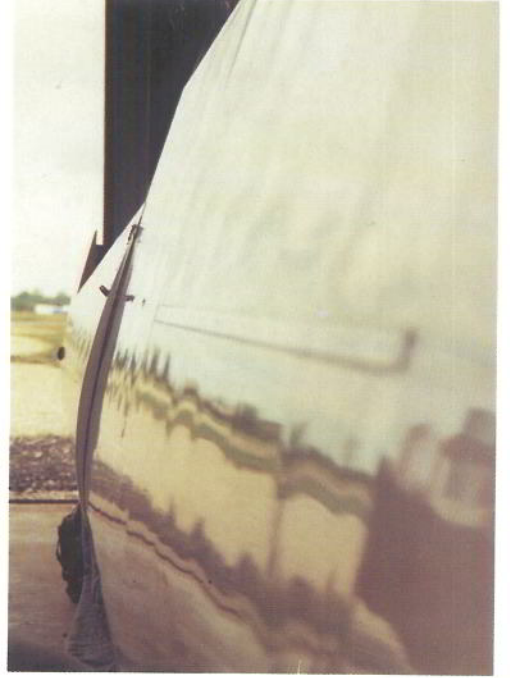
**FIG.5 COCKPIT VIEW - CORRECTLY LOCKED**
