## ACCIDENT

<b>Aircraft Type and Registration:</b>	Tecnam P2002-JF, G-CDTE	
<b>No &amp; Type of Engines:</b>	1 Rotax 912-S2 piston engine	
<b>Year of Manufacture:</b>	2005	
<b>Date &amp; Time (UTC):</b>	15 October 2009 at 1250 hrs	
<b>Location:</b>	Old Sarum Airfield, Wiltshire	
<b>Type of Flight:</b>	Training	
<b>Persons on Board:</b>	Crew - 1	Passengers - None
<b>Injuries:</b>	Crew - None	Passengers - N/A
<b>Nature of Damage:</b>	Wings, cowling, propeller, nosewheel	
<b>Commander's Licence:</b>	Student	
<b>Commander's Age:</b>	37 years	
<b>Commander's Flying Experience:</b>	34 hours (of which 7 were on type) Last 90 days - 7 hours Last 28 days - 7 hours	
<b>Information Source:</b>	Aircraft Accident Report Form submitted by the pilot and further enquiries by the AAIB

## Synopsis

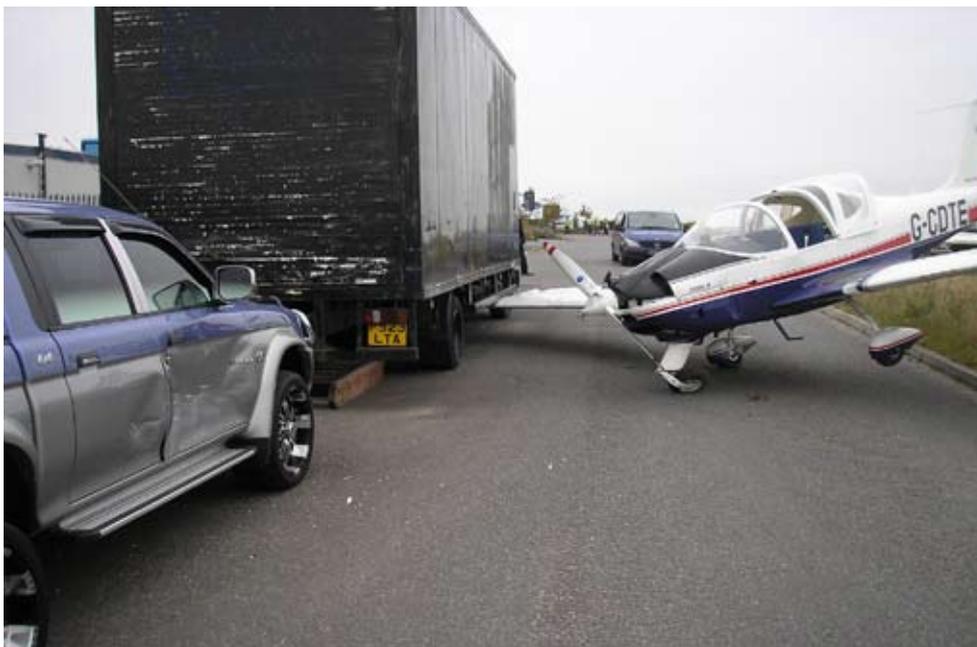
Figure 1

lorry. Following the impact sequence, the aircraft had rotated 90° to the left, the nose gear leg had collapsed through deformation of the yoke, and the right wing had wedged itself underneath the side of the lorry (see Figure 1). The student was unhurt and vacated the aircraft over the left wing in the normal manner.

The AAIB discussed the damage to the aircraft with the loss adjuster who inspected the aircraft on behalf of the insurance company. He considered that had the nose gear failed early in the takeoff through deformation of the yoke, the tyre was likely to have tried to dig itself into the grass surface rather than roll over it. Any yawing tendency due to the damage was likely to have been to the right if the nose wheel was still able to turn. The deformation of the yoke was consistent with an aircraft rotating left.

nosewheel. Had the nose gear been undamaged before the collision, the damage to the yoke observed afterwards was consistent with the impact sequence.

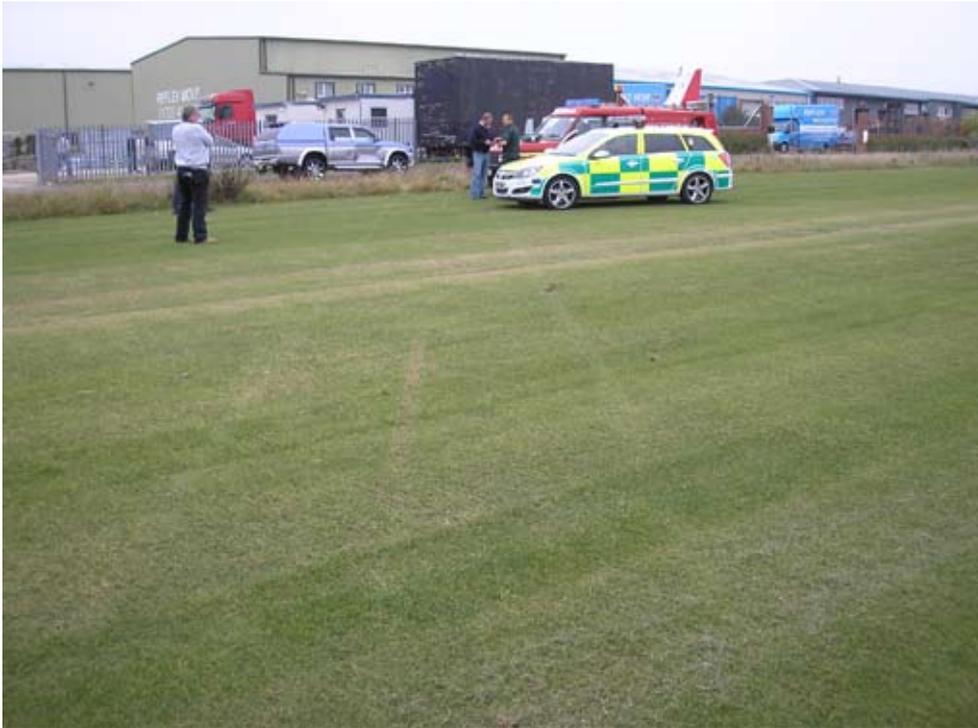
**Figure 2**

The pilot looked subsequently at markings left by the nose wheel just as the aircraft began its rapid swing and thought that they suggested the nose wheel was skidding. Figure 2 shows the tracks left later by the aircraft as it approached the road.

The tyre marks shown in Figure 2 were left by the aircraft shortly before the impact and, had the nose gear already collapsed, the marks would be consistent with the damage already done. The marks left by the

nosewheel were intermittent and more pronounced than those left by the main wheels. The intermittent nature of the marks supported the possibility that the pilot held the control column slightly aft of neutral during the takeoff run, in accordance with his normal technique, thereby causing the nosewheel to lift intermittently from the ground during the takeoff.

There were two possibilities as to why the nosewheel marks were more pronounced: the nose gear had already collapsed or the nosewheel was pointing right, due to the application of full right rudder, and was skidding on the grass. The pilot reported that the violent nature of the swing was consistent with failure of the nose gear, suggesting that the failure caused the swing. However, the nature of the deformation to the yoke would have tended to turn the nose to the right had the nosewheel still been free to rotate. If it was not free to rotate, it seemed likely that the nose would have tried to dig itself into the runway surface, which would probably have left more

If the nosewheel had lifted intermittently during the early stages of the takeoff run, it would explain the lack of directional control because neither the nose wheel nor the rudder would have been effective at controlling the yaw. With full rudder applied, each time the nosewheel contacted the grass it would have skidded and the marks on the ground seemed consistent with a skidding
