No: 11/90

Ref: EW/C1173

Aircraft Type and Registration: Rans Coyote S5, G-MWEJ

Information Source: AAIB Field Investigation

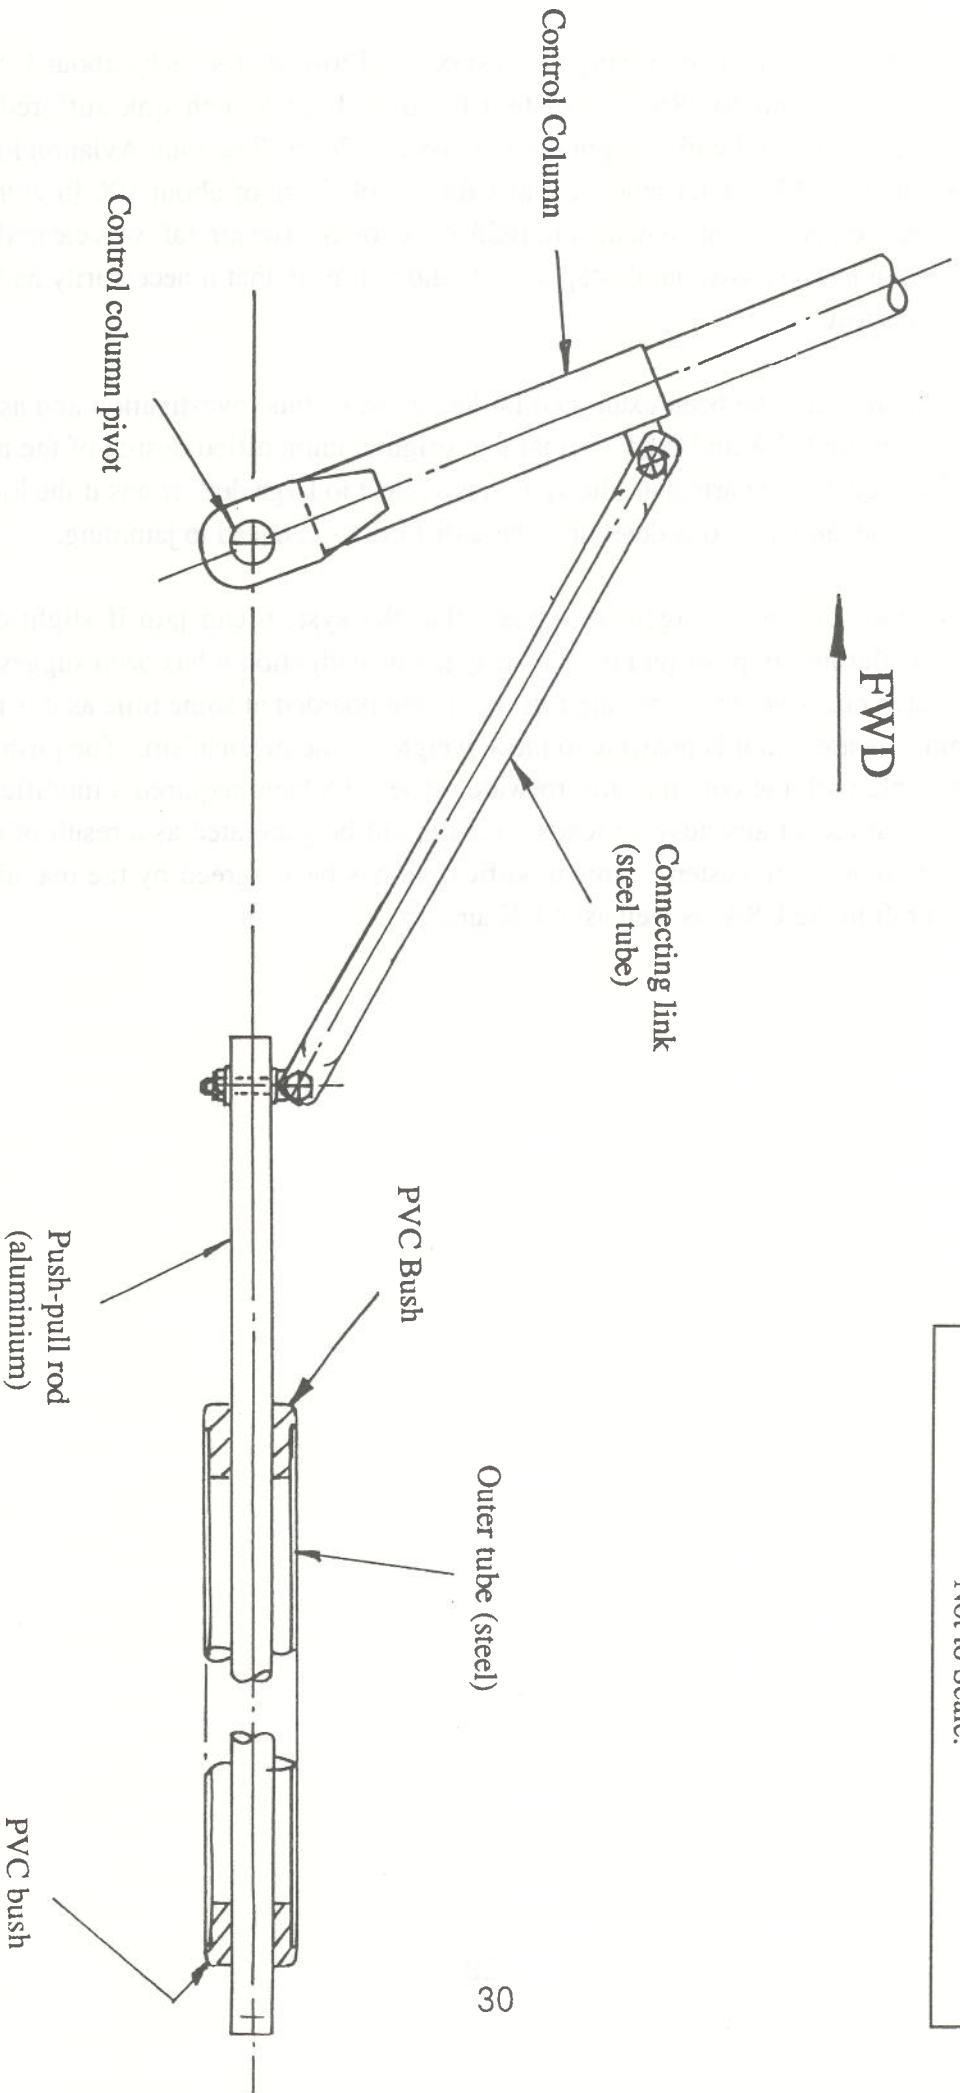
also noted that towards the forward end of its travel, movement of the control column resulted in downward bending of the elevator push-pull rod, causing it to jam in the bearing which supported the push-pull rod in its outer tube. The aircraft was subsequently flown back to its base without incident. The aircraft was not flown again until the accident flight.

Examination of the wreckage showed that the aircraft had struck the ground in a vertical attitude with a significant amount of negative 'G' force imposed on the structure. The pitch control mechanism had broken in the impact while the stick was in the fully forward position. There was evidence that the aluminium push-pull rod (see the attached diagram) had failed in bending before impact, presumably due to pilot-induced forces. The steel connecting link was found to be 8 inches long (between centres). The correct dimension for this link was 9 1/4 inches. There was also evidence that the PVC bushes in which the push-pull rod ran had been lubricated with mineral oil, and that the rod had been tight within the forward bearing.

The effect of shortening the connecting link to 8 inches was investigated. The link normally makes a 30° (approx) angle with the push-pull rod, resulting in half of the forces in the system acting at 90° to the desired direction of motion. By shortening the link, this angle was increased so raising these

adverse forces by about 25% and decreasing the desired, 'end-to-end', forces by about 10%. In a trial carried out by the UK agent for Rans, a system fitted with an 8 inch link suffered permanent deformation of the push-pull rod with an applied stick force of 70 lb. The Joint Aviation Requirements Very Light Aeroplanes (JAR-VLA) schedule calls for a stick force of about 100 lb without failure. This is a similar requirement to that contained in BCAR section S. The aircraft was cleared by the PFA using the VLA schedule as a basis, but this apparently did not mean that it necessarily had to meet the schedule in every respect.

Several S4 and S5 aircraft have been examined in the course of this investigation and as a result the AAIB have informed the CAA and the PFA that the original unmodified design of the pitch control system appears inadequate. In particular, the system is subject to large deflections if the loads within it increase for any reason, and it is considered that these distortions can lead to jamming.

From the trial carried out by the agent it appears that the system can jam if slight distortion is introduced into the aluminium push-pull rod. During the investigation it has been suggested that this distortion could have occurred while the aircraft was being boarded at some time as it is necessary to move the column forward and it is possible to place weight on the mechanism. The push-pull tube is at its most vulnerable with the column fully forward. The PFA have required a modification which relieves the push-pull rod of any adverse loads which might be generated as a result of either slight distortion or of friction in the system. This modification has been agreed by the manufacturer and introduced on aircraft in the USA, as well as to UK aircraft.

RANS COYOTE pitch control mechanism.
 Shown with control column fully forward, with
 maximum overhang of the push-pull rod.
 Not to Scale.
