**ACCIDENT**

<b>Aircraft Type and Registration:</b>	Cessna 421C Golden Eagle, G-HIJK
<b>No &amp; Type of Engines:</b>	2 Continental Motors Corp GTSIO-520-L piston engines
<b>Year of Manufacture:</b>	1977
<b>Date &amp; Time (UTC):</b>	16 May 2012 at 1535 hrs
<b>Location:</b>	Bournemouth Airport
<b>Type of Flight:</b>	Commercial Air Transport (Passenger)
<b>Persons on Board:</b>	Crew - 1                      Passengers - 2
<b>Injuries:</b>	Crew - None                      Passengers - None
<b>Nature of Damage:</b>	Propellers, nose landing gear, nose bay doors and radome damaged, engines shock-loaded
<b>Commander's Licence:</b>	Commercial Pilot's Licence
<b>Commander's Age:</b>	42 years
<b>Commander's Flying Experience:</b>	3,458 hours (of which 50 were on type) Last 90 days - 50 hours Last 28 days - 13 hours
<b>Information Source:</b>	Aircraft Accident Report Form submitted by the pilot

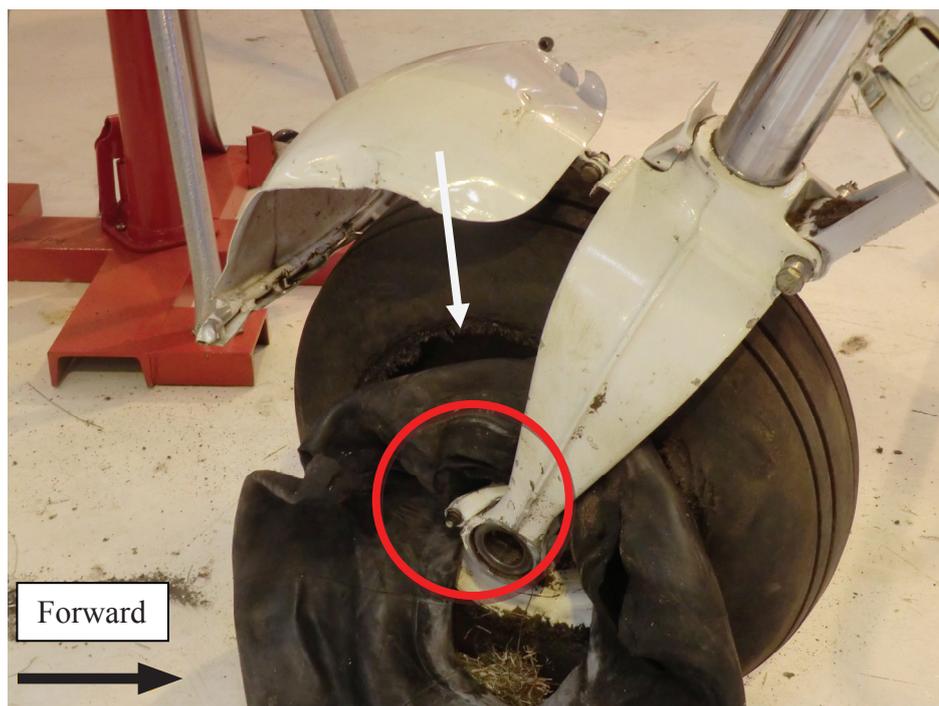
**Figure 1**

evacuated through the overwing emergency exit without any injury. The aircraft was resting on its main landing gear and the nose fuselage and the propeller tips had struck the ground. It was recovered to a hangar for examination where it was found that the NLG leg had folded into the retracted position due to overload failure of the downlock mechanism. The nosewheel tyre had completely deflated due to what appeared to be massive wear of the sidewall on the right side (see Figure 1). The inner tube had been liberated from the inside and was wrapped around the axle.

bottom used a shaped tubular brace which attached to the forks either side of the axle. The mudguard had remained attached at the top but had been buckled with the braces at the bottom broken. On the right side, the broken bracing tube had rotated through almost 180° and become jammed between the fork and the tyre (Figure 1). This was consistent with the pilot's recollection of a "whining noise" followed by severe vibration and shimmy as the tyre deflated.

There was no immediately apparent reason for the failure of the bracing tube. Circumstantially, it is most likely that it was damaged either during taxiing or ground handling, since the attachments were intact.

View of deflated nosewheel tyre showing worn tyre sidewall (arrowed) and broken mudguard bracing tube jammed between nosewheel fork and tyre (circled).
