ACCIDENT

| Aircraft Type and Registration: | DHC-2 Mk.III Turbo-Beaver, OY-JRR | |
| Date & Time (UTC): | 11 March 2007 at 1615 hrs | |
| Location: | Headcorn Airfield, Kent | |

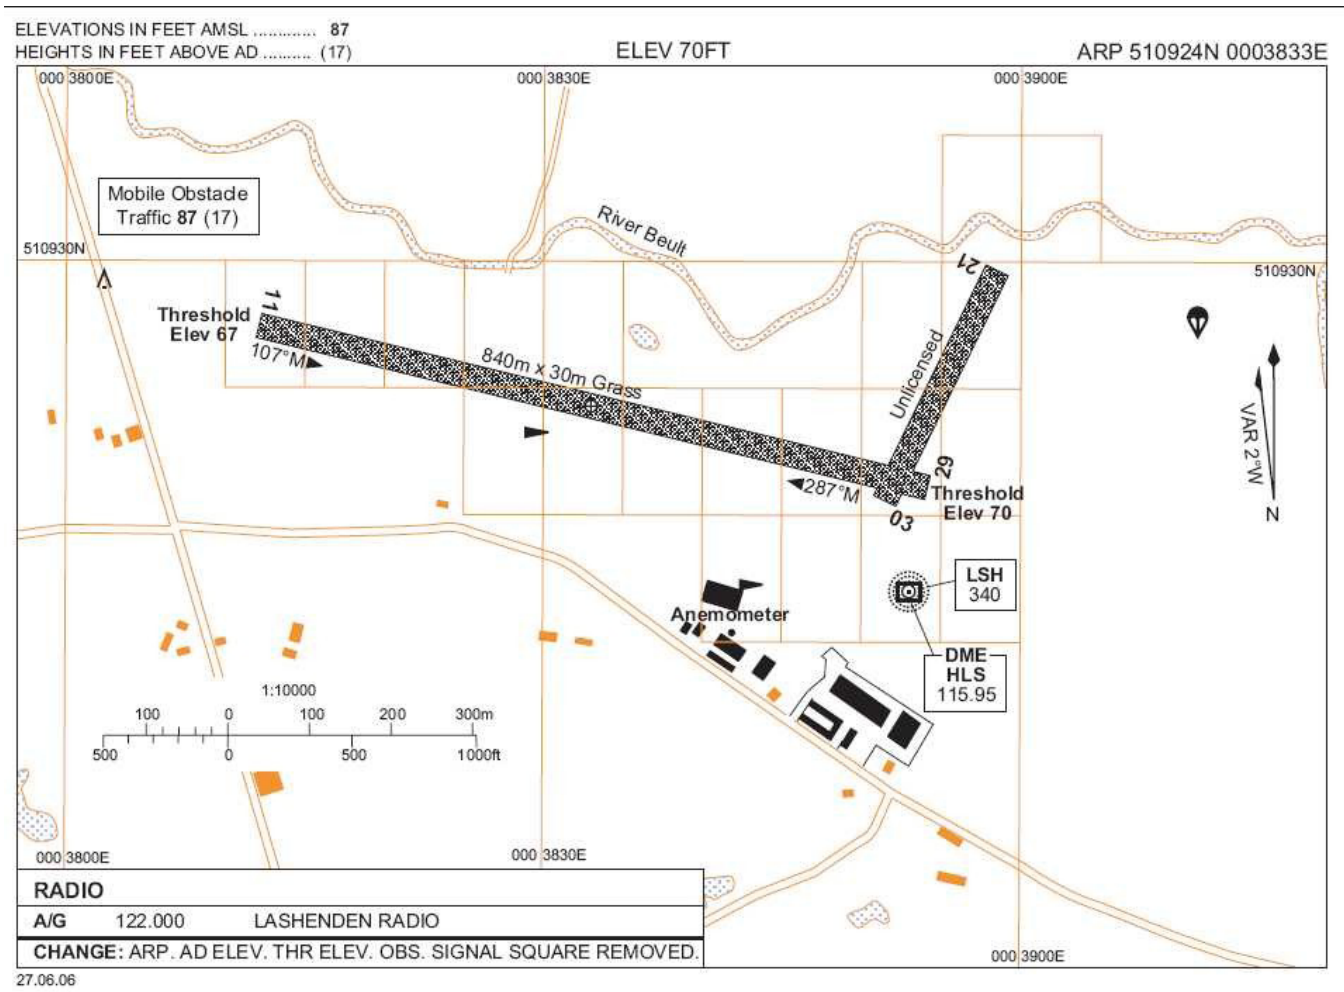
Figure 1

Headcorn Airfield is a grass aerodrome with two landing strips. Runway 11/29 is licensed with a declared takeoff distance of 840 m. Runway 21/03 is unlicensed, which means that it does not necessarily comply with the provisions of CAP 168 – *'Licensing of Aerodromes'*, a document that describes the minimum standards necessary to meet licensing requirements, including the provision of runway markings and freedom from obstacles. The Headcorn Aerodrome Manual stated that the length of Runway 21/03 was 312 m, being

the distance between the marked northern threshold of Runway 21 and its intersection with Runway 29/11. The distance from this threshold to the position of the parked F100 fighter aircraft was approximately 570 m.

The UK Aeronautical Information Package (AIP) contains information about individual licensed aerodromes. The edition of the AIP current at the time of the accident concurred with the declared length of Runway 11/29 but did not report the length of the unlicensed Runway 21/03 (see Figure 1). One of the commercially available aerodrome guides noted that Runway 21/03 was unlicensed but had a length of 312 m. Another such guide, whilst also referring to this runway as unlicensed, gave its length as 549 m. The publishers of both guides commented that in respect of unlicensed runways they rely on information provided by the aerodrome operator except where graphical representation of the aerodrome shows an obvious geometric error.

A diagram on the Headcorn Aerodrome website depicted the runway layout. It showed Runway 21/03 extending south beyond the location shown in the Headcorn Aerodrome Manual so that it resembled the depiction in the aerodrome guide which quoted its length as 549 m.

The aerodrome operator commented that historically Runway 21/03 was considered to be 549 m long. More recently, whilst applying to license this runway, the aerodrome operator reduced its nominal length to 312 m in order to comply with the provisions of CAP 168 in relation to obstacles. The operator considered, however, that the provision of threshold markings, in accordance with CAP 168, would have been confusing visually. Consequently, these markings were not provided and the runway remained unlicensed, albeit at the reduced published length of 312 m.

Aerodrome chart, UK AIP

It is recommended that Headcorn Aerodrome should install markings that indicate the southern end of Runway 21.

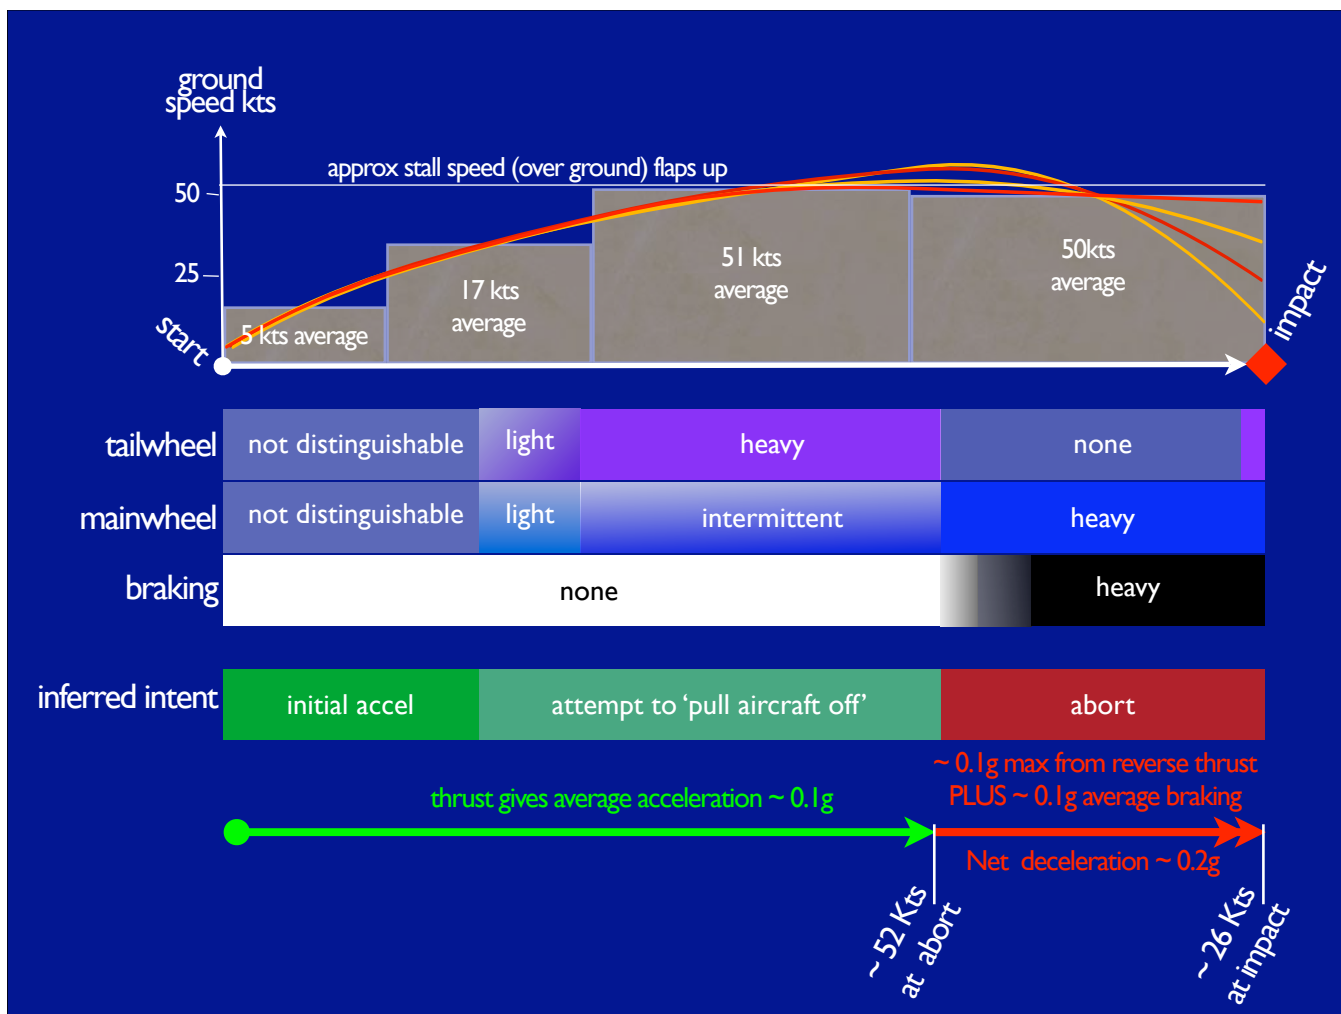
Figure 2
Possible speed profiles

Figure 2 shows a range of speed profiles broadly compatible with the average acceleration segment speeds from the GPS data, giving a range of terminal speeds (at impact with the F100 aircraft). Those profiles having terminated at a high impact speed with the F100 also fit well with the average segment speeds for both acceleration and abort phases. Those profiles giving an impact speed below about 35 kt do not make for a very convincing fit with the final average speed block, suggesting that the maximum speed obtained was more likely to have been 52 - 53 kt than the 60 kt which lower impact speed profile would imply. An abort speed of 52 - 53 kt is also consistent with the tyre track evidence, which suggest that the aircraft was marginally wing-borne at that stage. (No lift off speed is given by the manufacturer for a takeoff without flap, but the flaps-up stall speed of 52 kt would equate to a ground speed, in this case, of the order of 51 kt.) It is also the case that the principal decelerative forces acting on the aircraft comprising the combination of main wheel braking and, if used, reverse thrust, would not have been capable of slowing the aircraft significantly, and certainly not below 25 kt at impact.

would have had very little effect because with the aircraft almost wing-borne very little weight would have acted on the main wheels. The retardation force acting on the aircraft derives from the slip resistance (friction) developed between the tyre and the ground, and is directly proportional to the weight borne by that wheel. If the aircraft was 90% wing-borne, therefore, the braking force available to slow the aircraft will be only 10% of that available with no lift being developed by the wings. Even with no lift and the whole of the aircraft’s weight being carried by the main wheels, the braking coefficient on grass is not likely to have exceeded 0.2 (giving approximately 0.2g deceleration).

Reverse thrust would, if used, have contributed to the aircraft’s deceleration. The GPS data suggests that the net forward thrust prior to the abort gave an acceleration of approximately 0.1g, and it therefore follows that at best (had the reverse pitch propeller efficiency been comparable to that during forward thrust, which it certainly would not have been), reverse thrust could not have contributed more than 0.1g to the aircraft’s overall deceleration. Following an abort at 52 kt, deceleration of 0.1g from braking and 0.1g from reverse thrust, both significantly optimistic assumptions in the circumstances, would give an impact speed of the order of 26 kt.
