AIRCRAFT ACCIDENT REPORT 7/2007

Air Accidents Investigation Branch

**Report on the serious incident to
Airbus A310-304, F-OJHI
on approach to Birmingham International Airport
23 February 2006**

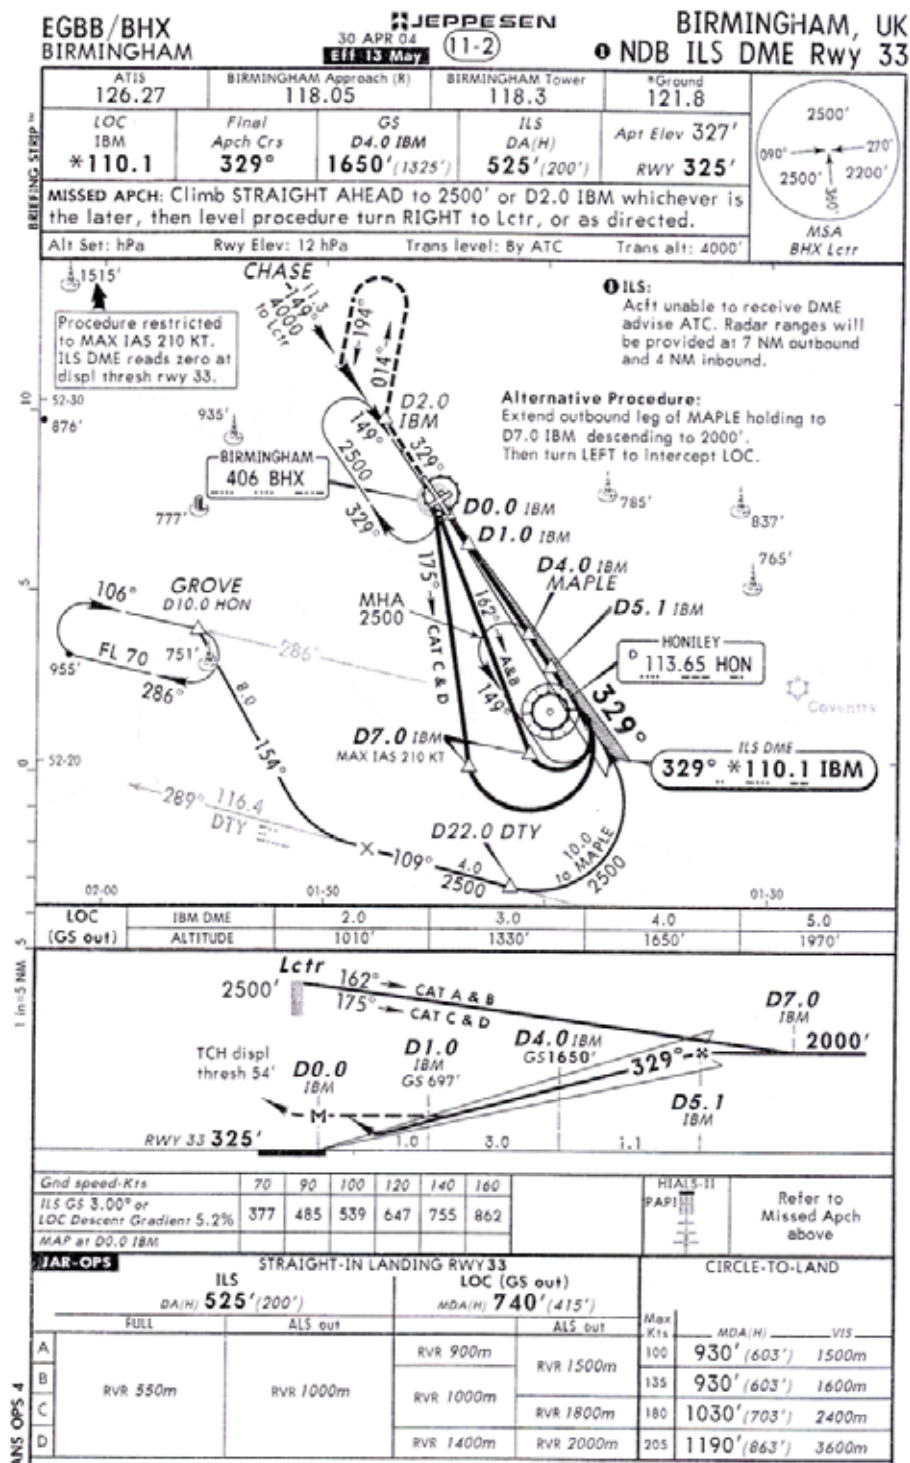
Figure 1

The aircraft was cleared for the Grove 1A standard terminal arrival, via Honiley, Ebony and Grove, for the Localiser/DME approach to Runway 33. The approach procedure is shown at Figure 1. At some stage, which the crew recalled as being probably during the downwind leg, the captain of the crew for the return sector entered the flight deck and secured himself in the 'jump seat' located behind and between the operating crew. He is referred to as the supernumerary captain throughout the report.

Instrument approach chart used by the crew for the
 Localiser/DME approach

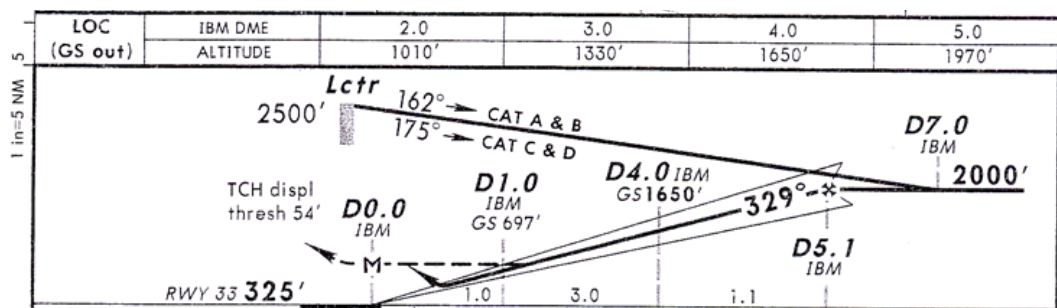
Figure 4

The vertical profile for the approach to Runway 33 at Birmingham, with the ILS glide slope not available, is shown at Figure 4. The vertical profile is based on the mean sea level pressure (QNH) and commences with the aircraft established on the final approach track of 329° at an altitude of 2,000 ft. At the Final Approach Fix (FAF), located 5.1 DME from the I-BM, the aircraft is descended at a Constant Descent Angle (CDA) of 3° to an MDA of 740 ft. The Missed Approach Point is at 0 DME, which is coincident with the threshold for Runway 33. Altitude cross checks are provided at 5, 4, 3, and 2 nm to assist the pilot in maintaining a 3° glide path. The HON VOR is not part of the approach procedure.

Vertical approach profile

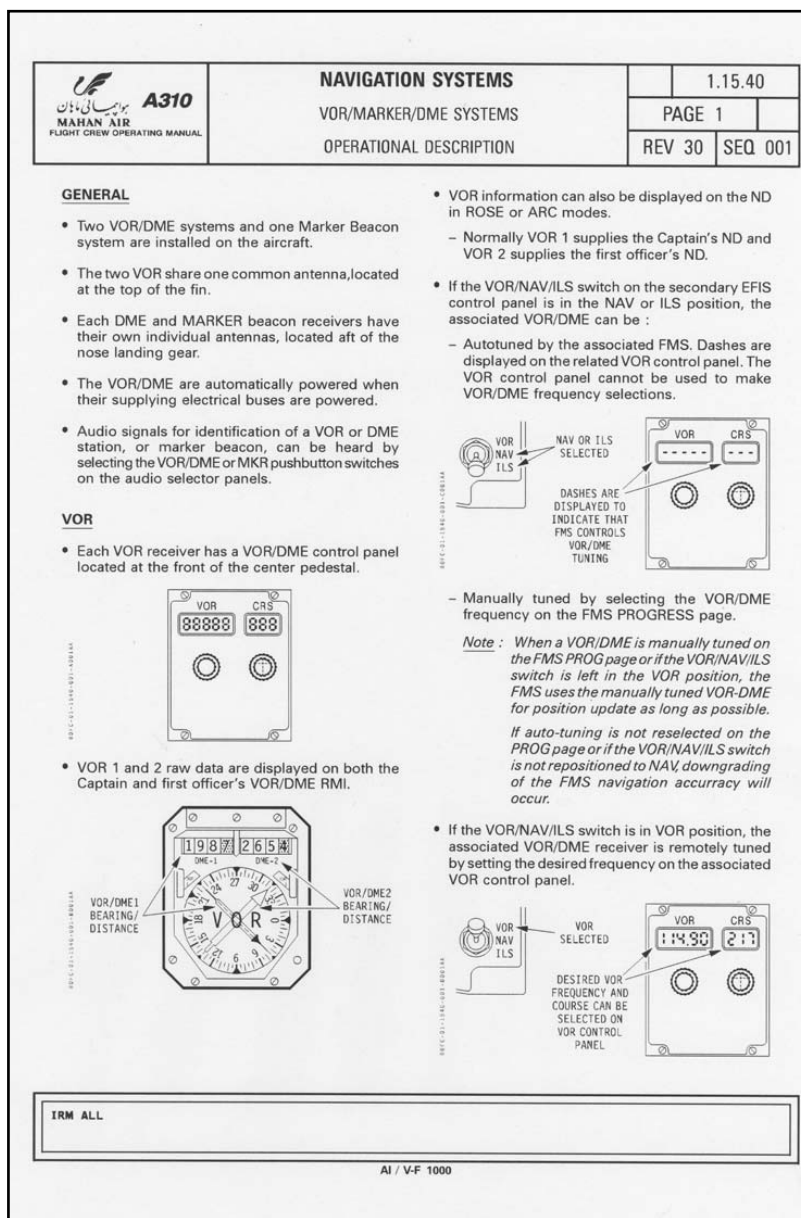
Figure 5

Also included with this text was a copy of the relevant page from the FCOM shown below as Figure 5. This Operational Notice correctly reflects the Airbus SOPs, which also recommend that raw data for the reference navigational aid should be monitored during the final approach when conducting a non-precision approach.

Relevant FCOM guidance

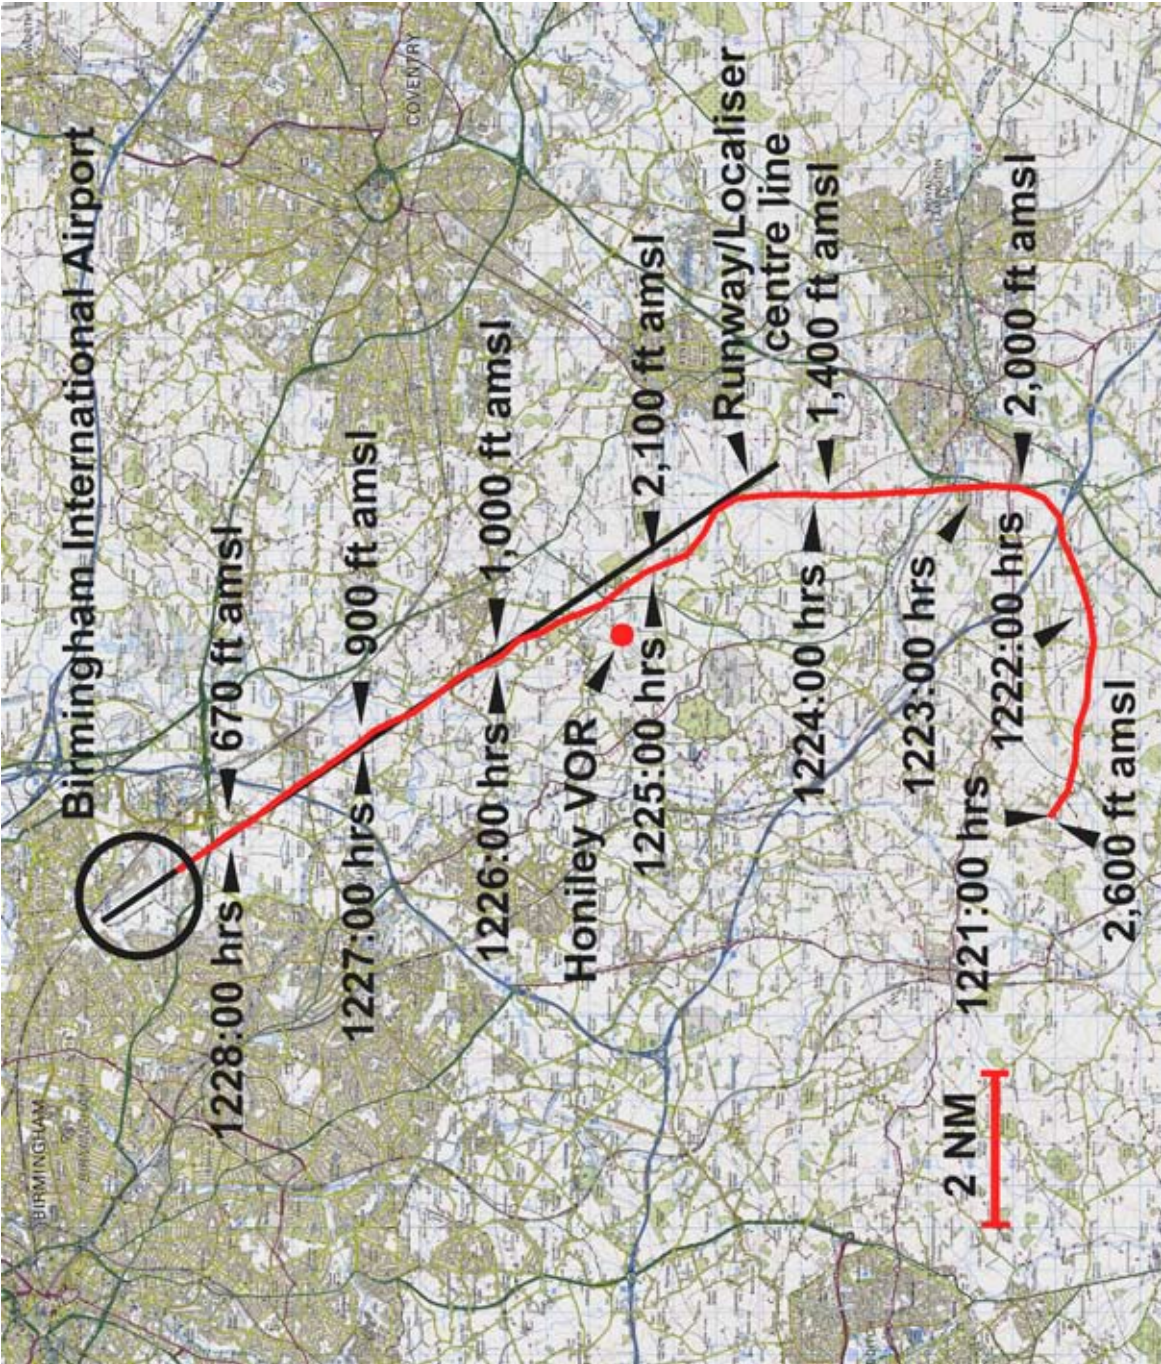
Aircraft ground track during second approach

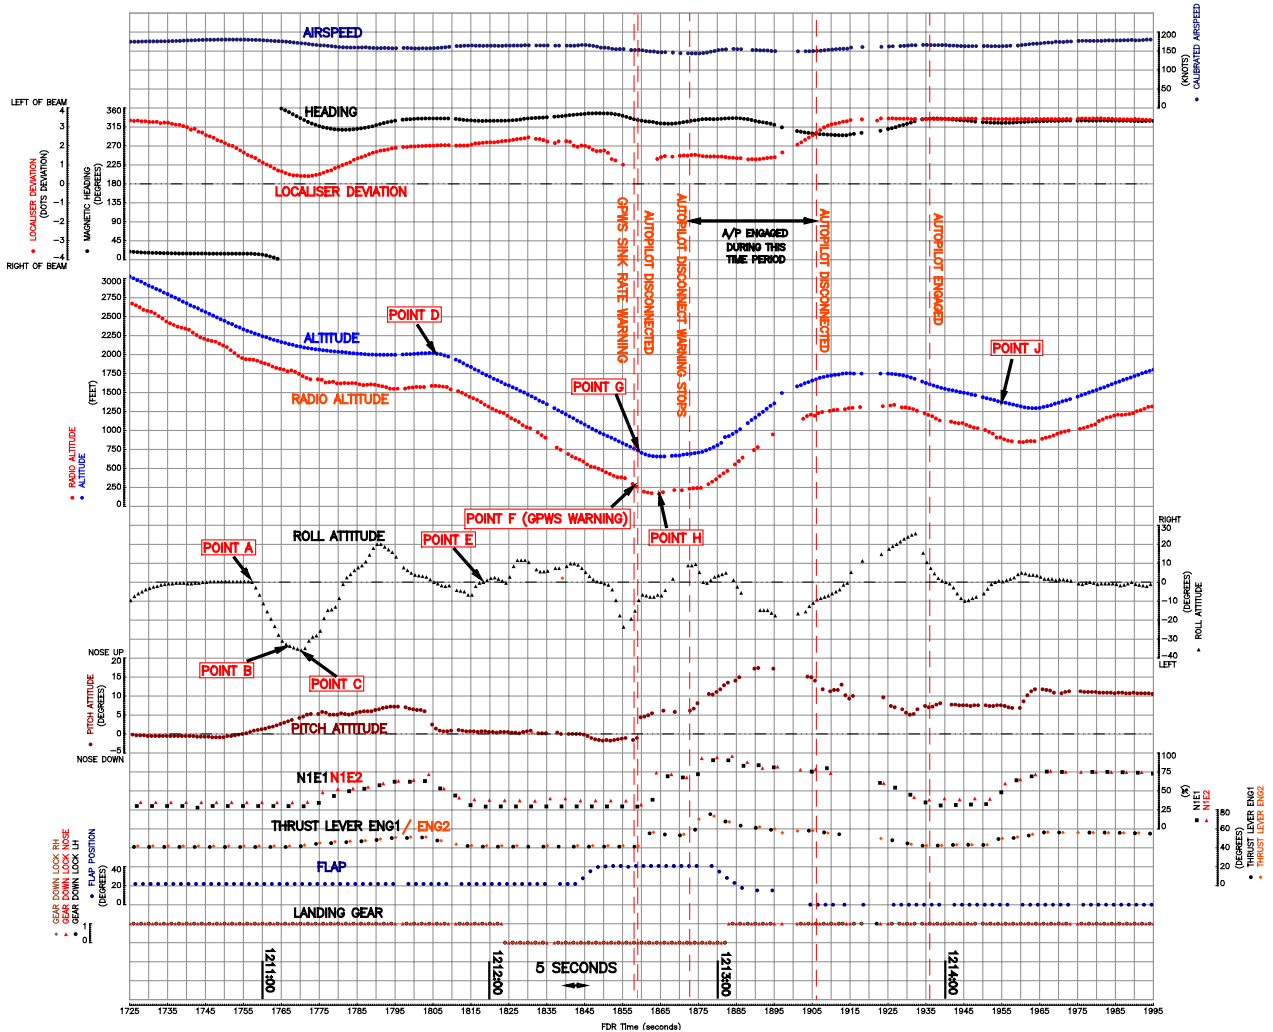
Salient FDR Parameters during first approach
(Incident to F-OJHI on 23 February 2006)

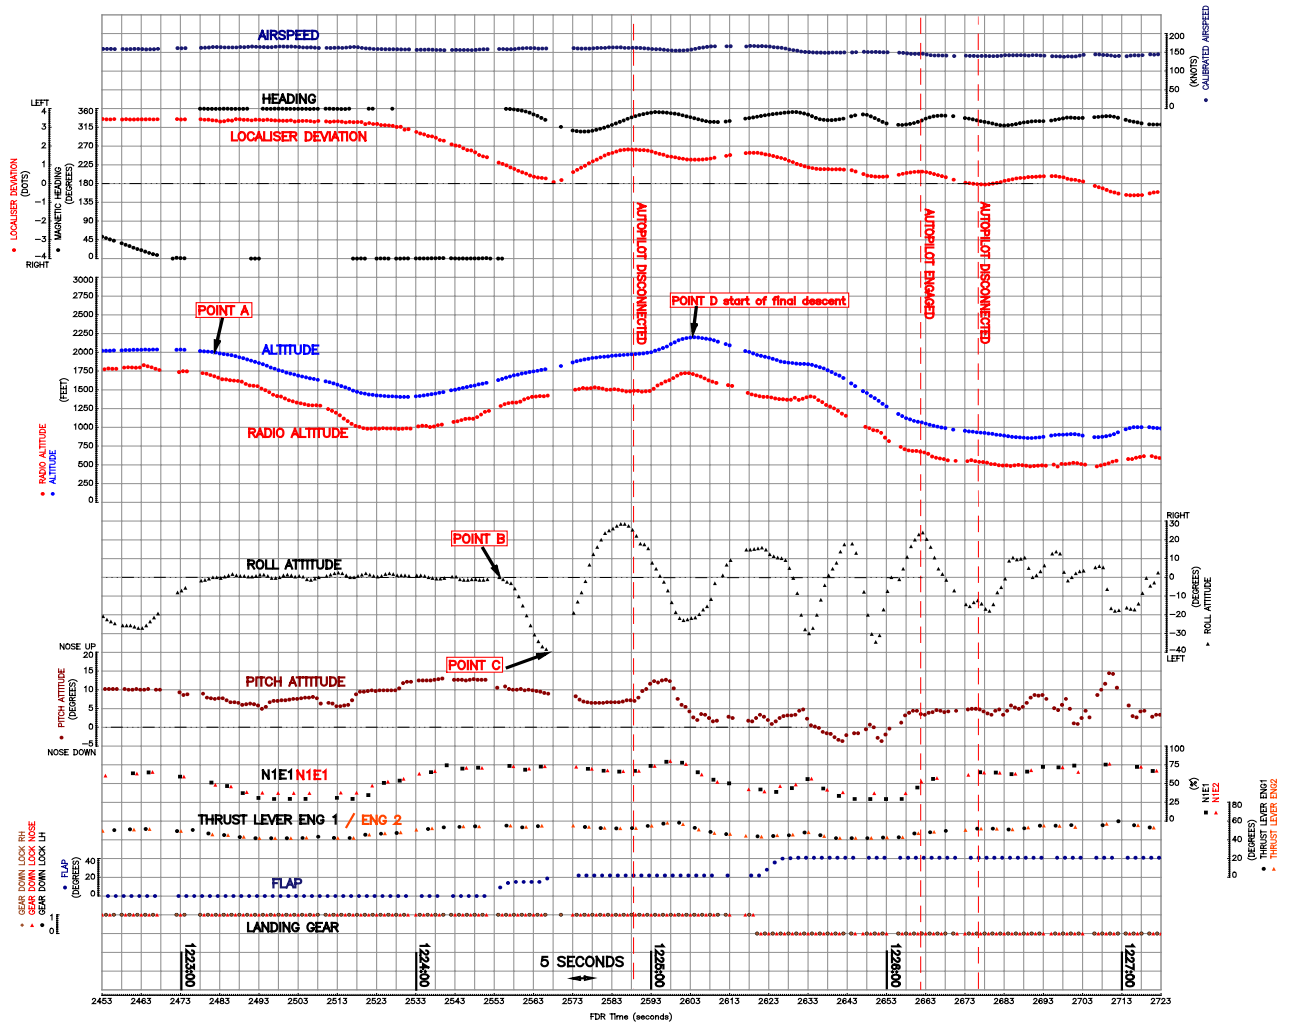
Salient FDR Parameters during second approach
(Incident to F-OJHI on 23 February 2006)
