Aircraft type and registration:	Piper PA 34—200 Seneca G-BETT (light fixed wing twin engined aircraft)	
Year of Manufacture:	1972	
Date and time (GMT):	11 September 1984 at 0845 hrs	
Location:	Headcorn Aerodrome, Kent	
Type of flight:	Aerial Photography	
Persons on board:	Crew — 1	Passengers — 1
Injuries:	Crew — None	Passengers — None
Nature of damage:	Both propellers damaged and engines shock loaded, distortion of nose undercarriage bay structure.	
Commander's Licence:	Commercial Pilot's Licence	
Commander's Age:	30 years	
Commander's total flying experience:	2230 hours (of which 70 were on type)	
Information Source:	Aircraft Accident Report Form submitted by the pilot.

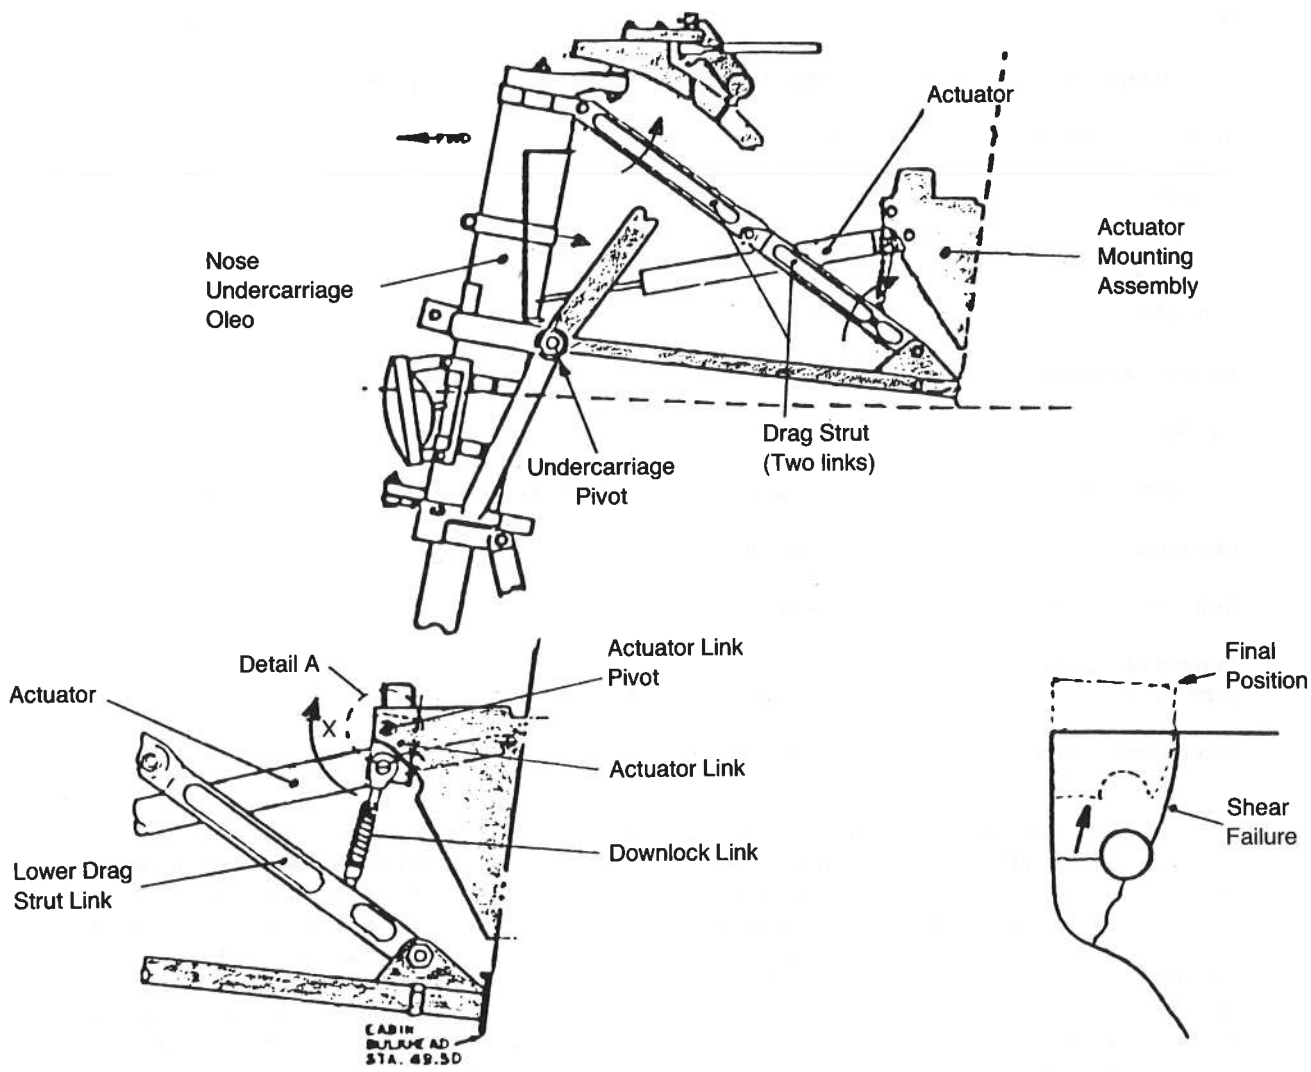
FIG.1

Examination showed that the nose undercarriage actuator mounting assembly had sheared vertically upwards from the actuator link pivot bolt hole, (refer to Figure 1) and the downlock link had been bent. The forces required to cause these failures can only have resulted from the folding of the drag strut with the actuator and its link in the locked down position.

It was not possible to determine the reason for this having occurred. Piper Service Bulletin No 413 of 16 April 1974 draws attention to the potential for inadvertent nose gear retraction in a hard landing and calls for a dimensional check on the drag strut overcentring.

Arrow X — Denotes direction of rotation of actuator link on normal retraction
