Air Accidents Investigation Branch

**Report on the accident to
Eurocopter EC225 LP Super Puma, G-REDU
near the Eastern Trough Area Project (ETAP)
Central Production Facility Platform
in the North Sea
on 18 February 2009**

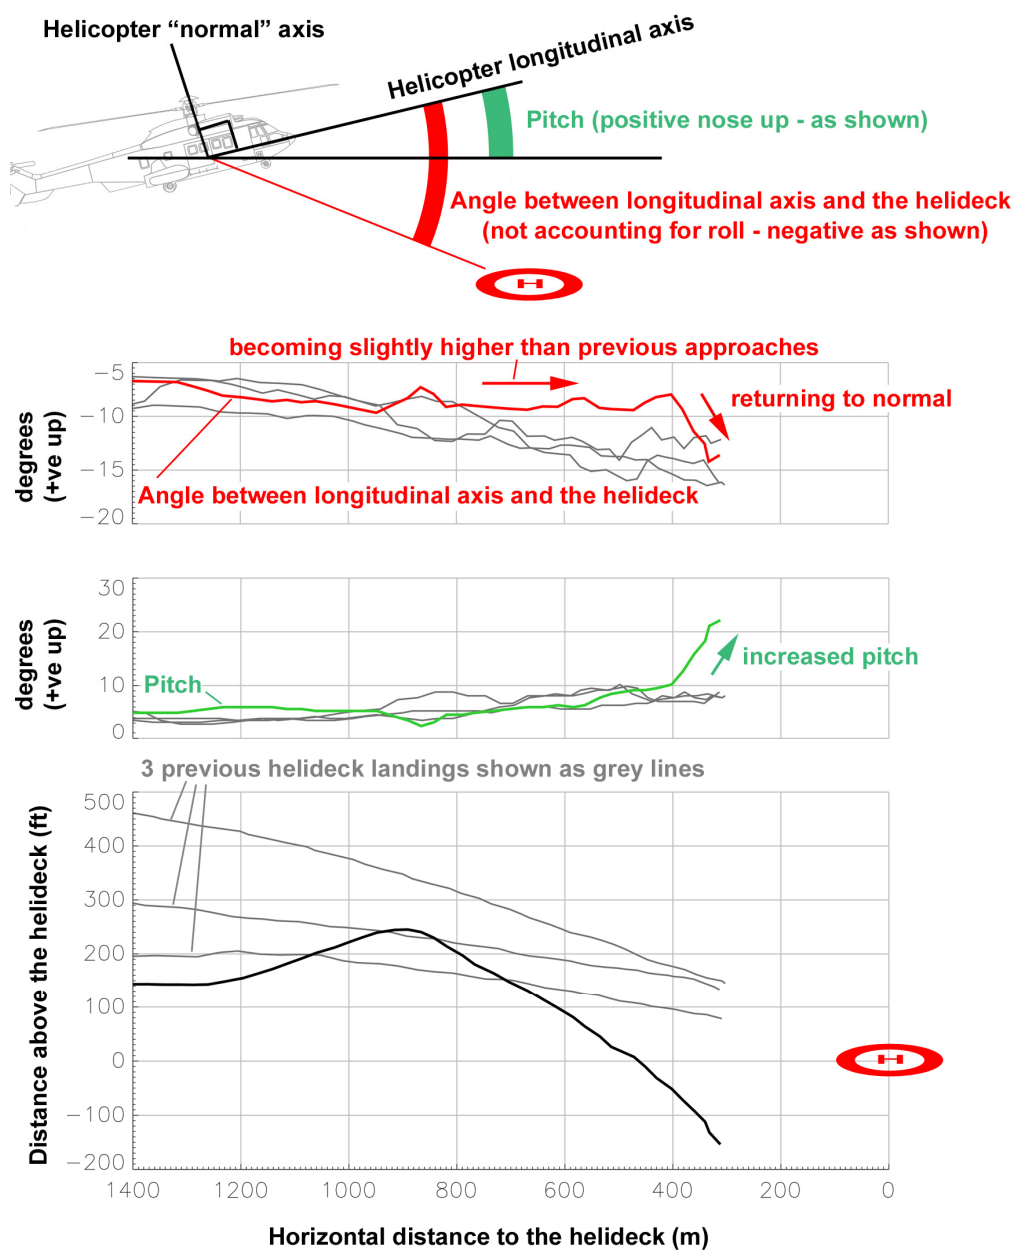
Figure 7

Comparison of the angles between the helicopter's longitudinal axis and the sight line to the helideck during the accident flight and three previously recorded platform landings

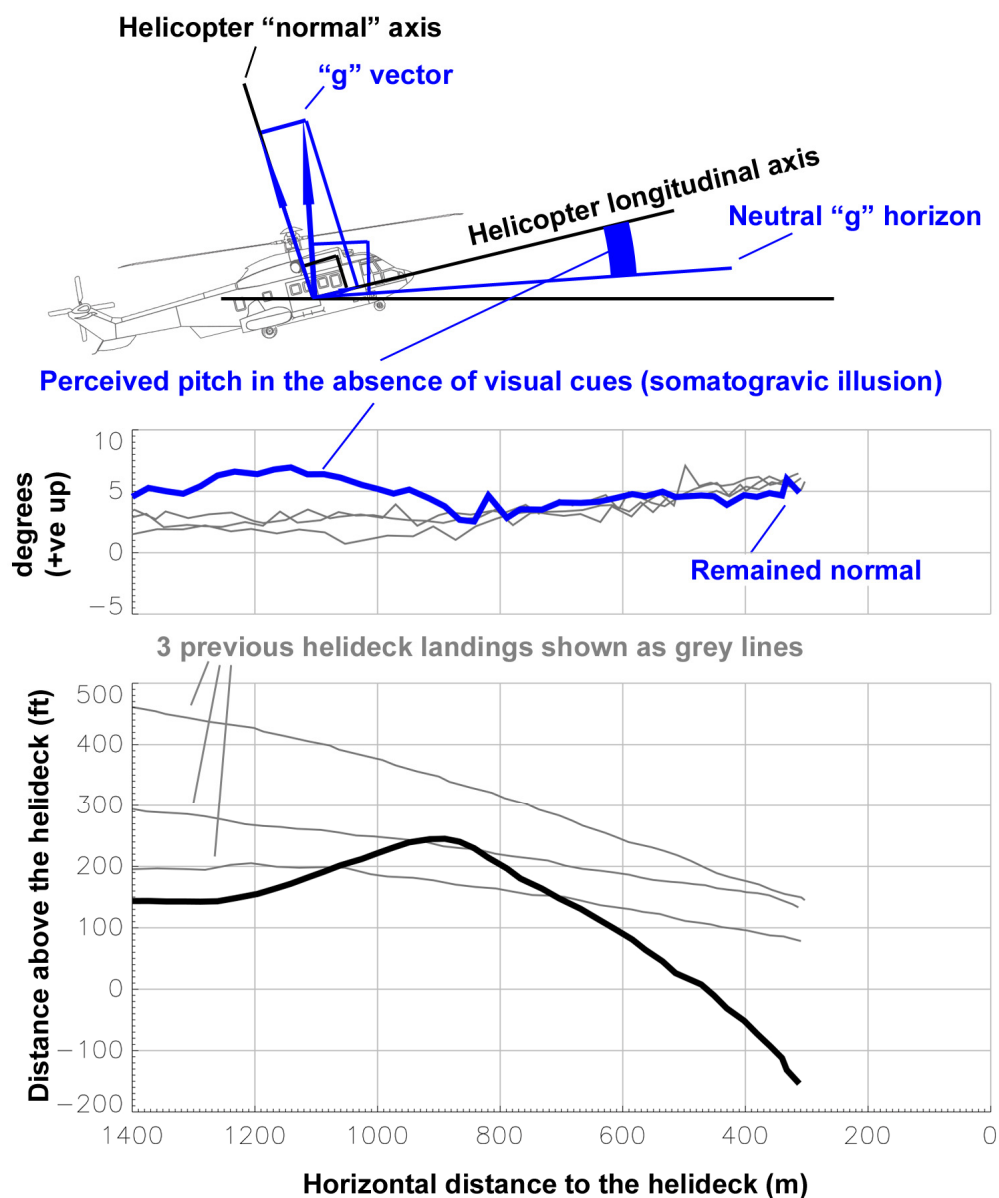
**Figure 8**

The perceived pitch of the helicopter during final approach,
without visual cues

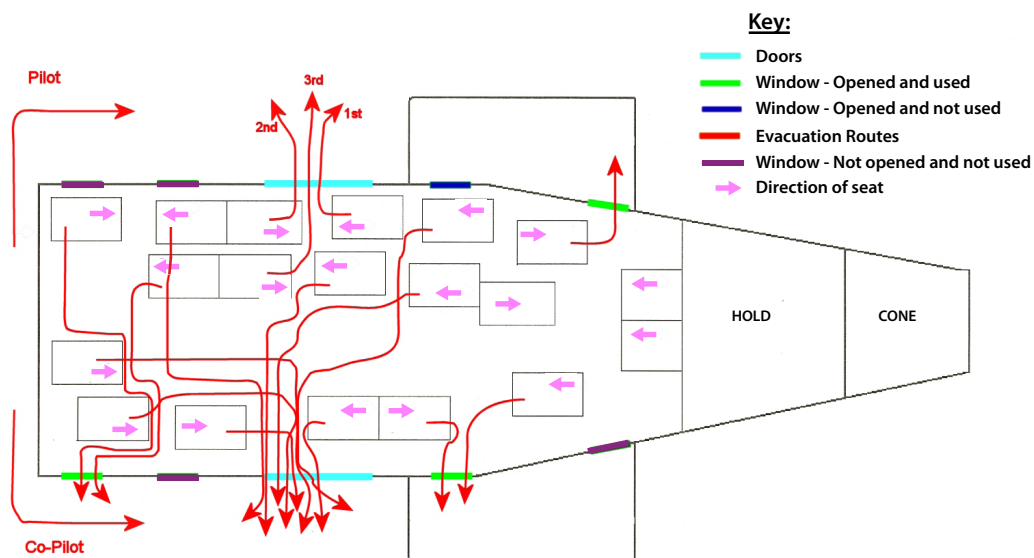
Figure 11

The helicopter remained stable and upright on the surface and the passengers evacuated through windows and doors (see Figure 11). The passengers, and the commander, exited the aircraft directly into the life rafts. The co-pilot jumped into the water, via his own door, then climbed into the left liferaft.

Passenger seating arrangement and evacuation routes

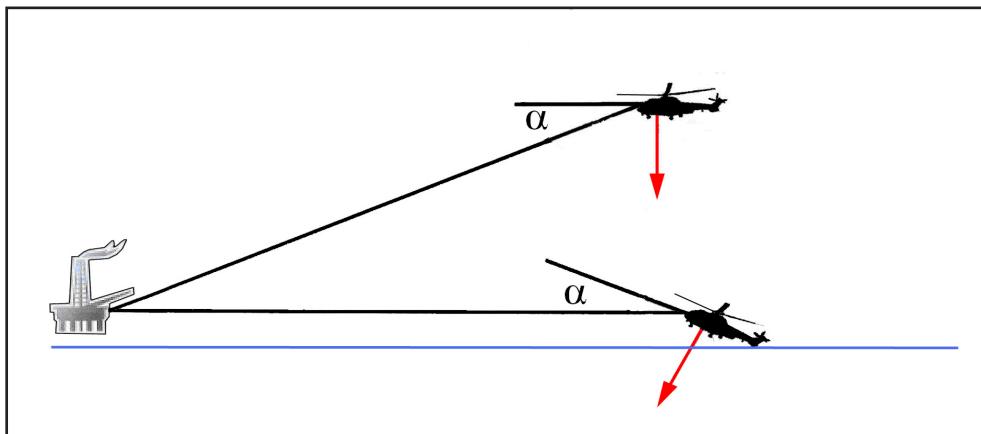
Figure 6

The oculogravic illusion. Because the force vector generated by the lift of the main rotor remains vertical with respect to the aircraft despite increasing pitch up, the aircraft feels to the occupants as it would if it were still in level flight. This misperception leads to error in the spatial localisation of isolated objects in the field of view.

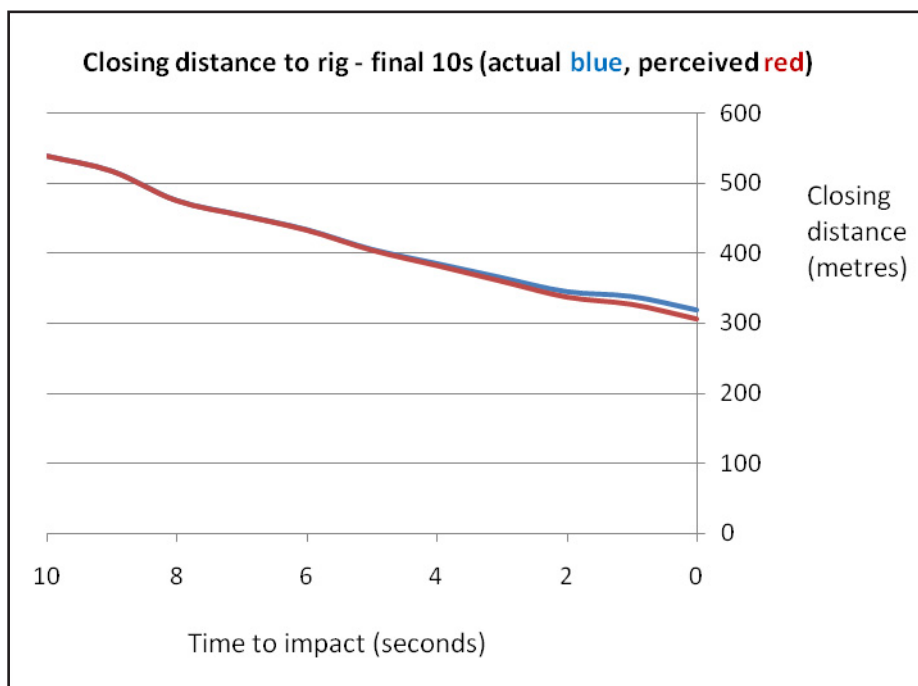
**Figure 9**

Actual and perceived distance from the platform.
A small discrepancy becomes evident in the 4s before impact.
