ACCIDENT

Aircraft Type and Registration:	Rans S6-ESD (Modified), Coyote II, G-MYSP	
No & Type of Engines:	1 Rotax 582-48 piston engine	
Year of Manufacture:	1992 (Serial no: PFA 204-12265)	
Date & Time (UTC):	28 August 2013 at 1118 hrs	
Location:	Redhill Aerodrome, Surrey	
Type of Flight:	Private	
Persons on Board:	Crew - 1	Passengers - None
Injuries:	Crew - 1 (Fatal)	Passengers - N/A
Nature of Damage:	Aircraft destroyed	
Commander's Licence:	National Private Pilot's Licence (Aeroplanes)	
Commander's Age:	57 years	
Commander's Flying Experience:	63 hours (of which 4 were on type) Last 90 days - 9 hours Last 28 days - 3 hours	
Information Source:	AAIB Field Investigation

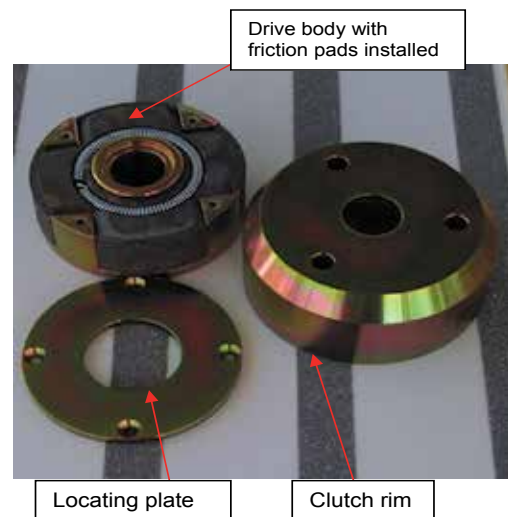
Figure 2

This type of clutch (Figure 2) consists of a drive body secured to the engine output shaft, four friction pads (held together by two circular springs) which locate in the drive body, a locating plate and the clutch rim, which is secured to the gearbox coupling flange. The clutch is designed to remain disengaged until the engine speed reaches approximately 2,400 rpm, at which point the friction pads move outwards, contacting the clutch rim and causing the gearbox to rotate. The installation of this clutch reduces engine vibration during engine start and at idle speed, and allows the installation of a larger propeller than would normally be fitted to a 'direct drive' engine. In flight, however, the engine speed must be maintained above 2,400 rpm to prevent the clutch from disengaging and allowing the propeller to windmill. If this were to occur it would affect the gliding performance of the aircraft.

RK400 clutch assembly

The damage observed on the starter gear casing and the clutch rim confirmed that the engine was rotating at impact, although no indication of engine speed could be made. It could not be determined whether the rotational damage to the propeller blades was the result of a propeller strike or caused during the impact sequence. It was not possible to confirm whether the clutch was engaged at the time of impact.

While no defects were identified with the ignition triggering mechanism, the inability to test the capacitive discharge units, ignition leads or spark plugs meant that the investigation could not rule out the presence of a defect in these components. If the engine speed falls below 2,400 rpm the clutch will disengage, allowing the propeller to windmill and cause a significant reduction in aircraft performance.
