SERIOUS INCIDENT

Aircraft Type and Registration:	Fokker F.28 Mark 0070, PH-KZB
No & Type of Engines:	2 Rolls-Royce Tay 620-15 turbofan engines
Year of Manufacture:	1996
Date & Time (UTC):	29 September 2008 at 1705 hrs
Location:	Manchester Airport
Type of Flight:	Commercial Air Transport (Passenger)
Persons on Board:	Crew - 4 Passengers - 70
Injuries:	Crew - None Passengers - 2 (Minor)
Nature of Damage:	Emergency inverter cooling fan capacitor burnt out
Commander's Licence:	Airline Transport Pilot's Licence
Commander's Age:	43
Commander's Flying Experience:	9,820 hours (of which 3,908 were on type) Last 90 days - 153 hours Last 28 days - 54 hours
Information Source:	AAIB Field Investigation

Synopsis

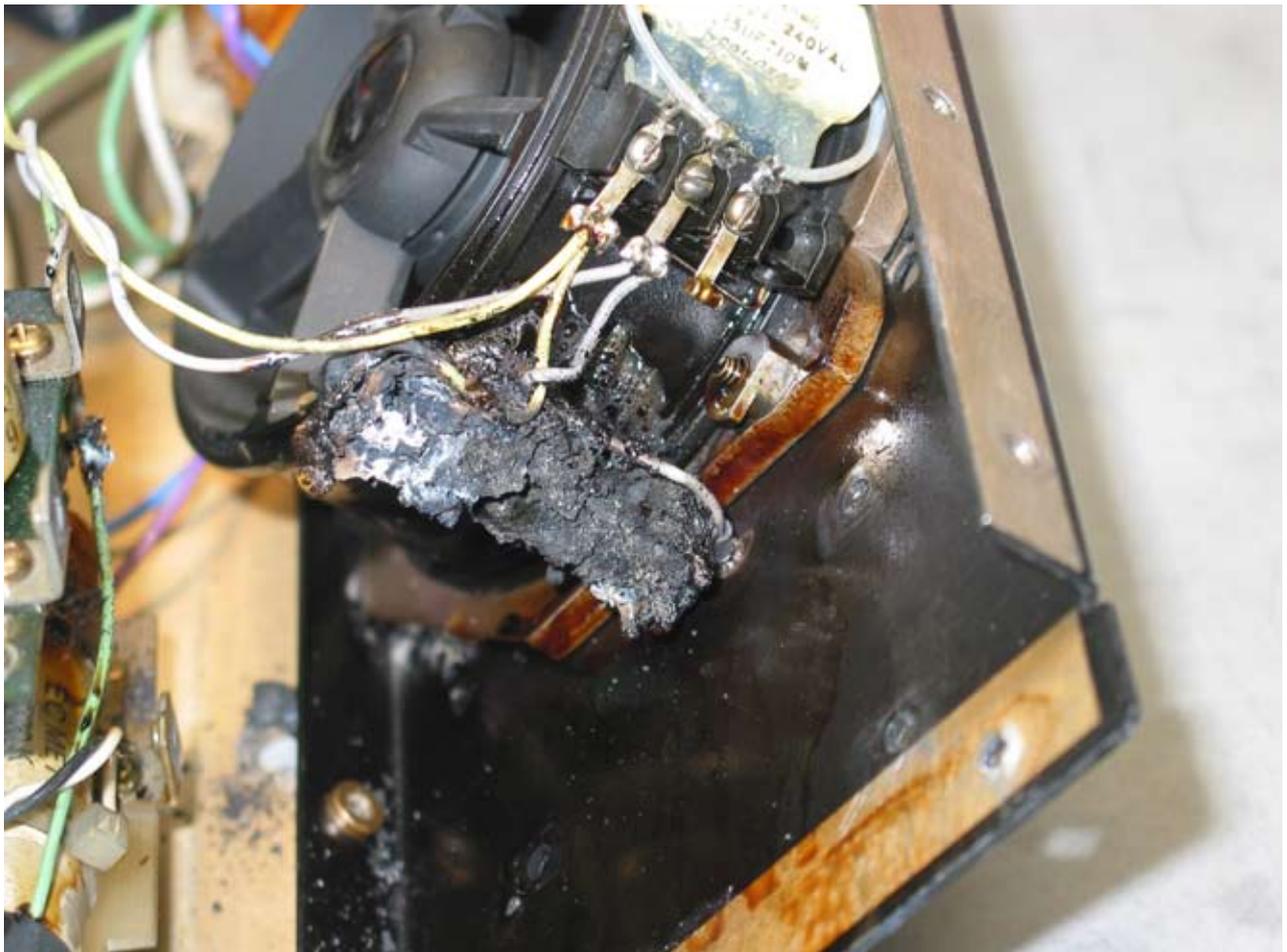
Figure 1

test bench power supply. As soon as electrical power was applied, smoke emanated from the area around the cooling fan. Further disassembly of the unit identified that a capacitor in the cooling fan power supply circuit was completely burnt out. (Figure 1) The capacitor was too badly damaged to allow any further analysis of why it had failed. The inverter was then repaired and tested, with no further anomalies identified.

loss of normal ac supply. The inverter is continually powered while the aircraft is electrically powered and as its operation is completely autonomous, the only means of isolating it is to pull the 28 V supply circuit breaker or to completely de-power the aircraft. The overheated capacitor which caused the smoke was part of a modification to the unit installed during aircraft development, to reduce the fan speed and therefore the level of noise which it generated on the flight deck. Should the cooling fan fail to operate, a thermistor within the inverter isolates the power supply when the temperature reaches 110°C.

Burnt out capacitor

During the incident, a cooling fan power supply capacitor, located adjacent to the fan within the emergency inverter unit, overheated and generated a significant quantity of smoke. The cooling fan continued to operate, drawing the smoke out of the inverter casing and through the hole in the dividing wall between the inverter equipment bay and the area behind the upper circuit breaker panel. As this space was completely enclosed, it then entered the flight deck via the gaps around the panel. The co-pilot opened his sliding window to allow the smoke to clear, but this most likely set up a circulation cell

It has not been possible to isolate the reason for the capacitor overheating due to the severity of the damage. Previous failures of this component are low in

number, although the recent frequency of failures may suggest that the failure rate is beginning to increase. Given the time since manufacture of the capacitors, the failure mode may potentially be a service life related issue. This event is the first recorded incident where smoke in the flight deck has been reported as a consequence of this capacitor overheating. No anomalies could be identified which might explain the number of overheat failures associated with this aircraft. Routine fleet airworthiness reviews between the inverter manufacturer and the Civil Aviation Authority (Netherlands) aim to identify any adverse trend in reliability and ensure mitigating action is taken if necessary.
