ACCIDENT SITE PHOTOGRAPHS

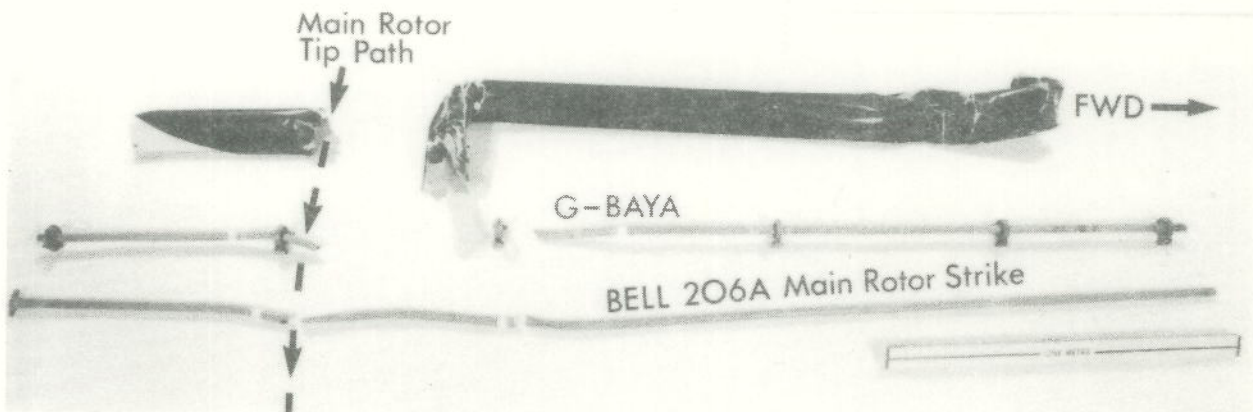
LONG DRIVE SHAFT FAILURES
