## ACCIDENT

<b>Aircraft Type and Registration:</b>	Eurocopter EC135 T2, G-IWRC	
<b>No &amp; Type of Engines:</b>	Two Turbomeca Arrius 2B2 turboshaft engines	
<b>Year of Manufacture:</b>	2002	
<b>Date &amp; Time (UTC):</b>	16 September 2007 at 1316 hrs	
<b>Location:</b>	East of North Weald Airfield, Essex	
<b>Type of Flight:</b>	Private	
<b>Persons on Board:</b>	Crew - 1	Passengers - 1
<b>Injuries:</b>	Crew - None	Passengers - None
<b>Nature of Damage:</b>	Extensive damage to fuselage, tailboom and rotors	
<b>Commander's Licence:</b>	Private Pilot's Licence	
<b>Commander's Age:</b>	55 years	
<b>Commander's Flying Experience:</b>	2,500 hours (of which 450 were on type) Last 90 days - 48 hours Last 28 days - 15 hours	
<b>Information Source:</b>	AAIB Field Investigation

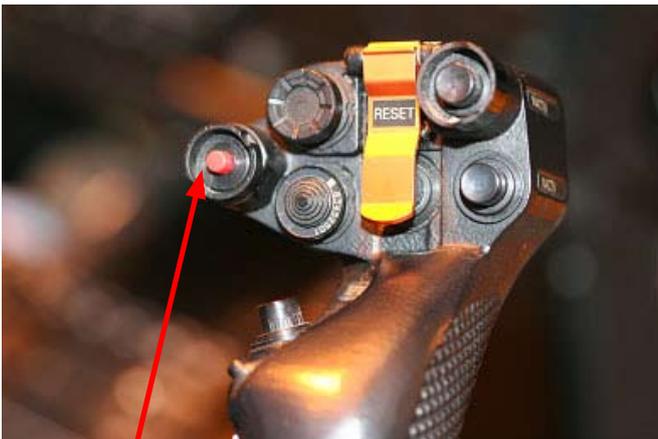
**Figure 1**

A SAS DCPL switch is mounted on top of each cyclic grip and, whilst it is protected from inadvertent operation by an annular guard, the switch sits about 1 mm proud of the guard (see Figure 1). Tests were undertaken, on the ground, to establish if either of the front seat occupants could have inadvertently operated this switch. In the first test the corner of the magazine which the passenger had been reading was knocked against the switch. The test proved that it is possible for the corner of a heavy magazine to operate the switch. The second test simulated the pilot turning to place a book in the right door stowage. This test proved that it is possible for an elbow to operate the switch. On both tests the pressure to operate the switch also caused the cyclic stick to move forwards.

Position of SAS DCPL Switch

Whilst it was possible for the pilot's elbow to operate the SAS DCPL switch inadvertently on the ground, in flight the position of the cyclic control, when the helicopter is flown at 130 kt, means that it is unlikely that he could have done so whilst returning the flight guide to its stowage. The passenger was a frequent flyer on the helicopter and the pilot believes that it is also unlikely that she would have inadvertently knocked the SAS DCPL switch with her magazine.

Whilst it is unlikely that the inadvertent operation of the SAS DCPL switch caused this accident, it is felt that the guard provides insufficient protection and might not comply with the guidance given in EASA CS-27. The use of a guard that more effectively protects the switch might help to prevent inadvertent operation. Equally a change in philosophy, such that the initial operation of the AFS fast disconnect switch leaves a basic level of SAS still engaged, might help to prevent inadvertent operation.

It is recommended that Eurocopter review the design of the Stability Augmentation System (SAS) DCPL switch on the EC135 helicopter to reduce the likelihood of inadvertent de-activation of the SAS.

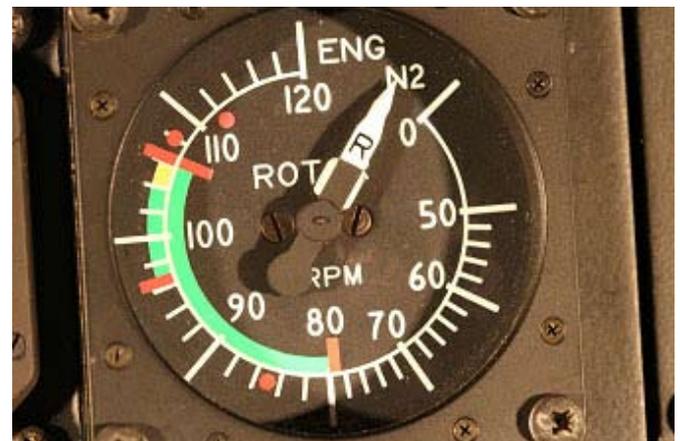
**Figure 2**

The two N2 pointers are below the NR pointer in this photograph of the gauge at rest.

Note the tail of the NR pointer.

The triple tachometer gauge

The triple tachometer gauge is a complex instrument and a brief examination might lead to errors in interpretation, such as confusing rotor rpm and engine N2, or mistaking the tail of the rotor rpm needle for an engine N2 pointer. The pilot appears to have gained a vivid impression of an unusual set of indications, but not a detailed and accurate interpretation sufficient to inform him that the engines were performing normally.

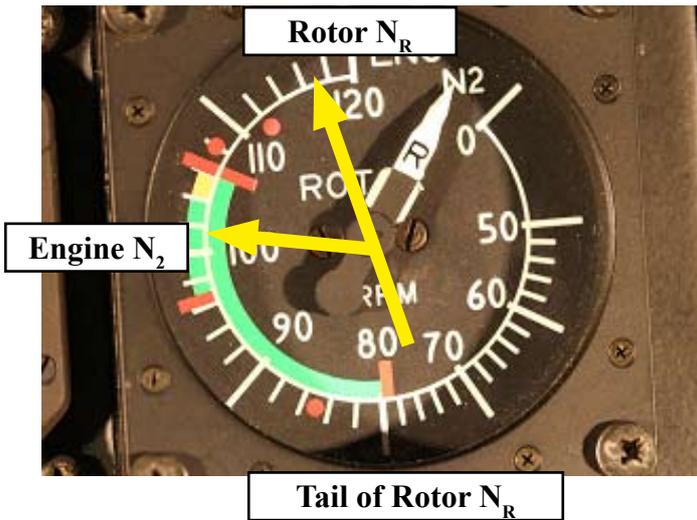
**Figure 3**

The Triple tachometer gauge with the positions of the pointers, as determined by the investigation, superimposed in yellow. The N2 pointers are not visible as, in this photo, they are hidden by the NR pointer
