No: 5/89

Ref: EW/C1096

Aircraft Type and Registration: (1) Cessna 182R G-BLFV
(2) Cessna F152 G-WACD

Location: Wycombe Air Park, Marlow, Bucks

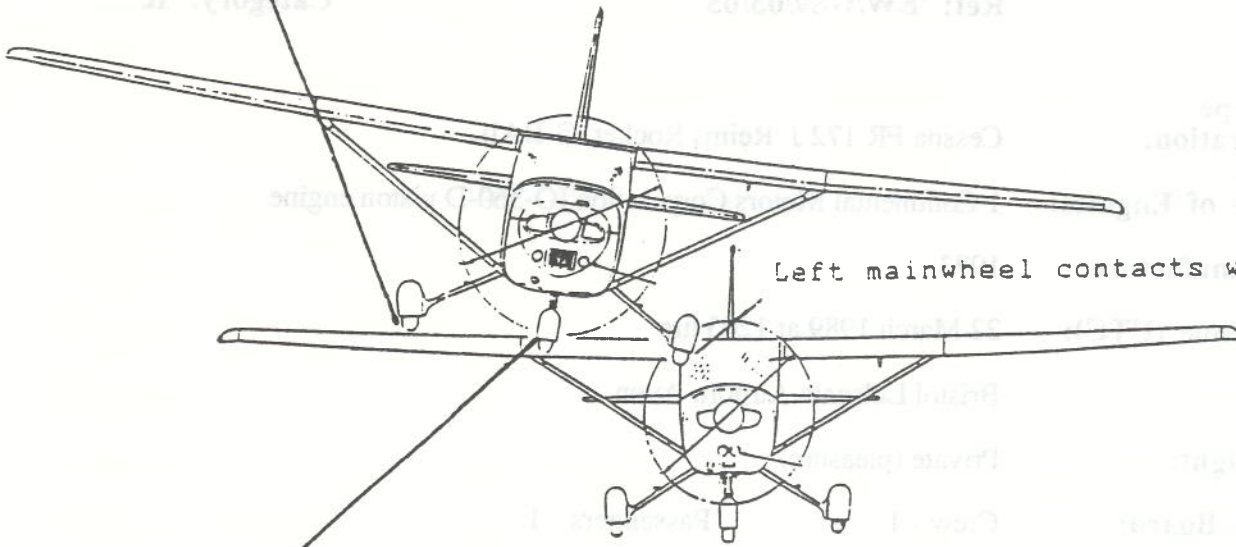
Two propeller strikes were identified on the upper surface of CD's right wing: one starting 4-4½ ft in from the tip immediately aft of the forward spar and another immediately forward of it further inboard in the area of the strut attachment to the wing. The latter strike had penetrated the upper and lower wing skins. Neither strike had penetrated the fuel tank or severed any flying control cables. A tyre mark and an indentation at the top of the wing strut were identified as having been made by FV's nosewheel, which accounted for the fragments of spat found on the runway. The only other airborne damage sustained by CD was the broken windscreen and this was attributed to a blow from the left

No discernible contact by right
mainwheel on wing upper surface

Left mainwheel contacts windscreen

Prop strikes near wing LE and
nosewheel mark at top of strut
