ACCIDENT

Aircraft Type and Registration:	Robinson R22 Beta, G-TTHC	
No & Type of Engines:	1 Lycoming O-320-B2C piston engine	
Year of Manufacture:	1989	
Date & Time (UTC):	14 February 2009 at 1240 hrs	
Location:	Near Sandtoft Aerodrome, Humberside	
Type of Flight:	Training	
Persons on Board:	Crew - 1	Passengers - None
Injuries:	Crew - 1 (Fatal)	Passengers - N/A
Nature of Damage:	Aircraft destroyed	
Commander's Licence:	Student pilot	
Commander's Age:	54 years	
Commander's Flying Experience:	75 hours (of which 75 were on type) Last 90 days - 6 hours Last 28 days - 6 hours	
Information Source:	AAIB Field Investigation

Synopsis

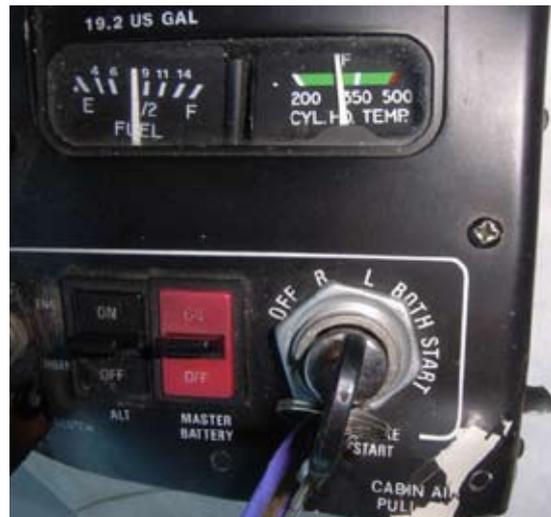
Figure 1

Initial examination of the wreckage by the AAIB found the controls in the cockpit in the following positions: the mixture control was fully IN, (full rich), the carb heat had been pulled out by 11 mm, the fuel shut off valve was in the OFF position, the primer was locked IN, the

governor switch on the end of the cyclic was in the ON position and the ignition switch was at the L position (See Figure 1). The key in the ignition switch was undamaged and there was relatively little damage in the area adjacent to the switch. Movement of the key during the impact is therefore considered unlikely.

Position of ignition switch

The helicopter should have been flown with the ignition switch selected at BOTH so that the failure of one magneto would not result in the engine stopping. However, the evidence indicates that the magneto switch was inadvertently set to the L position during the pre-flight checks, and the selected left magneto had failed in flight. The left magneto passed the checks undertaken during the 100 hour servicing carried out 2 hours 36 minutes before the accident and would have been checked by the instructor and student at the start of each of the flights undertaken on the day of the accident. Nevertheless, from the available evidence, it appears that as a result of

wear of the coil outlet tab the left magneto failed during the accident flight. With the right magneto turned off this would have resulted in the engine stopping.

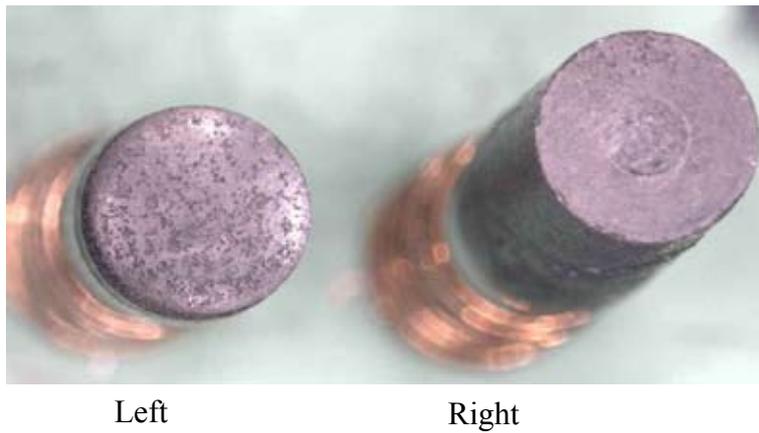
Figure 2

The brush and coil from the left magneto were examined by a metallurgist at the Royal Navy Material Integrity Group. They established that the wear pattern on the left and right magneto brushes was different and that material appeared to have been plucked out from the left brush. (See Figure 2)

Wear pattern on carbon brushes

It is probable that the damage to the brush and outlet tab on the coil occurred over a period of time and started with a build up of oxides, which are abrasive and poor conductors. The presence of an oxide in the area between the rotating brush and outlet tab would have accelerated the wear in the brush and worn the depression in the outlet tab. This progressive build-up of oxides would eventually have resulted in arcing between the brush and tab which would have formed a carbon deposit. A metallurgist advised the AAIB that this particular type of carbon deposit would be abrasive

with poor conductivity. Eventually the copper at the base of the depression would have reached a critical thickness such that the temperature rise from the arcing would be sufficient to melt the copper and force the remaining metal away from the tab. With the remainder of the outlet tab covered with oxides and a carbon (poor conducting) deposit there would no longer have been an electrical path between the coil and the distributor leads.

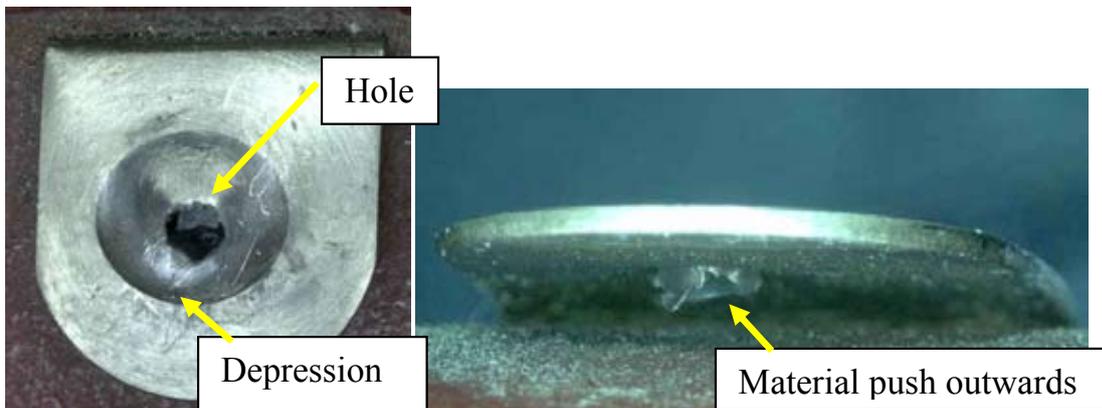
Figure 3

Examination of the copper outlet tab on the left magneto coil revealed that it was covered in a layer of oxide and that the depression had formed due to a loss of material. The hole at the bottom of the depression had formed as a result of the copper melting and being pushed out of the depression. (See Figure 3).

Copper outlet tab on left magneto coil

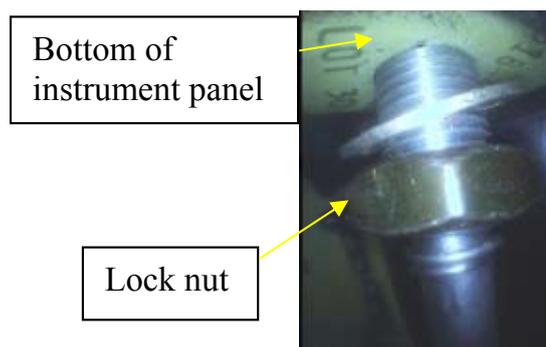
Figure 4

The lock nut on the carb heat control cable end fitting was found to have unwound such that when the carb heat control was pulled ON the fitting would lift out of the instrument panel by approximately 6 mm (See Figure 4). The maintenance records show that this cable had last been disturbed during the rebuild about 462 hours earlier.

After the accident the carb heat control in the cockpit was found to have been pulled out by 11 mm, which corresponded to a 7% opening of the hot air port by cross section. However, the carb heat control valve, which is fitted to the air box, had detached from the bottom of the engine distorting the valve and causing the control cable to bend around the structure. It is, therefore, possible that it had been pulled out further than the 11 mm, but during the impact was pulled towards the cold position. From the damage to the air box it was established that the hot air port could not have been open by more than 60% of its cross-sectional area. Therefore it is assessed that at the time of the accident the hot air port had been open between 7% and 60% of its cross-sectional area.

Carb heat cable end fitting
