## ACCIDENT

<b>Aircraft Type and Registration:</b>	Hawker Hunter T7, G-BVGH	
<b>No &amp; Type of Engines:</b>	1 Rolls Royce Avon MK 122 turbojet engine	
<b>Year of Manufacture:</b>	1958	
<b>Date &amp; Time (UTC):</b>	22 May 2007 at 1300 hrs	
<b>Location:</b>	Exeter Airport	
<b>Type of Flight:</b>	Private	
<b>Persons on Board:</b>	Crew - 2	Passengers - None
<b>Injuries:</b>	Crew - None	Passengers - N/A
<b>Nature of Damage:</b>	Right main landing gear leg failed, damage to right wing and rear fuselage	
<b>Commander's Licence:</b>	Private Pilot's Licence	
<b>Commander's Age:</b>	51 years	
<b>Commander's Flying Experience:</b>	2,350 hours (of which 35 were on type) Last 90 days - 19 hours Last 28 days - 5 hours	
<b>Information Source:</b>	Aircraft Accident Report Form submitted by the pilot and AAIB examination of the aircraft

## Synopsis

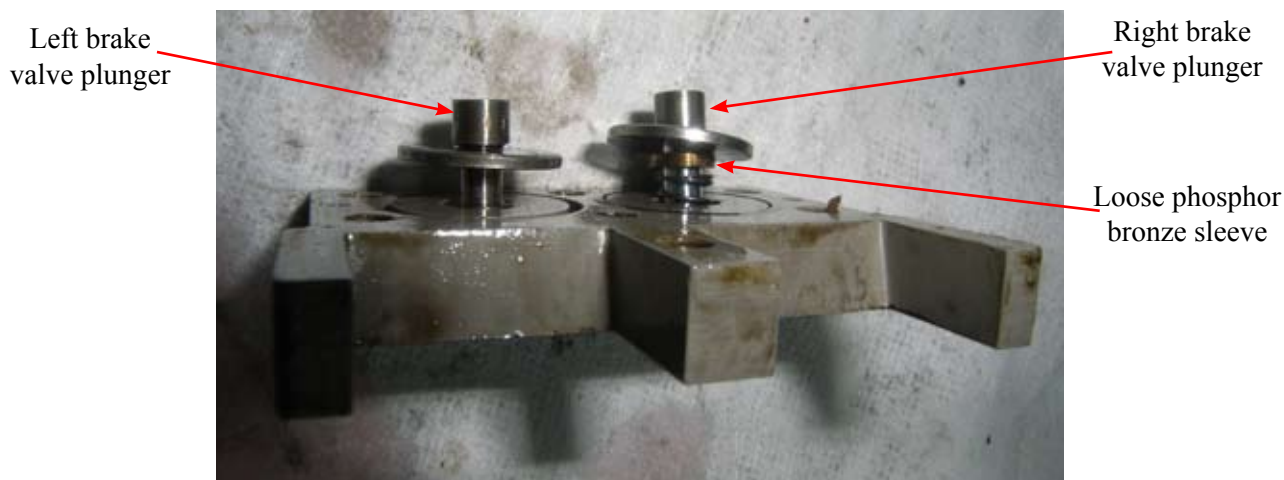
**Figure 1**

Brake valve plungers showing loose support sleeve on the right valve

for the left brake valve was secure within its housing, while the right valve sleeve sprang from the unit during disassembly. The right brake valve plunger exhibited witness marks on its shaft, and these appeared to have been caused by contact with the sleeve during operation; the left valve plunger was undamaged. Measurement of the right valve sleeve showed that a clearance of 0.06 mm existed between the outer diameter of the sleeve and the hole in the housing in which it had been mounted. This clearance would have allowed a small degree of 'rocking' movement of the sleeve which, over time, produced the witness marks on the plunger shaft and, on this occasion led to it becoming jammed.

It is considered that as the aircraft completed its right turn onto Runway 26, the right brake valve plunger within the selector unit became jammed, resulting in

a degree of pressure being continually applied to the right wheel brake. Given that the pilot did not have any directional control issues until the nosewheel left the ground, the level of braking to the right main wheel must have been low. As the aircraft accelerated down the runway, the heat build-up within the right brake unit would have been rapid and it is likely that it was sufficient to cause the brake unit to 'seize', just as the nosewheel lifted from the ground.

The brake selector unit is not subject to a fixed life and it was not determined when this unit had been fitted to the aircraft. As a result of this event, the maintenance organisation has introduced routine spectrographic oil analysis of the hydraulic fluid within the brake system to allow early identification of component deterioration.
