AAIB Bulletin No: 4/93

Ref: EW/G93/02/02

Aircraft Type and Registration: Jodel D120, G-AYGG

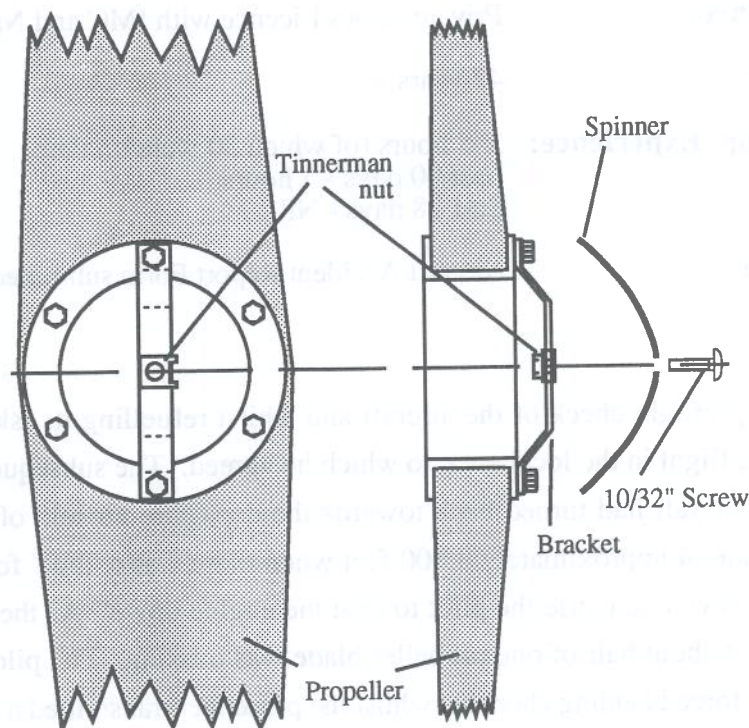
Subsequent inspection revealed that the propeller spinner was missing, and that the broken blade bore a paint smear of the same colour as the spinner. It was thus apparent that the spinner had become detached and then struck the propeller.

The spinner was of the 'scull cap' type, and the attachment details are shown in the accompanying diagram. The spinner was retained by a single, centrally located, 10/32 inch screw which engaged with a 'Tinnerman' nut that was located on a bracket mounted across the diameter of the propeller flange. An oversize hole in the bracket accommodated the screw such that the latter caused the nut to be retained on the bracket. Following the accident, the screw and Tinnerman nut could not be found, leading to the conclusion that the screw had become loose, allowing the spinner to detach.

Propeller spinner attachment details-schematic

Apart from the Jodel, this type of spinner is common on Piper Cub aircraft. However, neither the PFA nor the CAA had any record of a similar incident. Nevertheless, the PFA have stated that they will be issuing updated Notes to Inspectors, drawing attention to spinner security.
