# ACCIDENT TO CESSNA 152 AND SLINGSBY T67 AT CRANFIELD ON 25th FEBRUARY 1987

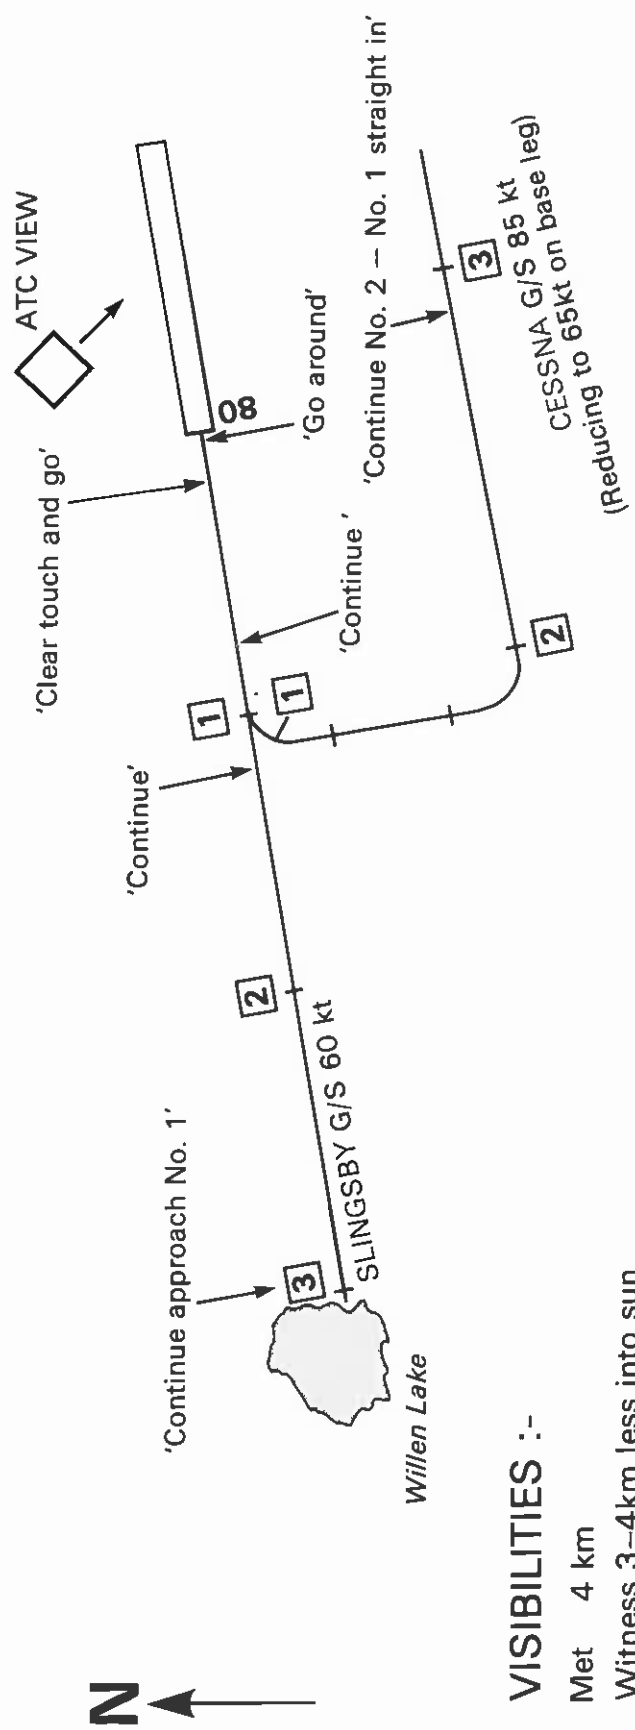
A reconstruction of the aircrafts' flight paths indicated that at this time the 152 had just started its finals turn and was quite close to the T67. Thirty seconds after the T67's 'finals' call, the pilot of the 152 reported finals and was also given clearance to continue the approach. At this point witnesses on the ground saw the aircraft in close proximity to each other with the 152 above and behind the T67. The 152 was observed to be on a steeper and faster approach than the T67. As the T67 neared the runway threshold, the ATCO was satisfied that there was no longer a conflict between the traffic landing on runway 08 and the instrument traffic on runway 22. Having scanned the approach to runway 08, which was directly into sun, he gave the T67 clearance to 'touch and go'. Almost immediately he became aware of the 152 making a steep approach close to the T67, assessed that there was a danger of collision and immediately instructed the 152 to 'go-around, go-around, acknowledge'. The pilot of the 152 received this instruction but later stated that before she could initiate a go-around she became aware of another aircraft below her and a collision occurred.

- Met 4 km
- Witness 3-4km less into sun
- Club rules for solo flight 6 km

WIND  
090°/10-15kt
