INCIDENT

Aircraft Type and Registration:	Boeing 737-300, EC-JUC	
No & type of Engines:	2 CFM 56-3C1 turbofan engines	
Year of Manufacture:	1990	
Date & Time (UTC):	18 July 2006 at 1425 hrs	
Location:	Near Aldergrove Airport, Belfast	
Type of Flight:	Public Transport (Passenger)	
Persons on Board:	Crew - 6	Passengers - 142
Injuries:	Crew - None	Passengers - None
Nature of Damage:	None	
Commander's Licence:	Airline Transport Pilot's Licence	
Commander's Age:	39 years	
Commander's Flying Experience:	7400 hours (of which 5800 were on type) Last 90 days - 210 hours Last 28 days - 90 hours	
Information Source:	Aircraft Accident Report Form submitted by the pilot, radar data, R/T transcripts and witness information

Synopsis

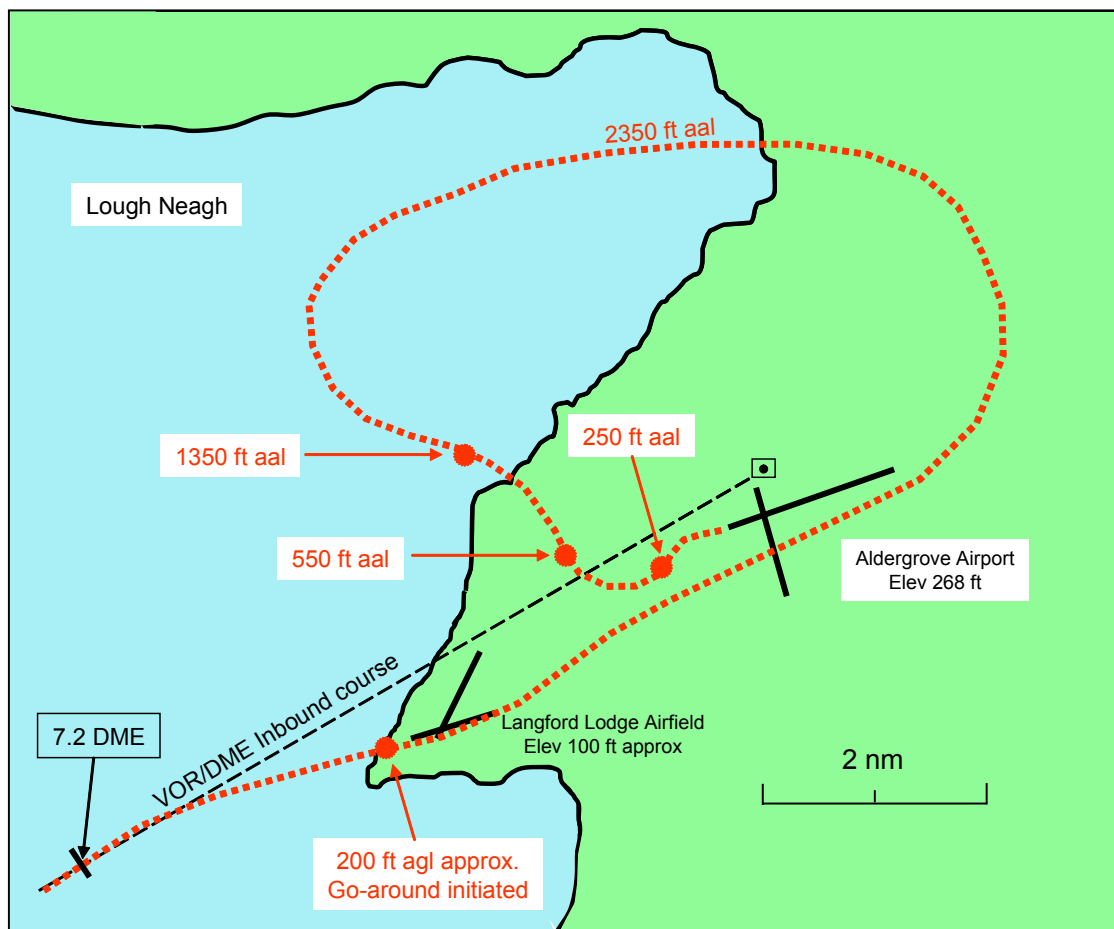
Figure 1

Radar data shows that the aircraft began to deviate to the right of the inbound VOR/DME course at about 2.5 nm from Runway 08 at Langford Lodge, or about 6.5 DME from the VOR/DME (Figure 1). Descent from 2,400 ft had begun at 7.2 DME, which was the correct descent point for the procedure. Mode C information showed the average descent rate to the point of go-around to be about 1,700 ft/min. The vertical profile also showed a gradually increasing rate of descent, with the lower 1,000 ft being flown at an average of approximately 2,000 ft/min. The aircraft took 74 seconds to travel from the final descent point at 7.2 DME to the point of go-around, just short of the runway at Langford Lodge. There are two returns at a minimum altitude of 300 ft amsl, about 200 ft above the airfield level, before the aircraft Mode C indicated a climb.

Radar-derived track and height information
