De Havilland Canada DHC-8-311, G-BRYJ

AAIB Bulletin No: 12/2003	Ref: EW/C2003/03/01	Category: 1.1
INCIDENT		
Aircraft Type and Registration:	De Havilland Canada DHC-8-311, G-BRYJ	
No & Type of Engines:	2 Pratt & Whitney Canada PW123 turboprop engines	
Year of Manufacture:	1991	
Date & Time (UTC):	2 March 2003 at 1035 hrs	
Location:	25 miles north of Edinburgh, Scotland	
Type of Flight:	Public Transport (Passenger)	
Persons on Board:	Crew - 4	Passengers - 29
Injuries:	Crew - None	Passengers - None
Nature of Damage:	None	
Commander's Licence:	Airline Transport Pilot's Licence	
Commander's Age:	40 years	
Commander's Flying Experience:	3,300 hours (of which 2,200 were on type)	
	Last 90 days - 86 hours	
	Last 28 days - 25 hours	
Information Source:	AAIB Field Investigation

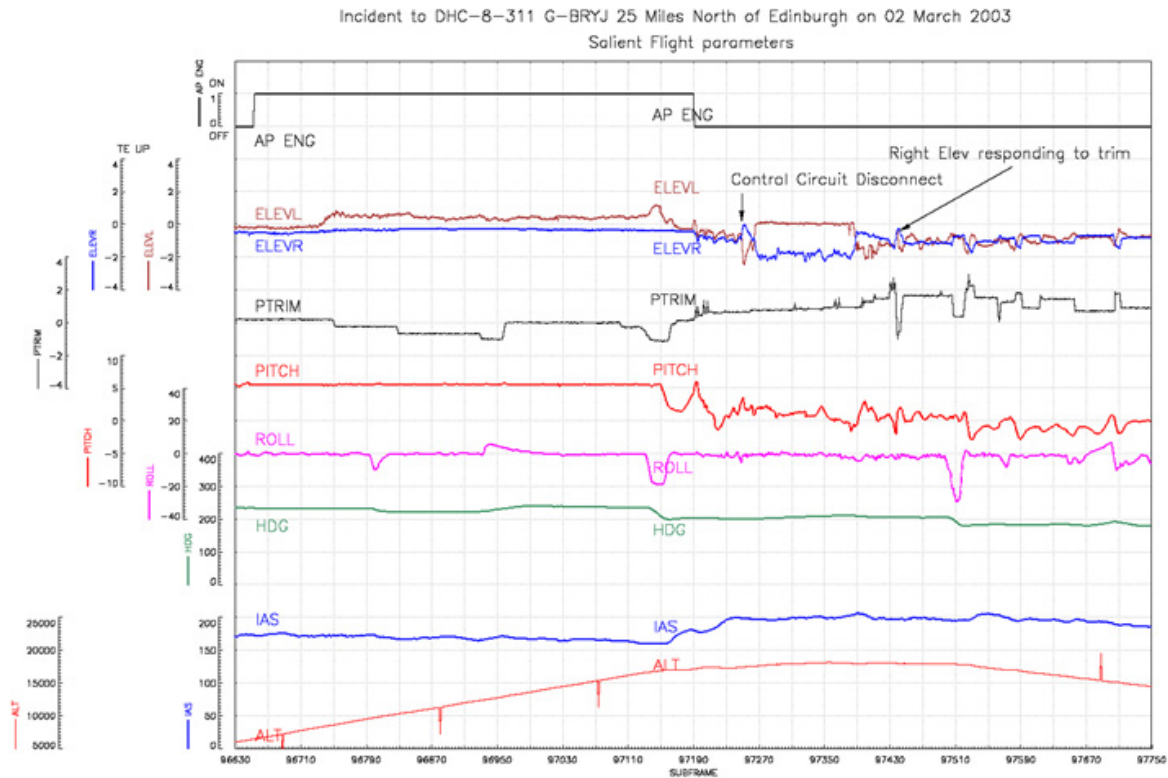
The relevant flight data parameters are shown in Figure 1. The autopilot was engaged about 5 minutes after takeoff with the aircraft in the climb at approximately FL64 at 173 kt. At this stage the left and right elevators appeared to be responding normally to the autopilot pitch trim inputs. Approximately 28 sec later however, whilst the aircraft was climbing through FL80, a pitch trim input was made by the autopilot. Whilst the left elevator appeared to respond to the trim input, the right elevator remained at a constant value of about -0.3° . The right elevator remained at this value until the autopilot was disengaged, about 8 minutes later at 181 kt and FL170. There were small movements of the left and right control surfaces at this time before the left and right sides of the pitch control circuit were split using the pitch disconnect handle. The splitting of the control circuit took place at around 180 kt and FL175 whilst climbing, about 57 secs after the autopilot was disengaged.

The left seat pilot subsequently controlled the aircraft using the left side only of the pitch control circuit, as, from Figure 1, the response of the aircraft in pitch matched closely the left elevator angle. It can also be seen that the right elevator was 'trailing', and not following the left elevator angle.

The right elevator appeared to resume responding to pitch trim inputs some 4 minutes after the pitch disconnect handle was operated with the aircraft at 197 kt and level at FL180; approximately 12 minutes after the original right elevator anomaly occurred.

Analysis of the FDR evidence would suggest that the control difficulties experienced by the crew were due to a restriction of the right elevator spring tab. This prevented both the autopilot and the crew from achieving the desired pitch control using the normal elevator system with the left and right systems interconnected. When the pilots disconnected the left and right systems the commander regained pitch control but the FO still reported control difficulties. No problems were found with the elevator control system post-flight. The subsequent incident which occurred on this aircraft was considered to be unconnected with this event.

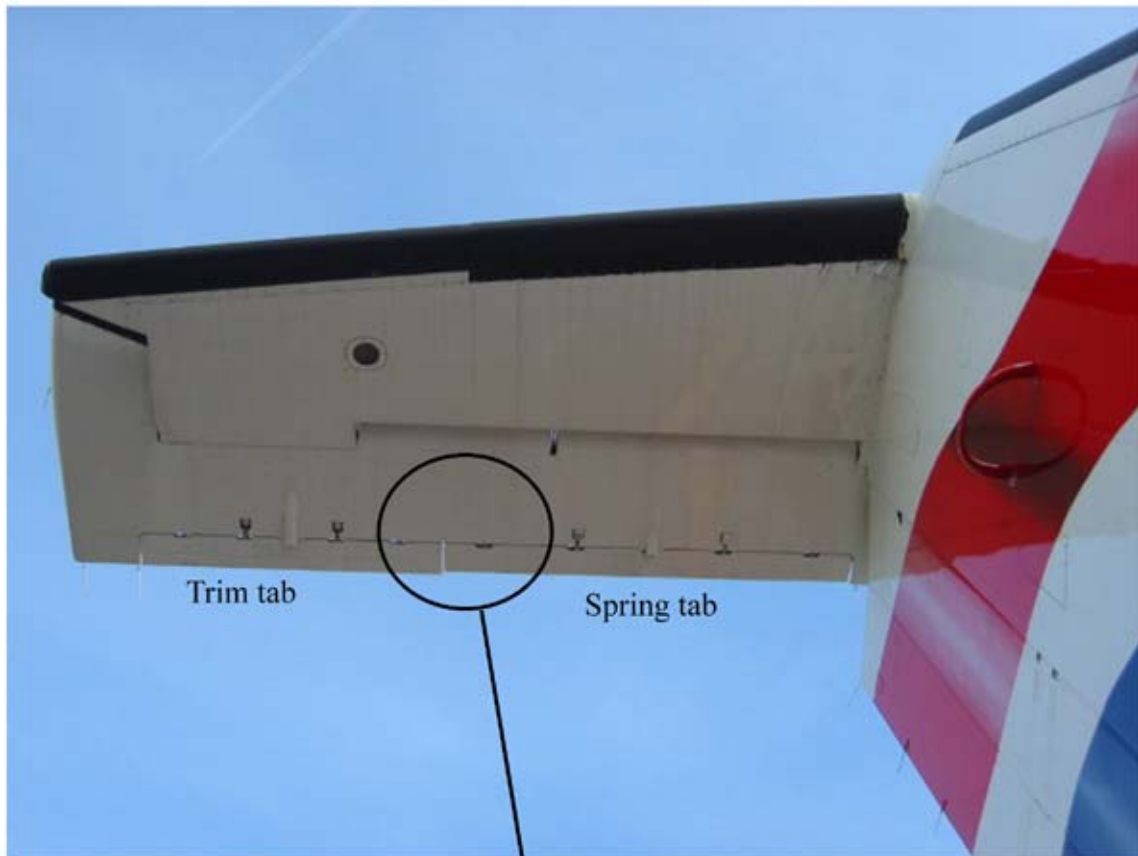
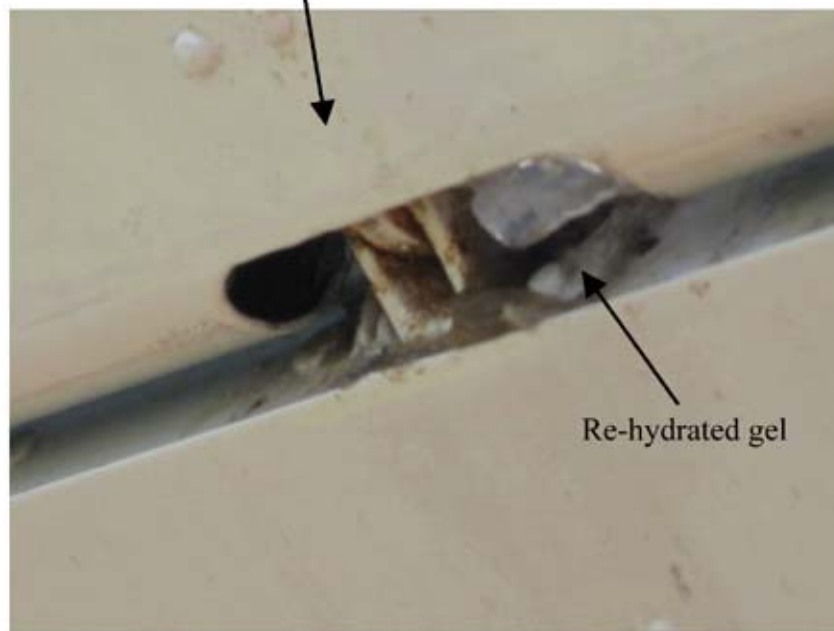
There was evidence of a gel with the consistency of 'wallpaper paste' around the spring tab and trim tab bearings. Figure 2 shows the tab arrangement together with a typical gel deposit found in the area of the hinge bearings.

Figure 2
(Typical re-hydrated gel found around area of tab hinges)

The repeated application of Type II and/or Type IV Fluids may lead to the build-up of residues in 'aerodynamically quiet' areas, such as flying control cavities. These residues are from previous treatments which subsequently dry out and are actually deposits of the thickening agent and appear as a dirty dry stain on the airframe. Residues can accumulate over a period of time and subsequently be re-hydrated by moisture, generally in the form of rain or drizzle, to form a gel like substance. This has the consistency and appearance similar to wallpaper paste.

It is probable that the movement of the right spring tab was affected by ice. There had been significant rainfall prior to the incident flight which could have allowed trapped moisture to cause the formation of ice around the spring tab area. Post-flight examination also revealed the presence of re-hydrated residues from previous anti-icing applications around the hinge bearings. Laboratory analysis showed a very low glycol content, and a freezing point of around -1.1°C. Therefore the possibility existed that this re-hydrated gel had frozen around the bearings and thus caused a restriction. This phenomena has also been seen to effect other aircraft types fitted with manual controls.

It is recommended that the Civil Aviation Authority satisfy itself that operators have in place the necessary measures to ensure that they have adopted the advice given in AIC 81/2001.

The Civil Aviation Authority should consult with anti-icing fluid manufacturers with a view to encouraging them to develop fluids, with suitable 'holdover' times, that incorporate gelling agents that are not re-hydratable.
