ACCIDENT

Aircraft Type and Registration:	Pulsar, G-BULM	
No & Type of Engines:	1 Rotax 582 piston engine	
Year of Manufacture:	1994	
Date & Time (UTC):	17 April 2007 at 1543 hrs	
Location:	Dairy House Farm Airstrip, Aston Juxta Mondrum, near Nantwich, Cheshire	
Type of Flight:	Private	
Persons on Board:	Crew - 1	Passengers - None
Injuries:	Crew - 1 (Fatal)	Passengers - N/A
Nature of Damage:	Aircraft destroyed	
Commander's Licence:	National Private Pilot's Licence	
Commander's Age:	56 years	
Commander's Flying Experience:	1,266 hours (of which 194 were on type) Last 90 days - 29 hours Last 28 days - 21 hours	
Information Source:	AAIB Field Investigation

Synopsis

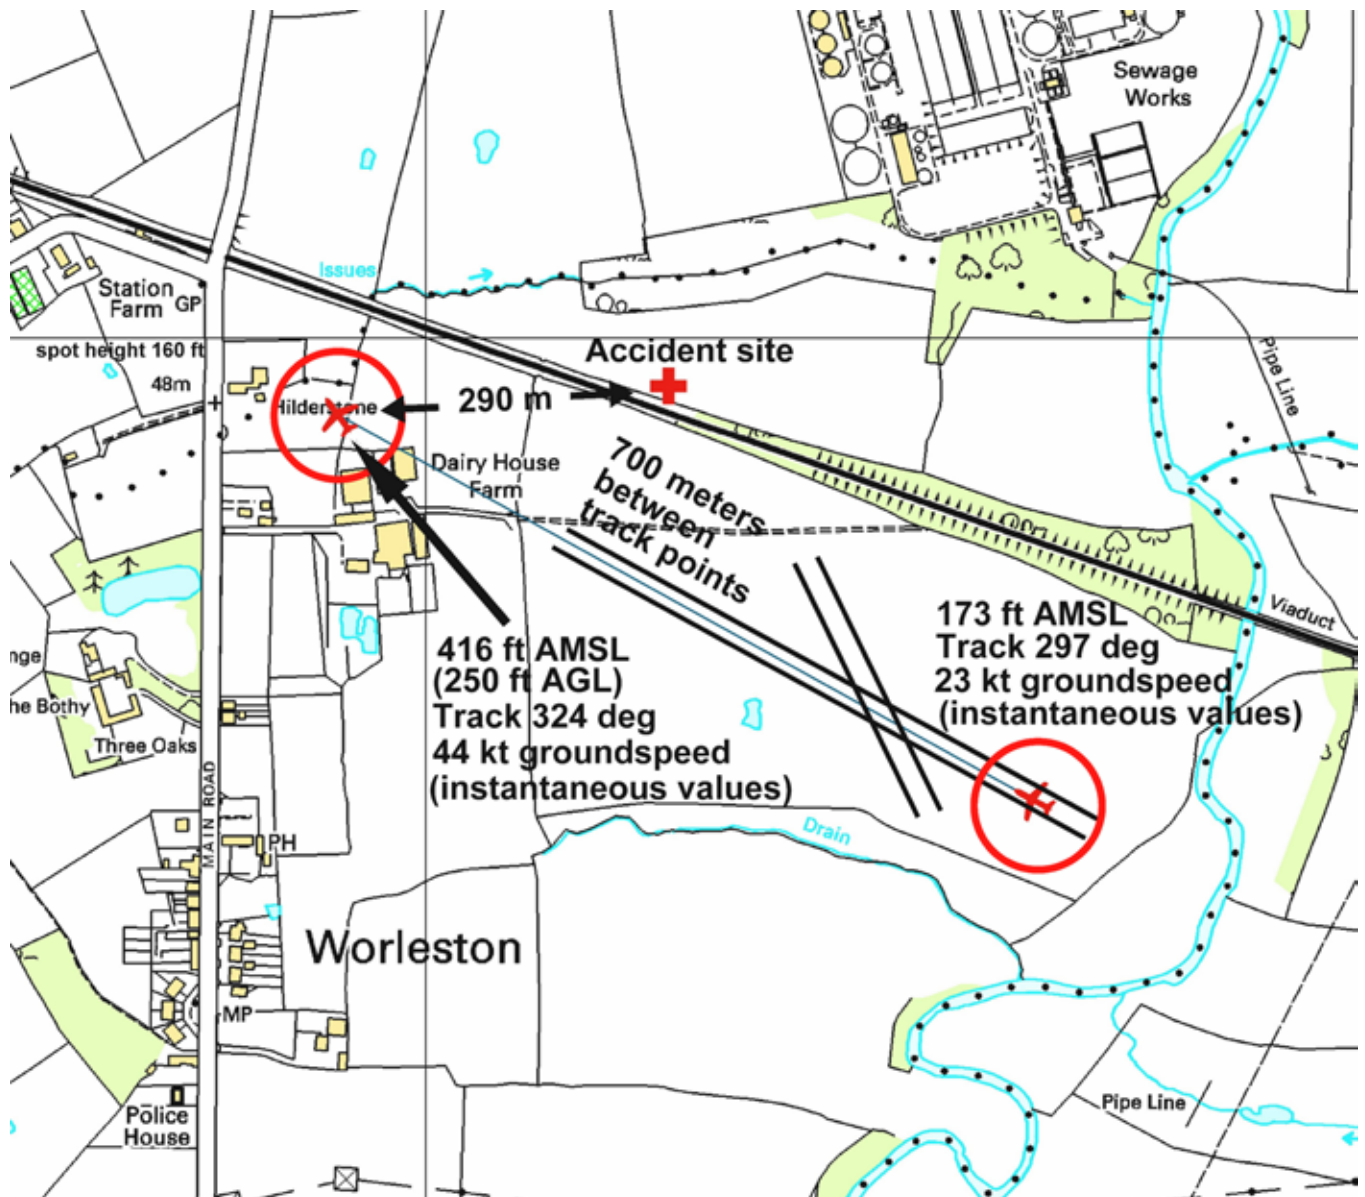
Accident at Dairy House Farm Airstrip

The accident track log consisted of two data points, with the first data point recorded at 1541:18 hrs and the second at 1541:48 hrs. Figure 1 provides a plot of the two data points and the position of the accident site. The first data point was recorded when the aircraft was travelling at a ground speed of 23 kt on a track of 297°. Altitude was 173 ft amsl. From the low ground speed and terrain elevation, it can be assumed that the aircraft was on

the ground when the first data point was recorded. The second data point was recorded after takeoff, at a height of approximately 250 ft agl. The aircraft's groundspeed was 44 kt and its track was 324°. The second data point position was about 290 meters from the accident site.
