ACCIDENT

Aircraft Type and Registration:	Tri Kis, G-BZDR	
No & Type of Engines:	1 Continental Motors Corp IO-240-A piston engine	
Year of Manufacture:	2000 (Serial no: 9403)	
Date & Time (UTC):	24 May 2014 at 0950 hrs	
Location:	Perth Airport, Scotland	
Type of Flight:	Private	
Persons on Board:	Crew - 1	Passengers - None
Injuries:	Crew - None	Passengers - N/A
Nature of Damage:	Nose landing leg failed, damage to nose leg assembly and propellers. Engine shock-loaded	
Commander's Licence:	Private Pilot's Licence	
Commander's Age:	54 years	
Commander's Flying Experience:	2,628 hours (of which 127 were on type) Last 90 days - 15 hours Last 28 days - 5 hours	
Information Source:	Aircraft Accident Report Form submitted by the pilot

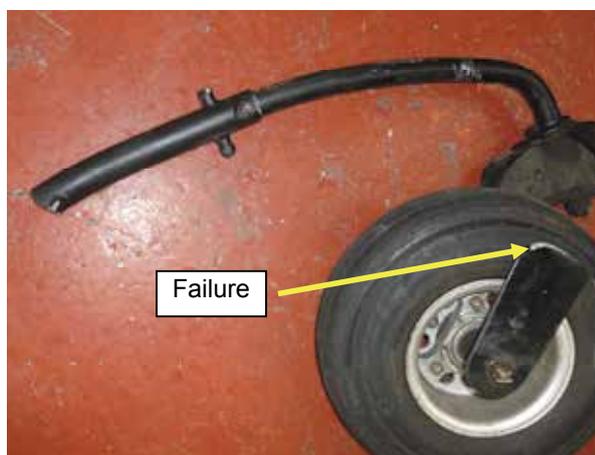
Figure 1

The event occurred as a result of the failure of one side of the fork on the nose landing gear leg. See Figure 1. The owner and the maintenance organisation that examined the landing gear leg reported visual evidence of a fatigue failure. Neither the AAIB nor the Light Aircraft Association had the opportunity to inspect the leg before it was repaired.

Failure of the nose landing gear
