Puma Sprint, G-MNFX

AAIB Bulletin No: 12/2004	Ref: EW/C2004/08/04	Category: 1.4
Aircraft Type and Registration:	Puma Sprint, G-MNFX	
No & Type of Engines:	1 Rotax 447 engine	
Year of Manufacture:	1985	
Date & Time (UTC):	15 August 2004 at 1900 hrs	
Location:	Arclid Industrial Estate, Hemmingshaw Lane, Sandbach, Cheshire	
Type of Flight:	Private	
Persons on Board:	Crew - 1	Passengers - 1
Injuries:	Crew - 1 (Serious)	Passengers - 1 (Serious)
Nature of Damage:	Damaged beyond economic repair	
Commander's Licence:	Private Pilot's Licence	
Commander's Age:	70 years	
Commander's Flying Experience:	374 hours (of which over 230 were on type)	
	Last 90 days - 2 hours 48 minutes	
	Last 28 days - 0	
Information Source:	AAIB Field Investigation

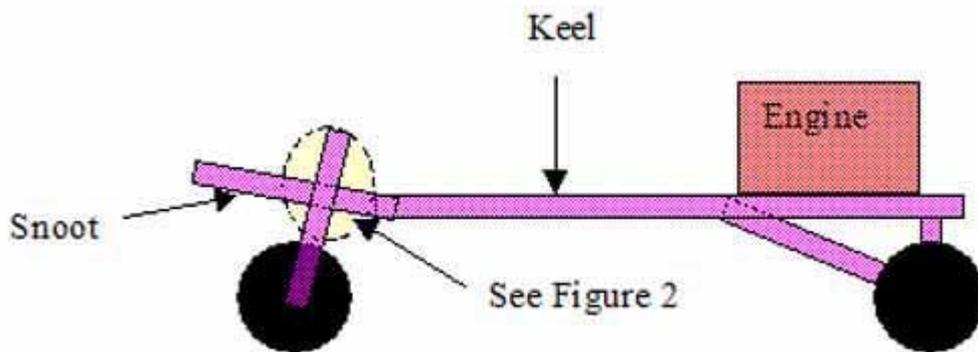
Inspection of the wreckage revealed that the 'snoot' (a forward extension of the keel tube, see Figure 1) had fractured at the nose wheel mounting location, resulting in the nose wheel assembly becoming detached from the microlight. Marks on the ground indicated that the remainder of the snoot, still attached to the keel tube, had scraped along the ground for approximately 5 metres before it dug in, causing the microlight to roll forward. As a result, the trike and wing sustained substantial damage.

Figure 1 - Diagram indicating the location of the snoot fracture

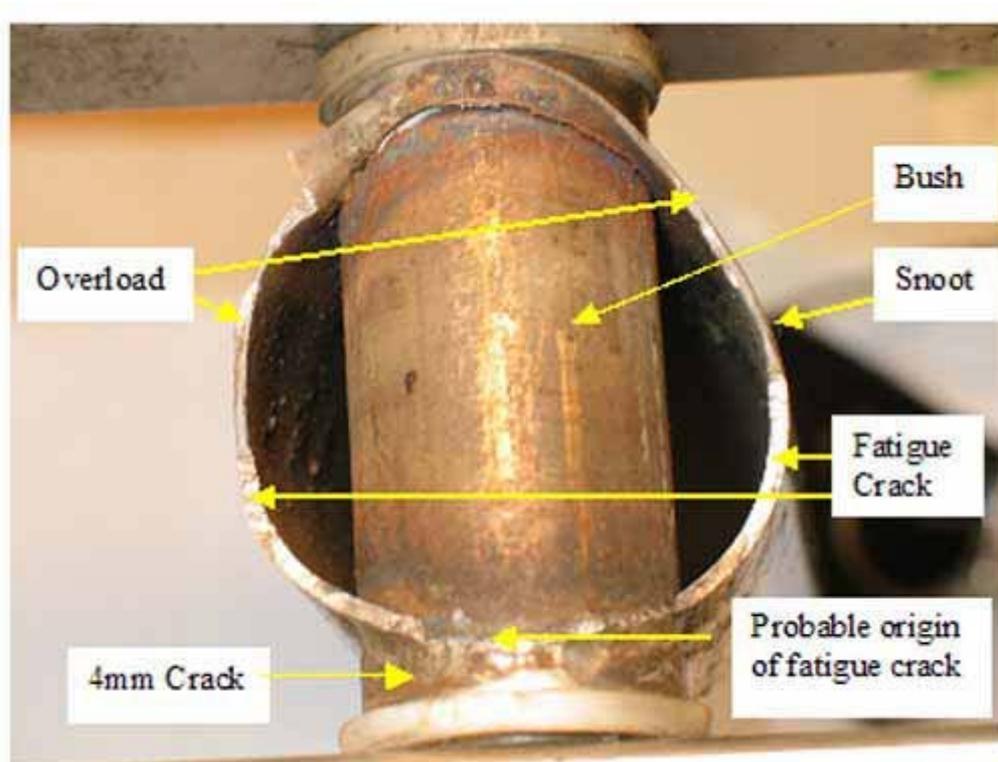
Inspection of the snoot revealed the presence of a fatigue crack running approximately half way around the circumference of the snoot and which had its origin in the weld that secured the nose wheel mounting bush to the snoot. The nature of the fracture face of the remainder of the circumference indicated that it had failed in overload. A crack was also present, approximately 4 mm in length, running from the weld towards the lower edge of the bush, and a small dent was apparent on the lower surface of the snoot between the bush and keel tube, Figure 2.

Figure 2 - Detail view of snoot failure

Whilst there was a small dent on the lower surface of the snoot there was no other damage on the microlight to indicate that a heavy landing had occurred on this or any previous occasion; it is, therefore, probable that the small dent occurred during the roll-over. The fracture face of the snoot indicated that the fatigue crack grew from a defect in the bush-to-snoot securing weld and that on the accident flight the fatigue crack had grown to a critical length such that the remaining material was insufficient to take normal landing loads. Consequently, during the landing the remaining intact cross section of the snoot failed in overload.

It is recommended that Medway Microlights should require the welds securing the nose wheel assembly mounting bush to the snoot fitted to Puma Sprint, Raven and Raven X microlight aircraft, to be inspected for cracks at the earliest opportunity.

It is recommended that Medway Microlights review the maintenance and inspection requirements and life expectation of the snoot assembly fitted to the Puma Sprint, Raven and Raven X microlight aircraft.
