ACCIDENT

Aircraft Type and Registration:	AS355F2 Twin Squirrel, G-BYPA	
No & Type of Engines:	2 Allison 250-C20F turboshaft engines	
Year of Manufacture:	1986	
Date & Time (UTC):	1 May 2007 at 2325 hrs UTC	
Location:	Near Thornhaugh, Peterborough	
Type of Flight:	Private	
Persons on Board:	Crew - 1	Passengers - 3
Injuries:	Crew - 1 (Fatal)	Passengers - 3 (Fatal)
Nature of Damage:	Helicopter destroyed	
Commander's Licence:	Airline Transport Pilot's Licence	
Commander's Age:	49 years	
Commander's Flying Experience:	8,000 hours, estimated (of which in excess of 500 hours were on type) Last 90 days - 47 hours Last 28 days - 18 hours	
Information Source:	AAIB Field Investigation

Synopsis

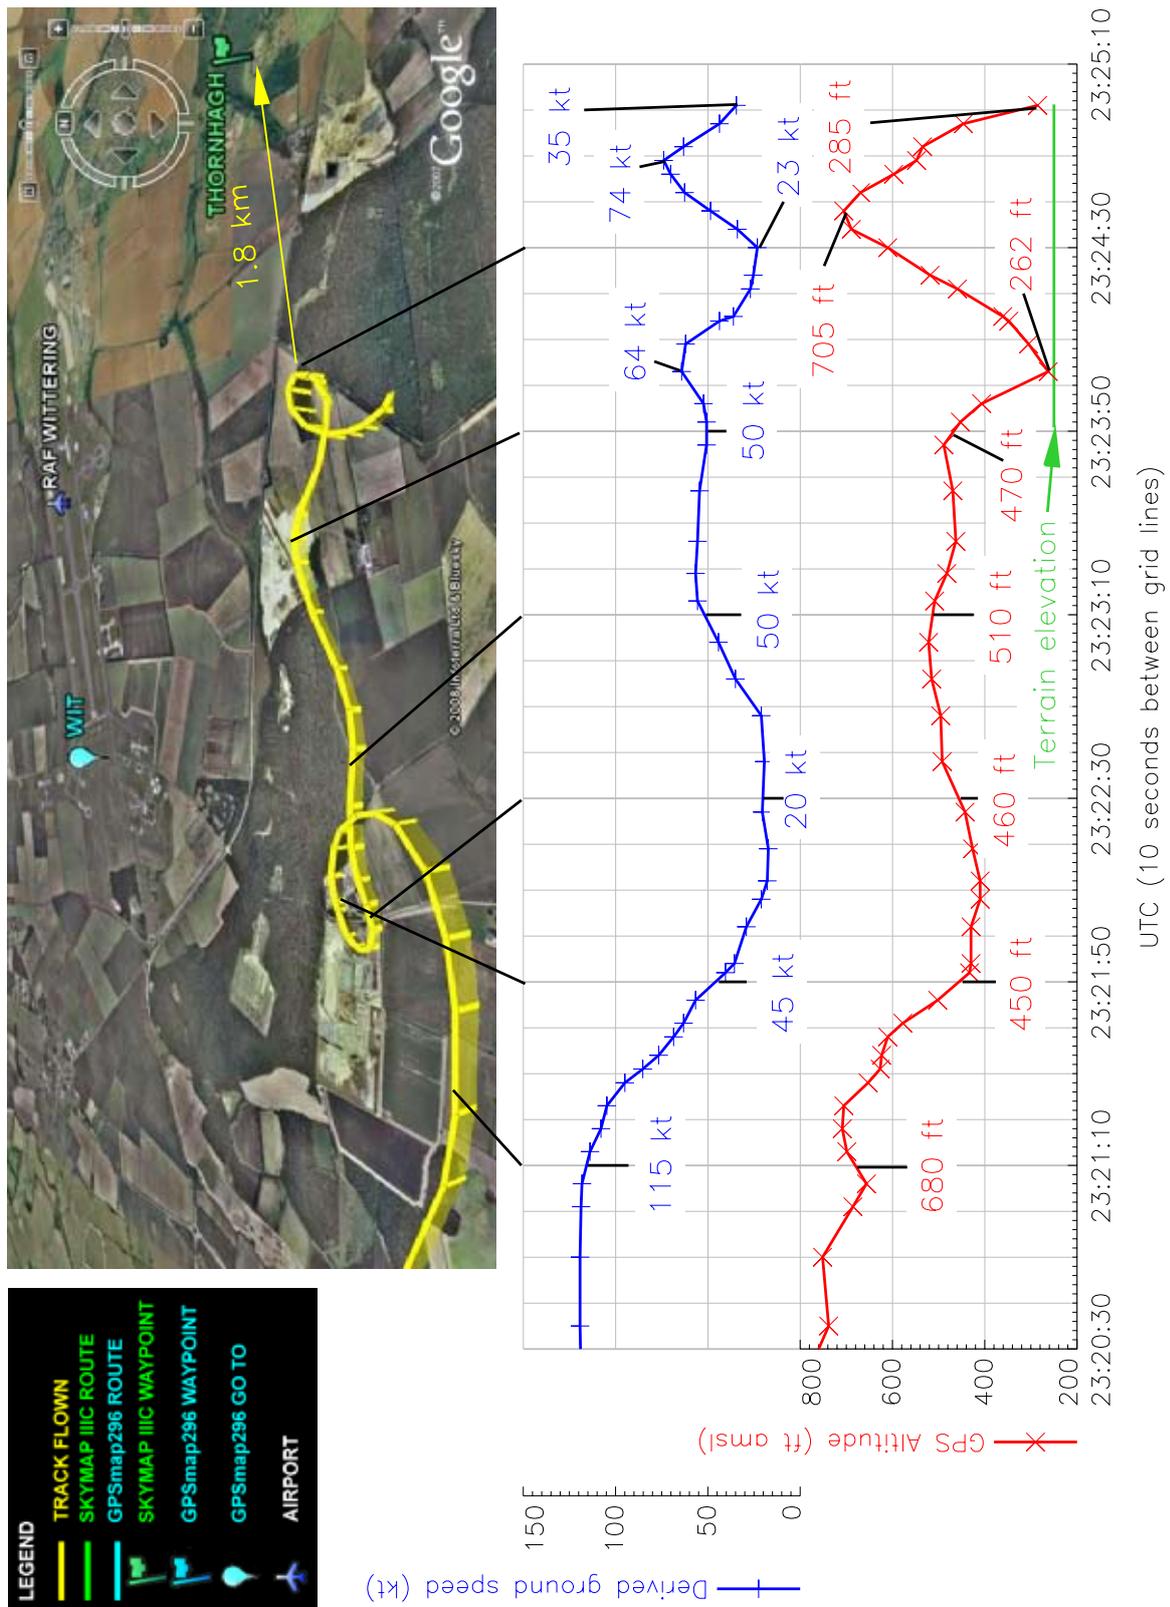
Figure 2

Last portion of track recorded by GPSmap296 and waypoint/route data in the memory of both the GPS receivers

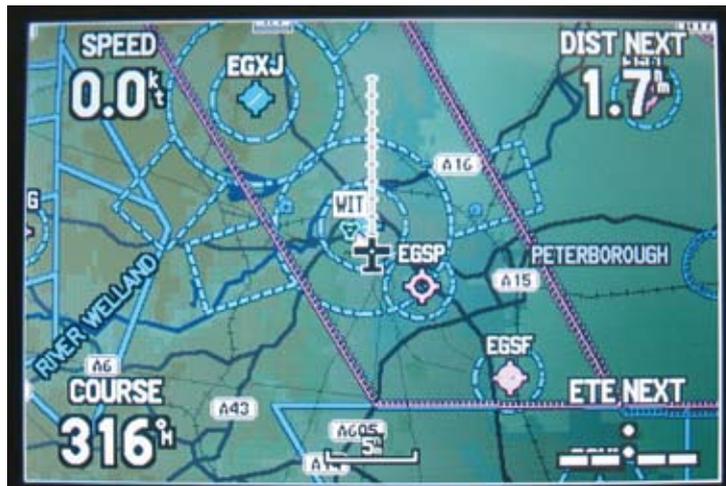
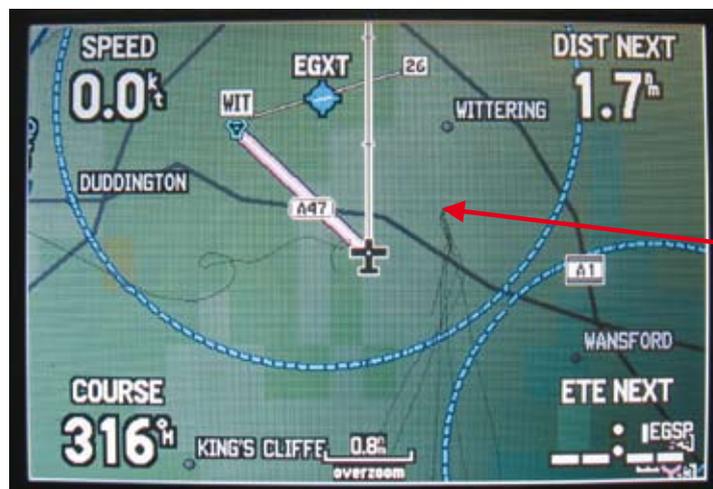
Figure 3

Location of
intended
destination

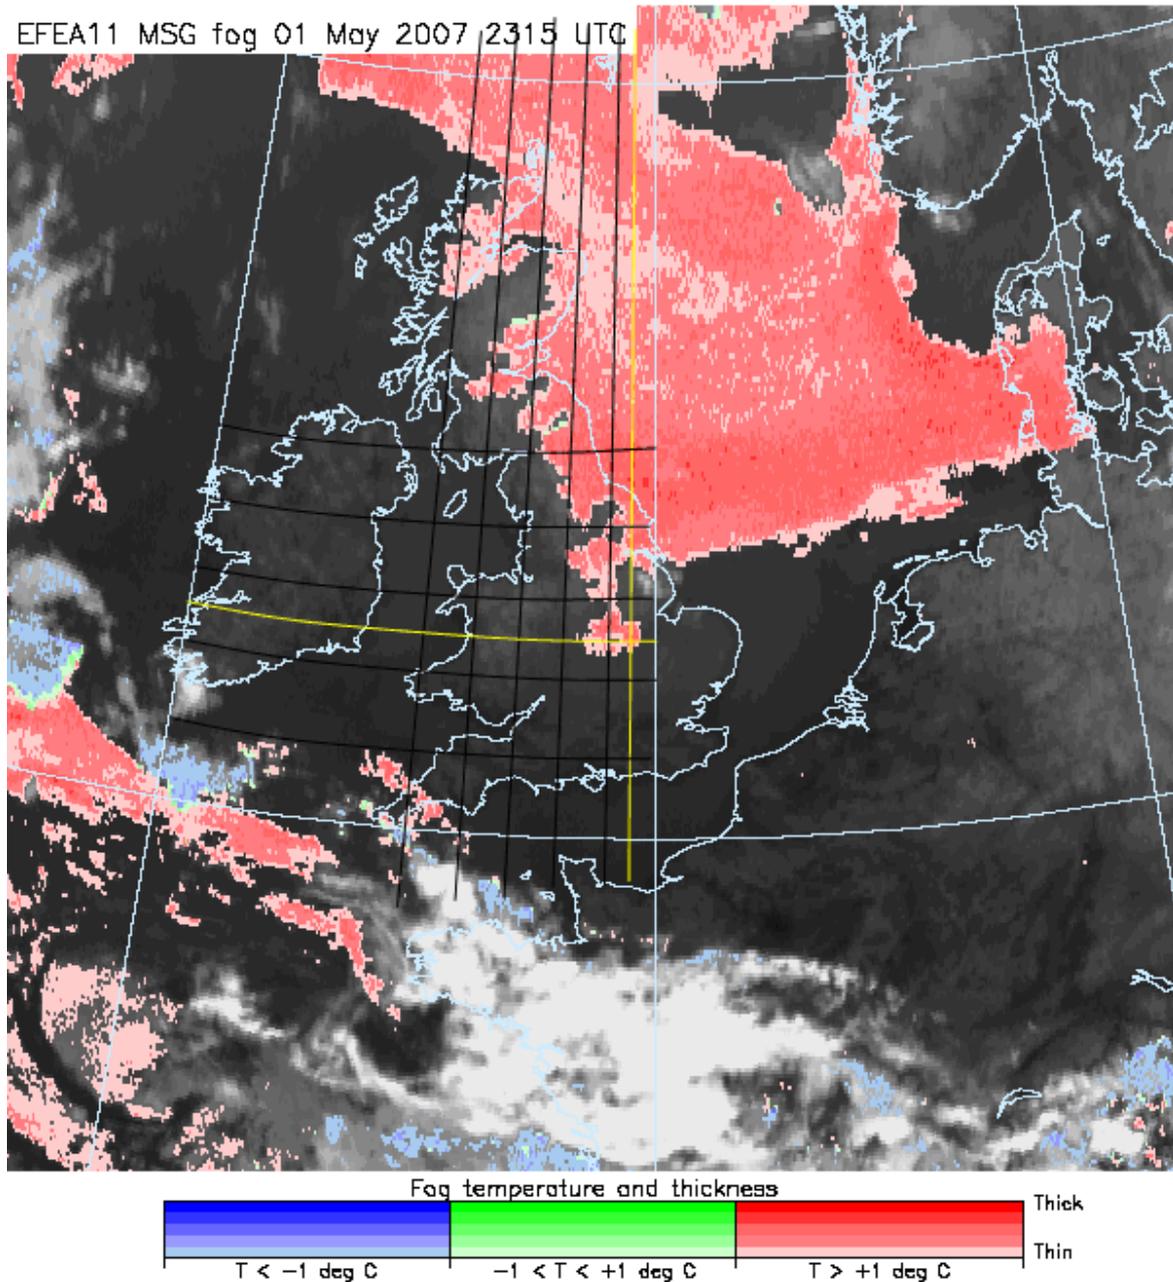
Appendix 5

At takeoff from Liverpool Airport, conditions were CAVOK, indicating there was no significant weather. East Midlands Airport reported no significant weather during the period 2220 hrs to 2350 hrs, although fog difference imagery² taken at 2315 hrs indicated low cloud over the area (Appendix 5).

Fog Difference Image
10 minutes prior to the accident
(Intersection of the yellow lines identifies RAF Wittering)
