Air Accidents Investigation Branch

**Report on the accident to
Airbus A320-211, registration JY-JAR
at Leeds Bradford Airport
on 18 May 2005**

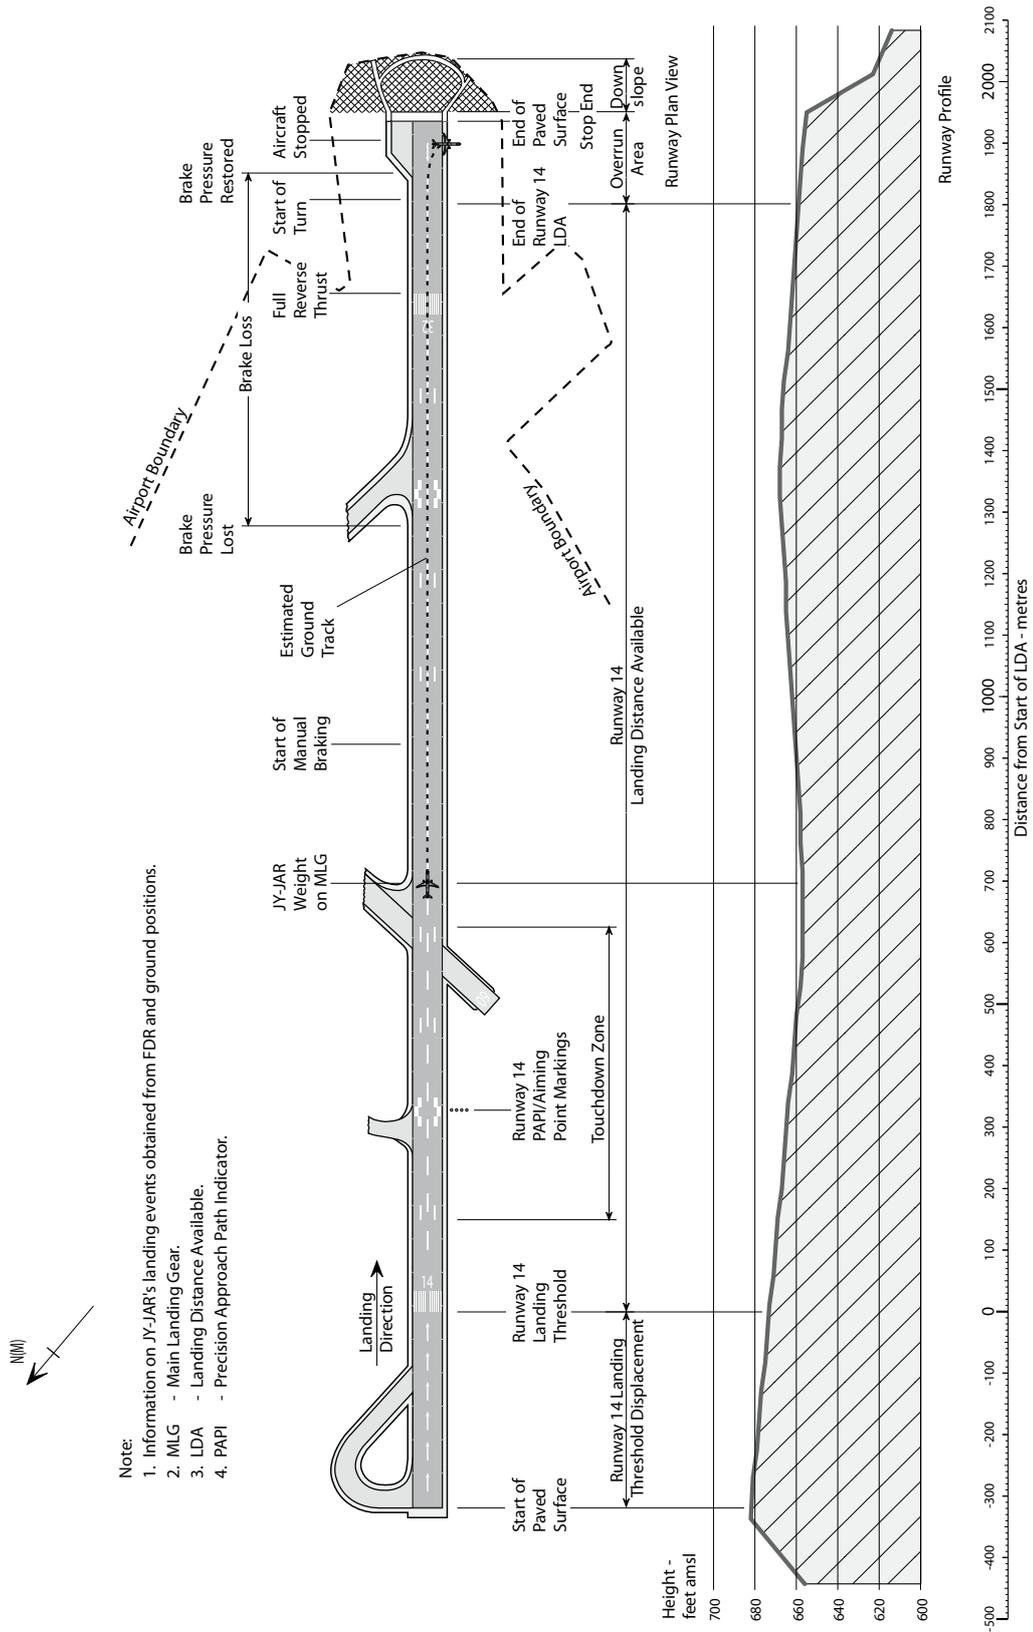
Figure 1

At 1143 hrs the aircraft touched down just beyond the end of the marked Touchdown Zone (TDZ), approximately 700 m beyond the touchdown threshold and 400 m beyond the Aiming Point (Figure 1, page 5). The pilots stated that they observed normal indications of ground spoiler deployment and the selection of idle reverse thrust. The commander commenced manual (pedal) braking shortly after touchdown. A few seconds later, he considered the rate of deceleration was inadequate so he applied increased brake pedal displacement and then maximum reverse thrust. Adequate retardation was not restored. The co-pilot shared the commander's perception and firmly depressed his own brake pedals. Judging that deceleration was still inadequate, the commander ordered the co-pilot to release his brake pedals whilst he continued to apply his own. As the aircraft crested a hump in the runway about 600 m before the end of the paved surface, the commander saw the end of the runway, which hitherto had been hidden from his view, and judged that the aircraft would not stop before the end. At that point he considered selecting the alternate braking system, but knew that this would cause loss of nosewheel steering. Because of the limited runway distance remaining, he considered that the only course of action available to avoid overrunning the end of the paved surface was to turn the aircraft on to a level grassed area beside the right-hand edge of the runway. Using nosewheel

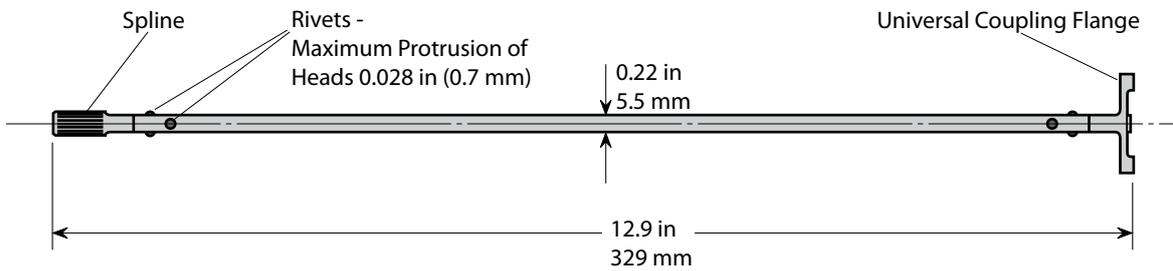
Figure 5
Tachometer Driveshaft

Examination of the mainwheel tachometer systems after removal from the aircraft showed no signs of excessive wear or looseness in the drive splines or universal joint. Each tachometer driveshaft had sustained local indentation damage to the surface of the spline fittings, consistent with moderate impact by hard objects, and moderate fretting damage to the mating faces of the universal joint had occurred. Both effects were rather more severe for No 2 and No 4 driveshafts than for the No 1 or No 3 driveshafts.

It was apparent that the No 2 and No 4 driveshafts were slightly bent and showed evidence of heavy rotational rubbing over their central portions. In both cases the bend was located approximately 1.8 inches (45 mm) from the outer end of the shaft and resulted in a radial displacement of the spline of approximately 0.04 inches (1 mm) relative to the axis of the unbent part of the shaft. In addition, the heads of the rivets securing the spline fitting to the shaft had suffered 'machining' damage in a number of cases, indicative of contact with surrounding static components while the driveshafts had been rotating. This was particularly severe for No 2 and No 4 driveshafts, where some of the rivet heads had been worn almost flush with the shaft surface.

No other anomalies with any aspect of the braking system were identified. The aircraft re-entered service 10 days after the accident, following replacement of the BSCU, the tachometers, the tachometer driveshafts and the NLG. No further braking problems have been reported.
