ACCIDENT

Aircraft Type and Registration:	Boeing 737-800, EI-DYM
No & Type of Engines:	2 CFM 56-7B26 turbofan engines
Year of Manufacture:	2008
Date & Time (UTC):	12 May 2011 at 0815 hrs
Location:	Liverpool John Lennon Airport
Type of Flight:	Commercial Air Transport (Passenger)
Persons on Board:	Crew - 6 Passengers - 169
Injuries:	Crew - None Passengers - None
Nature of Damage:	Damage to aircraft's nosewheel tyre and left main undercarriage assembly, and substantial damage to ground towing equipment
Commander's Licence:	Airline Transport Pilot's Licence
Commander's Age:	48 years
Commander's Flying Experience:	14,266 hours (of which 11,283 were on type) Last 90 days - 180 hours Last 28 days - 64 hours
Information Source:	Aircraft Accident Report Form submitted by the pilot, and reports from the airport authority, ground handling company and Air Traffic Control

Synopsis

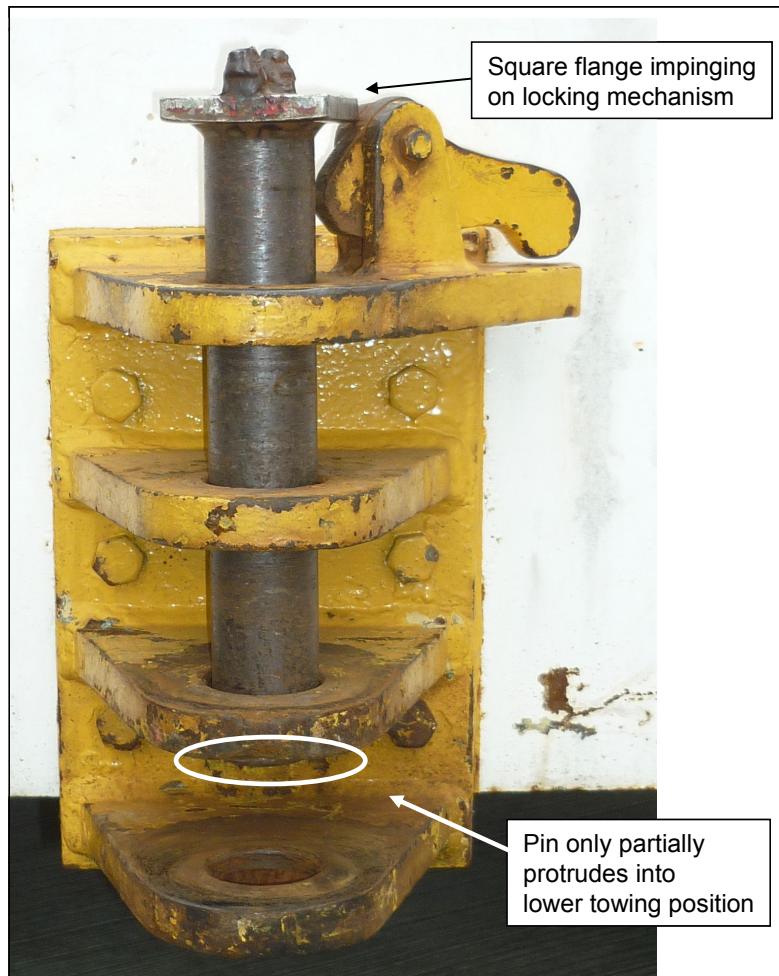
Figure 1

The pushback tug was found to have a towbar locking pin that was not fitted to the vehicle and was apparently not the original pin supplied with the vehicle. The history of the pin was not established but it was confirmed that the tug driver had used it before on two occasions.

From photographs supplied to the AAIB, the locking pin was seen to be fitted with a square flange at one end to which was attached the remnants of a handle, which had broken off a considerable time beforehand. The pin was photographed with the square flange resting on top of a locking mechanism, which was intended to prevent a correctly fitted pin from jumping out of the towing bracket whilst the tug was in motion (Figure 1). In the photographed position, the pin would only partially engage the towbar eye-end fitting if the fitting was inserted into the lower of the three available positions, and would not be mechanically prevented from lifting the small amount required to release the towbar.

Tug vehicle's rear towing bracket with locking pin

Disciplinary actions were taken against the two ground crewmen. The tug concerned was removed from service pending the installation of a radio and all tugs were inspected to ensure that correct towbar locking pins were fitted. Additionally, a programme of daily ramp inspections was initiated to ensure correct pushback procedures were being followed.
