**INCIDENT**

<b>Aircraft Type and Registration:</b>	DHC-8-402, G-JECG	
<b>No &amp; Type of Engines:</b>	2 PW150A turboprop engines	
<b>Year of Manufacture:</b>	2004	
<b>Date &amp; Time (UTC):</b>	10 December 2006 at 1930 hrs	
<b>Location:</b>	Approximately 10 nm east of Prestwick Airport	
<b>Type of Flight:</b>	Commercial Air Transport (Passenger)	
<b>Persons on Board:</b>	Crew - 4	Passengers - 71
<b>Injuries:</b>	Crew - None	Passengers - None
<b>Nature of Damage:</b>	None	
<b>Commander's Licence:</b>	Airline Transport Pilot's Licence	
<b>Commander's Age:</b>	56 years	
<b>Commander's Flying Experience:</b>	9,950 hours (of which 650 were on type) Last 90 days - 173 hours Last 28 days - 50 hours	
<b>Information Source:</b>	AAIB Field Investigation

**Synopsis**

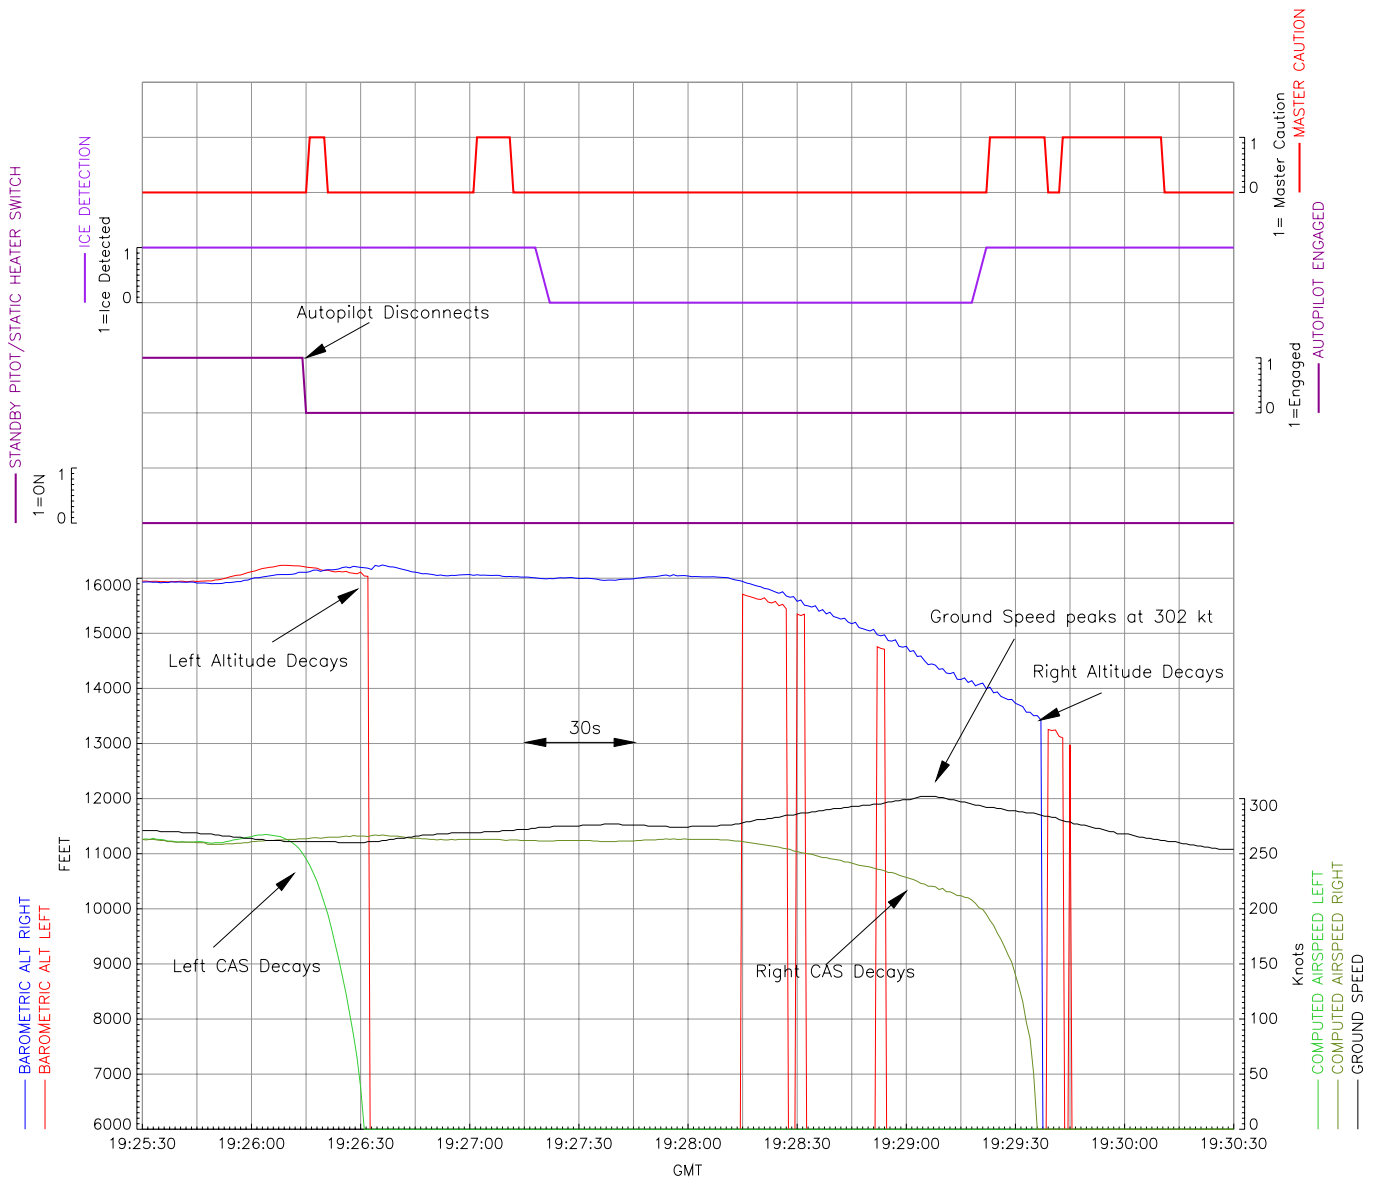
**Figure 1**

Just under four minutes after levelling off, the ice detection system again detected the presence of ice. Around 30 seconds later, both left and right ADC altitudes began to fluctuate again. As this occurred, the left ADC calibrated airspeed (CAS) dropped to zero and the autopilot disengaged. About 20 seconds after this, the recorded altitude data from the left ADC dropped to zero ft (Figure 1). The remaining altitude information from the right ADC indicated that the fluctuations then ceased and the altitude recovered to 16,000 ft.

Loss of flight data and aircraft descent

At 1928 hrs, about 6 minutes after levelling at FL160, a descent commenced with a CAS of 263 kt and ground speed of 270 kt. During the descent, the airspeed from the right ADC decreased but the groundspeed increased. Maximum ground speed achieved was 302 kt whilst the airspeed indicated 220 kt. During this descent, altitude data from the left ADC appeared to recover, but for no more than 6 seconds. About a minute after the descent had begun, the CAS from the right ADC decreased

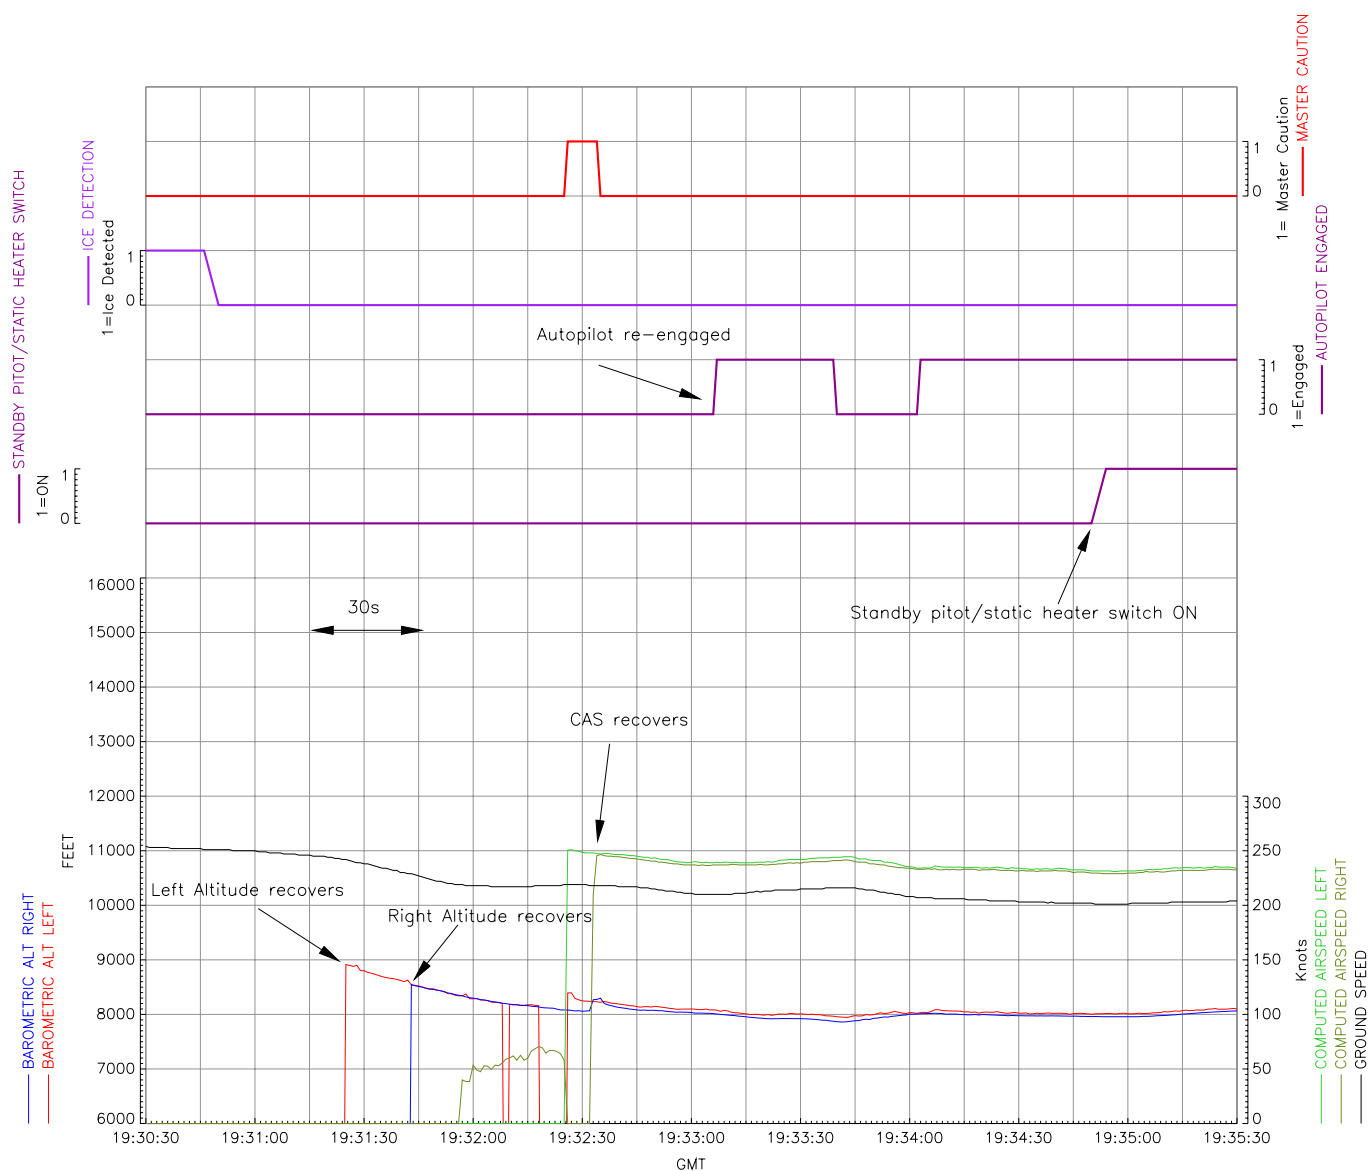
**Figure 2**

ADC altitude data returned at 8,914 ft and, 17 seconds later, the right ADC altitude also returned at the same value as the left ADC (Figure 2). CAS did not recover until nearly three minutes after being lost, as the aircraft was levelling at FL80, with an SAT of 2.75°C. Both CAS values recovered to within 3 kt of each other and within 30 kt of the ground speed. No further anomalous behaviour was observed with altitude or airspeed for the remainder of the flight.

At 1935 hrs, about 2 minutes after levelling at FL 80, the standby pitot heat switch was selected ON (Figure 2). No parameters from the standby instrumentation were recorded. Stall system outputs remained valid, with no stick shaker or stick push events recorded during the flight. Output from both Angle of Attack (AOA) vanes continued to vary within expected values for the flight conditions.

Aircraft level-off, flight data recovery and standby pitot heat switch position

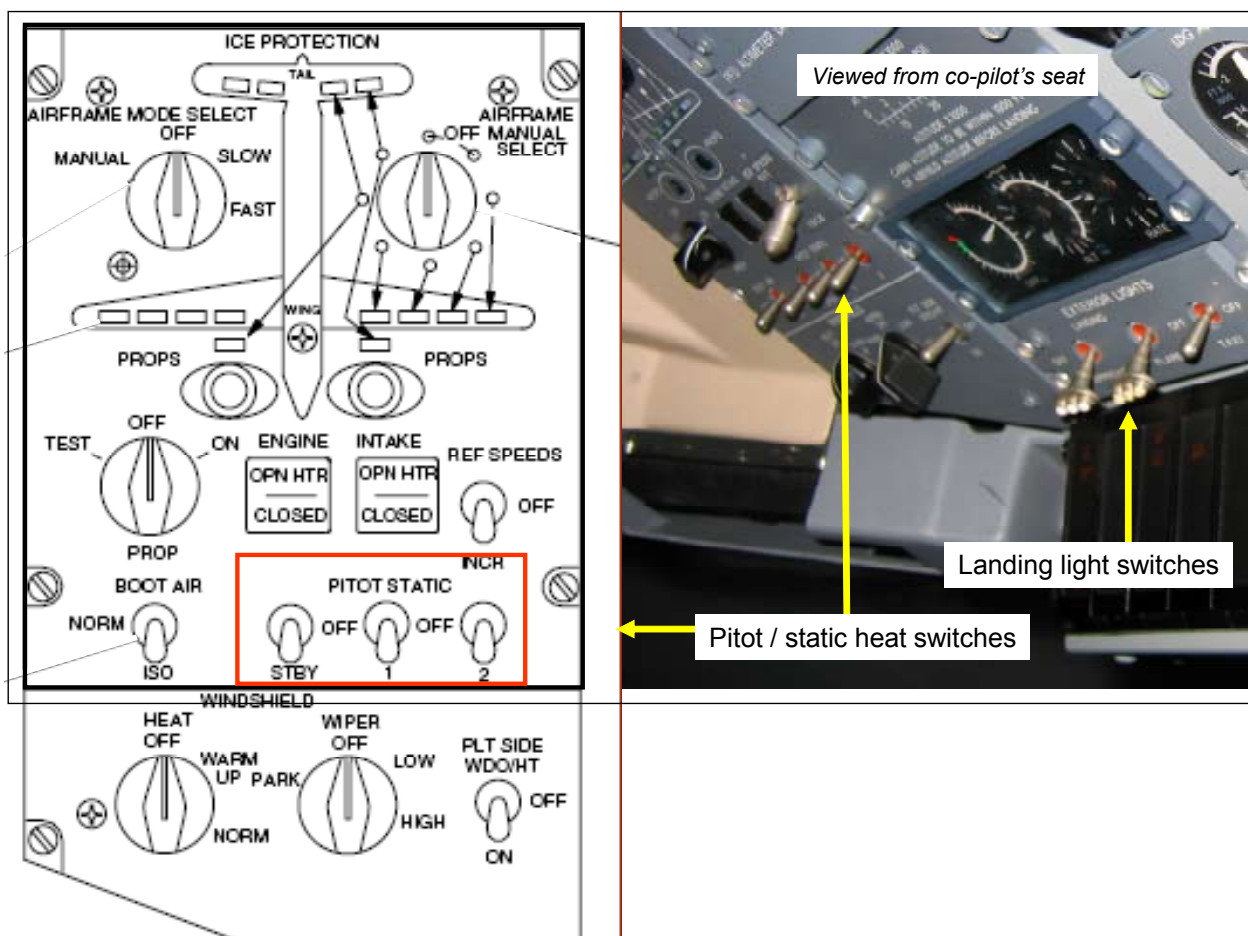
**Figure 3**

Pitot/Static probe heat switches – panel layout and cockpit view

The pitot heat switches were grouped together on the icing panel immediately above the commander's head. The switches were not large, and their throw was not great, such that it was difficult to be certain, when viewing the switches in isolation from either seat, whether they were all ON or all OFF. This was particularly true from the co-pilot's seat, looking up and across the panel (Figure 3), and even more so in low lighting conditions. However, this was only true when all the switches were in the same position: if one switch was in a different position from the other two, the fact was more obvious.

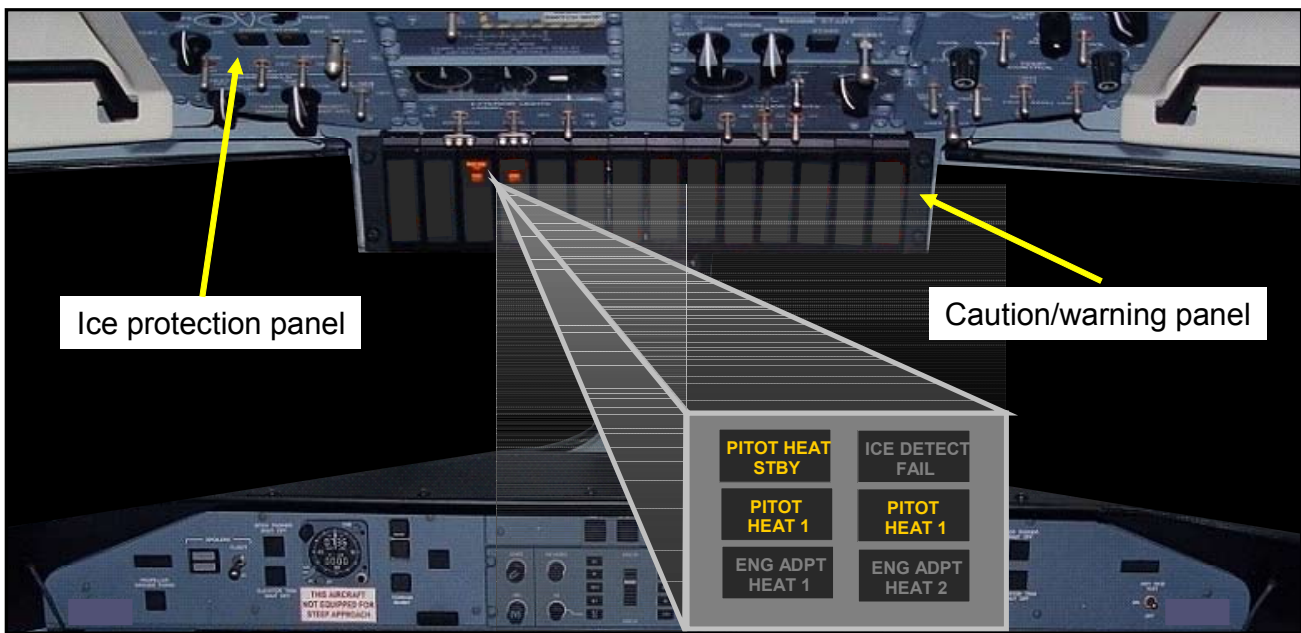
**Figure 4**

Each of the three pitot heat switches has an associated caution light on the CWP which illuminates if the systems fails or is switched off (Figure 4).

CWP arrangement and pitot/static caution lights

The three pitot heat caution lights were grouped together on the left side of the CWP. As expected, the cautions appeared obvious when illuminated together on an otherwise dark panel. However, it was noted that the CWP itself was not naturally in the line of sight of either pilot when seated correctly at the controls looking directly ahead or down at the flight instruments. While taxiing the three pitot heat cautions could be illuminated but not obvious to either pilot. Once airborne, it was felt that the three cautions, if illuminated, would be noticed by the crew as they looked up to action items on the overhead panel, such as turning off the landing lights. The visual impact made by the cautions themselves when the CWP was set to its night DIM setting was, to a limited extent, dependent upon the level of flight deck lighting selected by the crew. Overall, the pitot/static caution lights were generally less noticeable from the co-pilot's (right-hand) seat position.

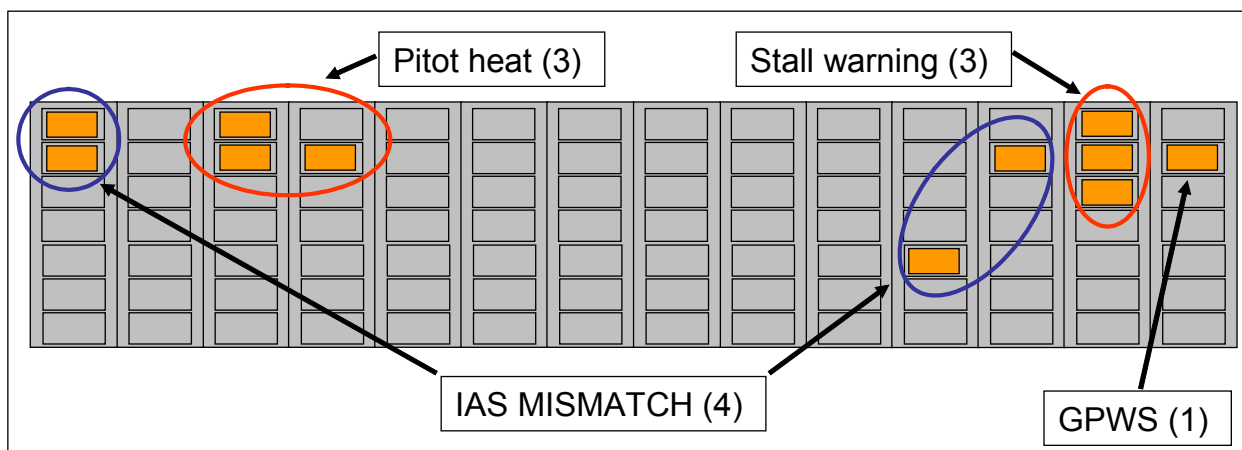
**Figure 5**

Distribution of CWP caution lights

of the stall protection modules or the AOA vanes. For other, non-critical failures, such as inputs from the ADCs, the SPS would not be prevented from generating a stall warning indication, so the CWP caution lights for such failures would be inhibited until 30 seconds after landing. The failure of both Mach number inputs to the SPS would generate all three cautions only after landing. The distribution of relevant CWP caution lights is shown at Figure 5.
