**ACCIDENT**

<b>Aircraft Type and Registration:</b>	Stampe SV4A (Modified), G-AZNK	
<b>No &amp; type of Engines:</b>	1 Gipsy Major 10 MK1 piston engine	
<b>Year of Manufacture:</b>	1946	
<b>Date &amp; Time (UTC):</b>	4 August 2006 at 1015 hrs	
<b>Location:</b>	Redhill Aerodrome, Surrey	
<b>Type of Flight:</b>	Private	
<b>Persons on Board:</b>	Crew - 1	Passengers - None
<b>Injuries:</b>	Crew - Nil	Passengers - N/A
<b>Nature of Damage:</b>	Damage to propeller and landing gear	
<b>Commander's Licence:</b>	Private Pilot's Licence	
<b>Commander's Age:</b>	56 years	
<b>Commander's Flying Experience:</b>	372 hours (of which 16 were on type) Last 90 days - 4 hours Last 28 days - 1 hour	
<b>Information Source:</b>	Aircraft Accident Report Form submitted by the pilot and AAIB enquiries

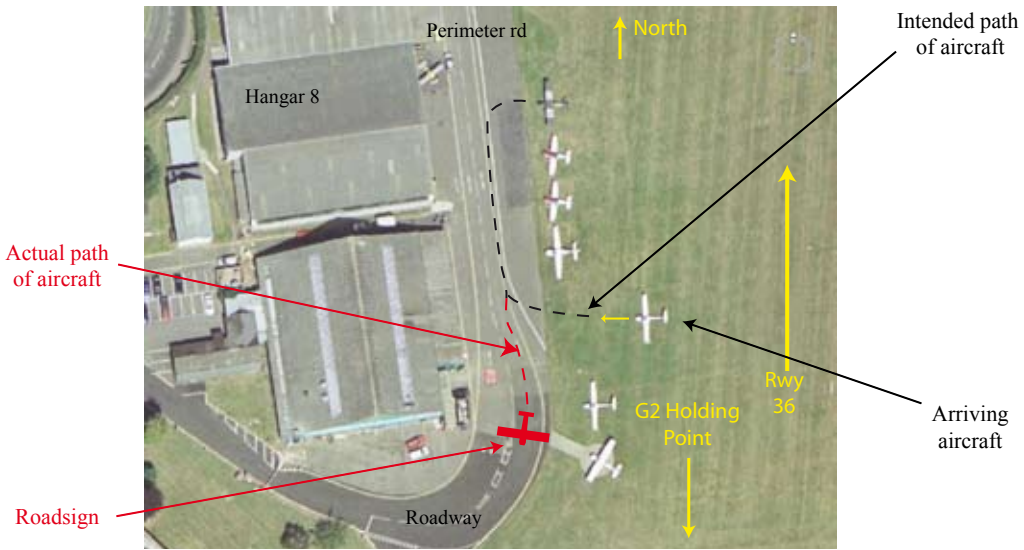
**Figure 1**

and a small ‘apron’, large enough to allow aircraft to be parked facing the hangars without infringing the road. Aircraft facing the hangar must taxi onto the road for a short distance and find a suitable point at which to turn back onto the grass surface before entering the area clearly marked as a road.

The airfield surface at Redhill Aerodrome is predominantly grass but, outside Hangar 8, there is a paved surface with markings for both a roadway
