**ACCIDENT**

<b>Aircraft Type and Registration:</b>	North American Rockwell OV-10B Bronco, G-BZGK
<b>No &amp; Type of Engines:</b>	1 Garrett Airesearch T76-G-418 turboprop engine 1 Garrett Airesearch T76-G-419 turboprop engine
<b>Year of Manufacture:</b>	1971 (Serial no: 338-17)
<b>Date &amp; Time (UTC):</b>	10 July 2012 at 1350 hrs
<b>Location:</b>	Cotswold (Kemble) Airport, Gloucestershire
<b>Type of Flight:</b>	Private
<b>Persons on Board:</b>	Crew - 1                      Passengers - None
<b>Injuries:</b>	Crew - 1 (Serious) Passengers - N/A
<b>Nature of Damage:</b>	Aircraft destroyed
<b>Commander's Licence:</b>	Commercial Pilot's Licence
<b>Commander's Age:</b>	47 years
<b>Commander's Flying Experience:</b>	4,096 hours (of which 179 were on type) Last 90 days - 41 hours Last 28 days - 18 hours
<b>Information Source:</b>	AAIB Field Investigation

**Synopsis**

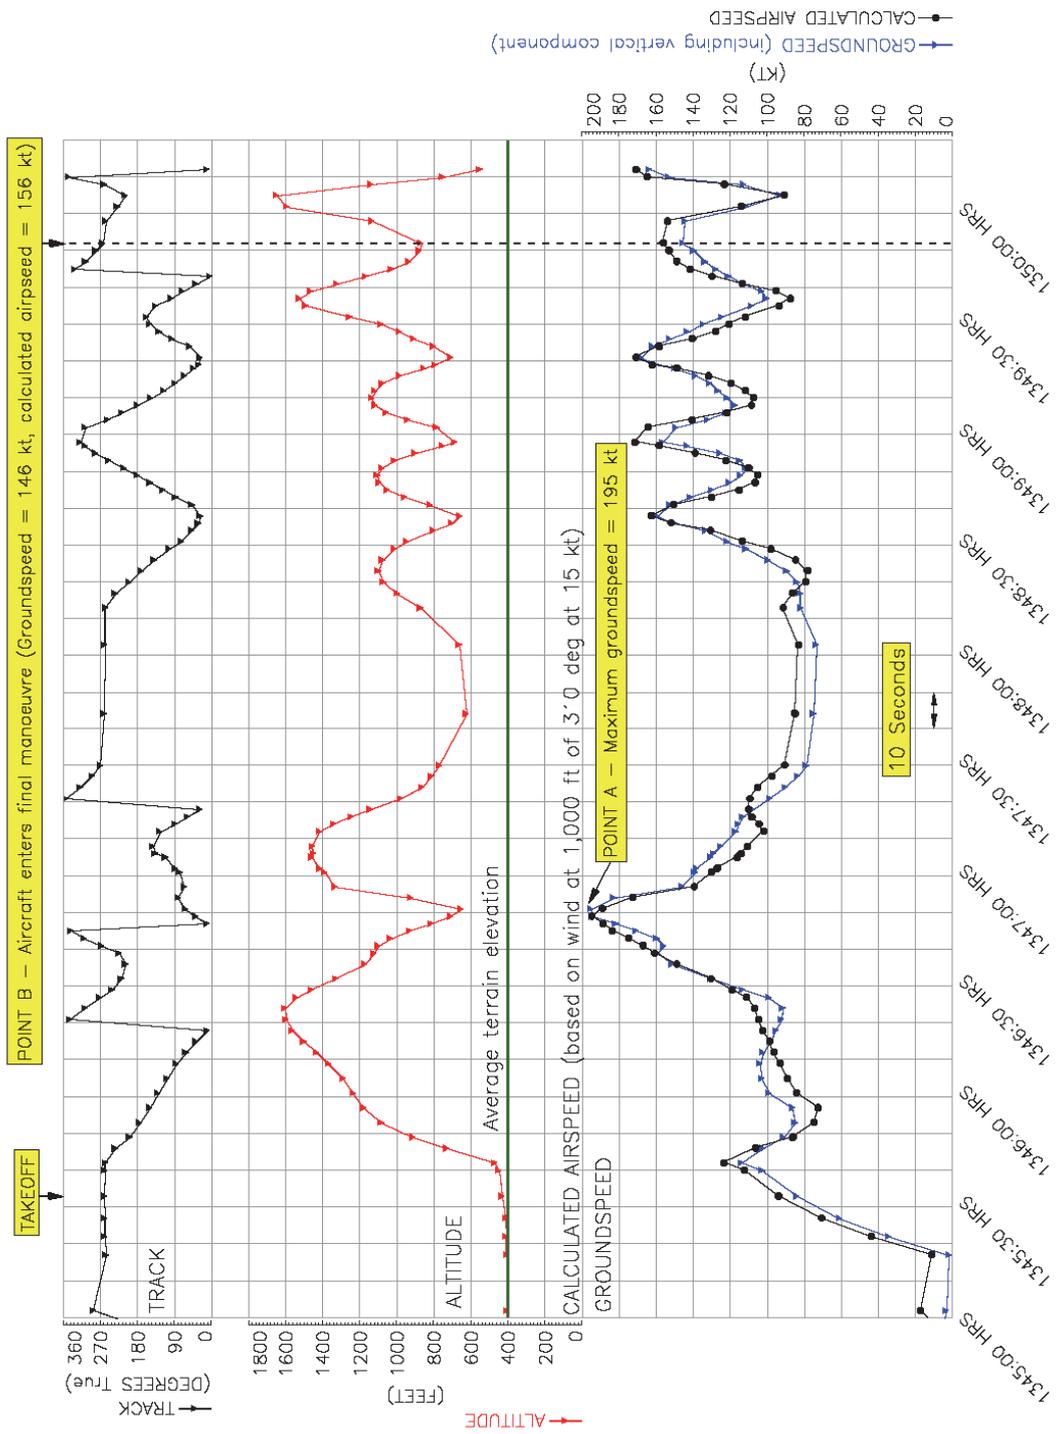
**Figure 5**  
GPS track, altitude, groundspeed and calculated airspeed profile

The maximum recorded ground and calculated airspeed during the flight (based on an estimated wind at 1,000 ft of 310°/15 kt) was 195 kt (Figure 5 - Point A). At 1347:22 hrs, the aircraft was photographed<sup>2</sup> with the landing gear and flaps extended, following which the aircraft made a slow speed pass, parallel to Runway 26, at a height of about 200 ft agl. As the aircraft approached the end of Runway 26, the landing gear was retracted. A photograph taken about 40 seconds later showed that the flaps had also been retracted.

At 1349:50 hrs, the aircraft was positioned about 130 m to the south of the Runway 26 threshold, at a height of approximately 440 ft. Two seconds later, having established an almost parallel track with the runway, the aircraft's groundspeed was 146 kt (calculated airspeed 156 kt) (Figure 5 – Point B). The next data point was recorded six seconds later, by which time the aircraft had climbed to 700 ft agl and the groundspeed had reduced to 142 kt (calculated airspeed 154 kt). During the next seven seconds, the aircraft proceeded to alter track by nearly 35° to the left, whilst climbing to a height of about 1,240 ft agl and reducing to a groundspeed of 93 kt (calculated airspeed 90 kt). The aircraft then descended rapidly whilst also altering track towards Runway 08/26. The final data point was recorded at 1350:12 hrs, with the aircraft at a height of about 120 ft agl, on a track of 012° and at a recorded groundspeed of 164 kt. The aircraft struck the ground shortly afterwards.

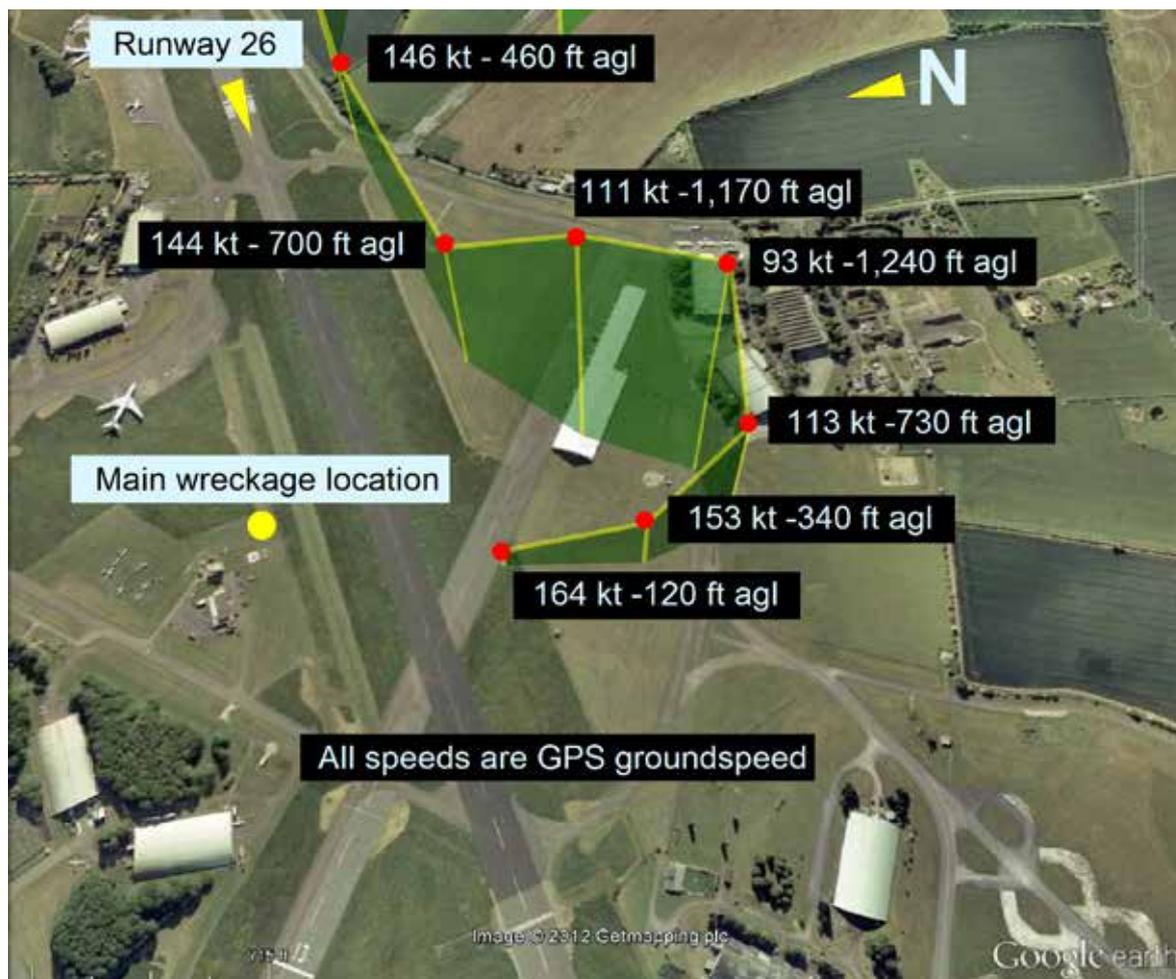
**Figure 6**

G-BZGK – Final manoeuvre

The pilot's display was one which he practised on a regular basis. Witnesses observed that the aircraft deviated from the intended barrel roll manoeuvre when it was in an inverted attitude and pitched down unusually rapidly. At this stage, they considered that a successful recovery could have been made. However, the aircraft continued to pitch down, with insufficient roll, and a steep nose-down attitude developed. The pilot recognised the problem after the aircraft had pulled through the vertical into an upright, nose down attitude, by which time, however, there was insufficient height to recover. An additional effect of continuing to pitch 'up', in the aircraft's normal axis, with insufficient roll, was to alter the trajectory of the aircraft, taking it towards and subsequently through the notional crowd line.
