No: 5/91

Ref: EW/C1191

Aircraft Type and Registration: Fokker F27-200, G-BHMX

Date and Time (UTC): 7 January 1991 at 1756 hrs

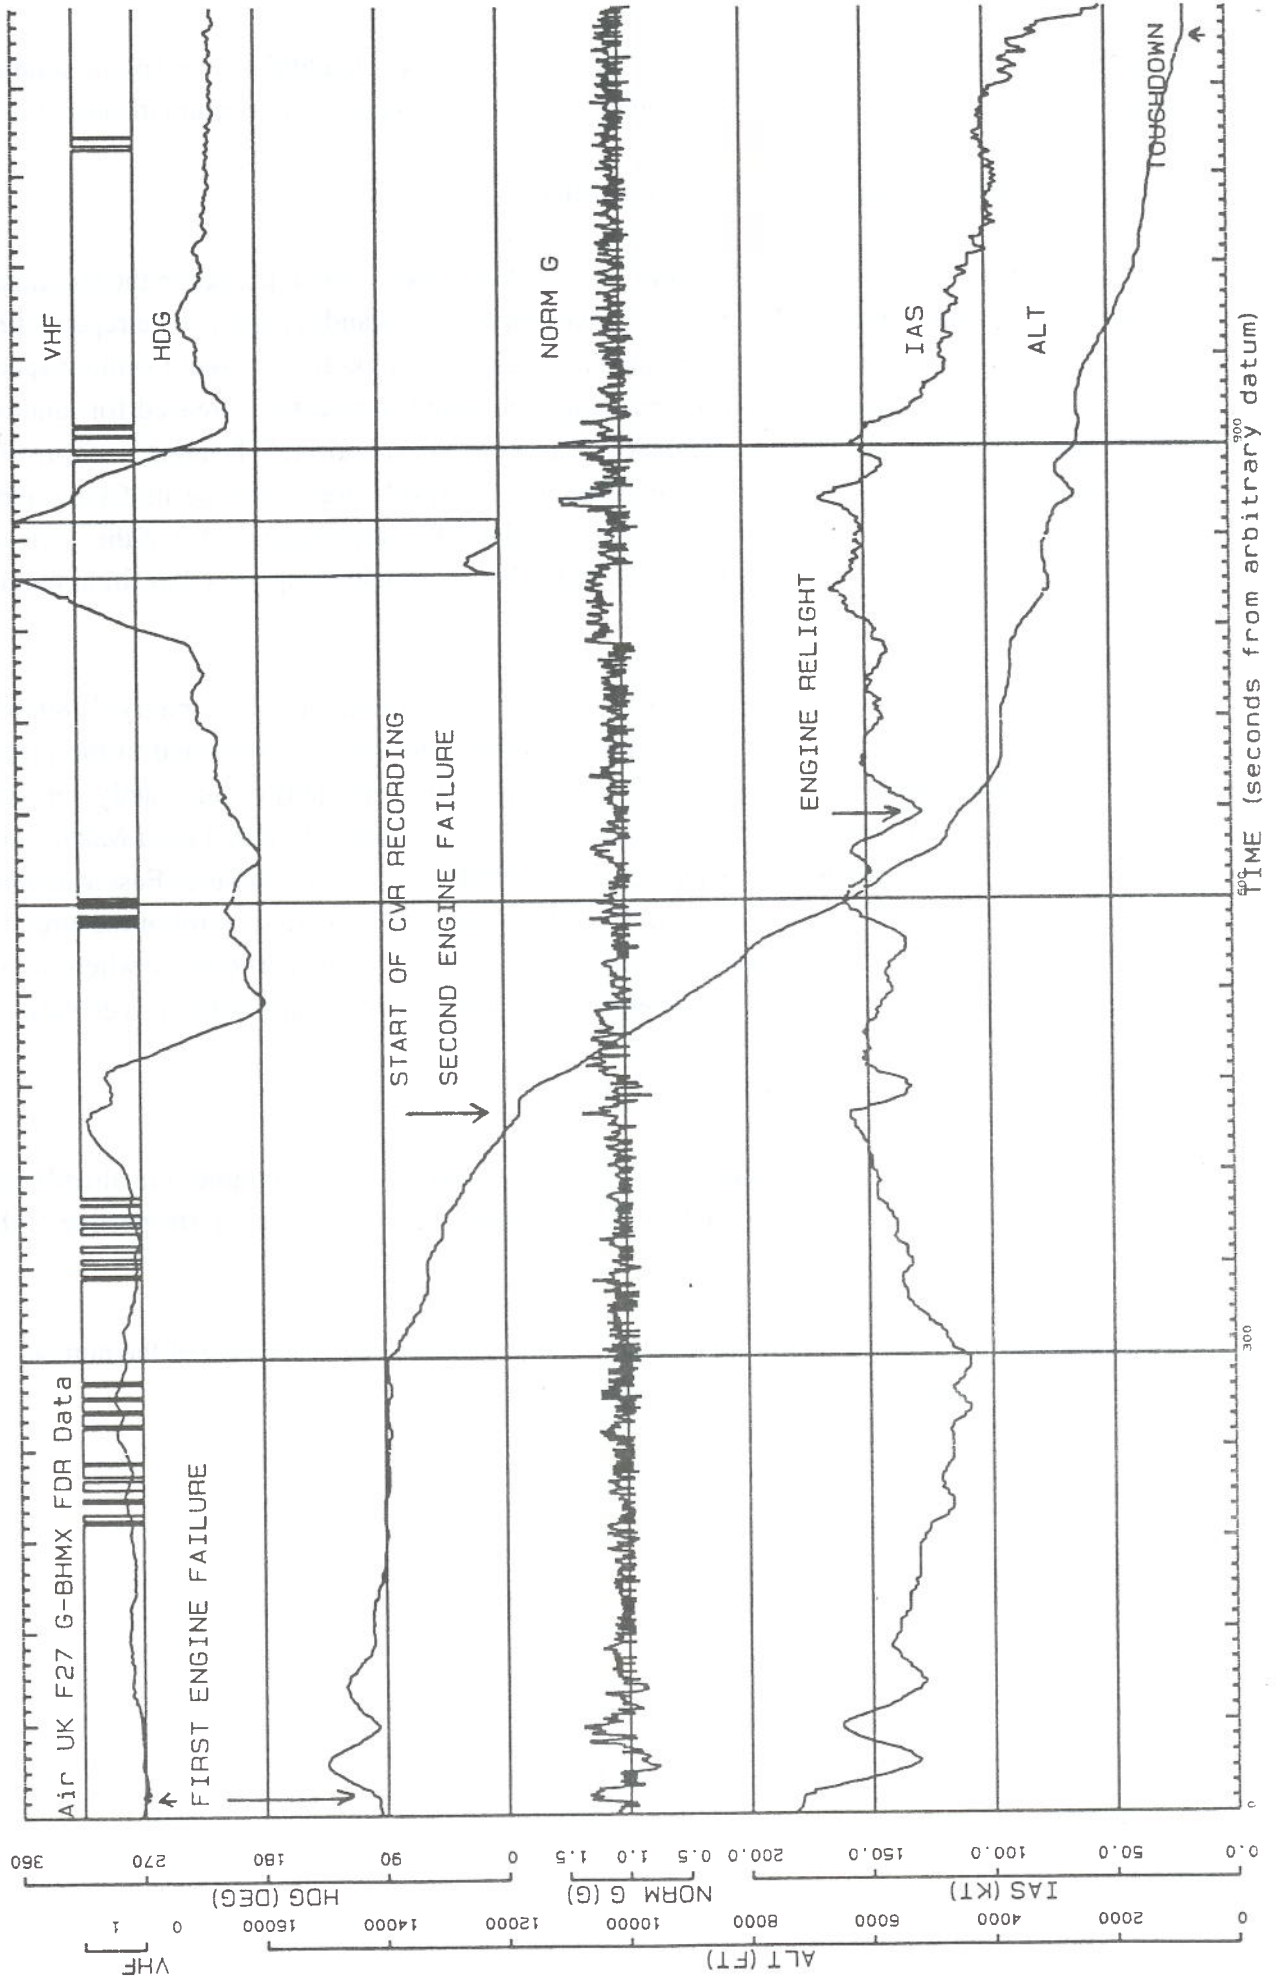
FIGURE 1

A plot of the data from just before the first engine failure until touchdown is shown at Figure 1. The time of the second engine failure and the relight are shown on the graph.
