INCIDENT

Aircraft Type and Registration:	Boeing 757-3CQ, G-JMAB	
No & Type of Engines:	2 Rolls-Royce RB211-535E4-B-37 turbofan engines	
Year of Manufacture:	2001	
Date & Time (UTC):	12 December 2007 at 1935 hrs	
Location:	Stand 32, Manchester Airport	
Type of Flight:	Commercial Air Transport (Passenger)	
Persons on Board:	Crew - 10	Passengers - 283
Injuries:	Crew - None	Passengers - None
Nature of Damage:	Front of No 1 engine nacelle dented at one o'clock position	
Commander's Licence:	Airline Transport Pilot's Licence	
Commander's Age:	48 years	
Commander's Flying Experience:	10,048 hours (of which 6,119 were on type) Last 90 days - 94 hours Last 28 days - 55 hours	
Information Source:	Aircraft Accident Report Form submitted by the pilot

Synopsis

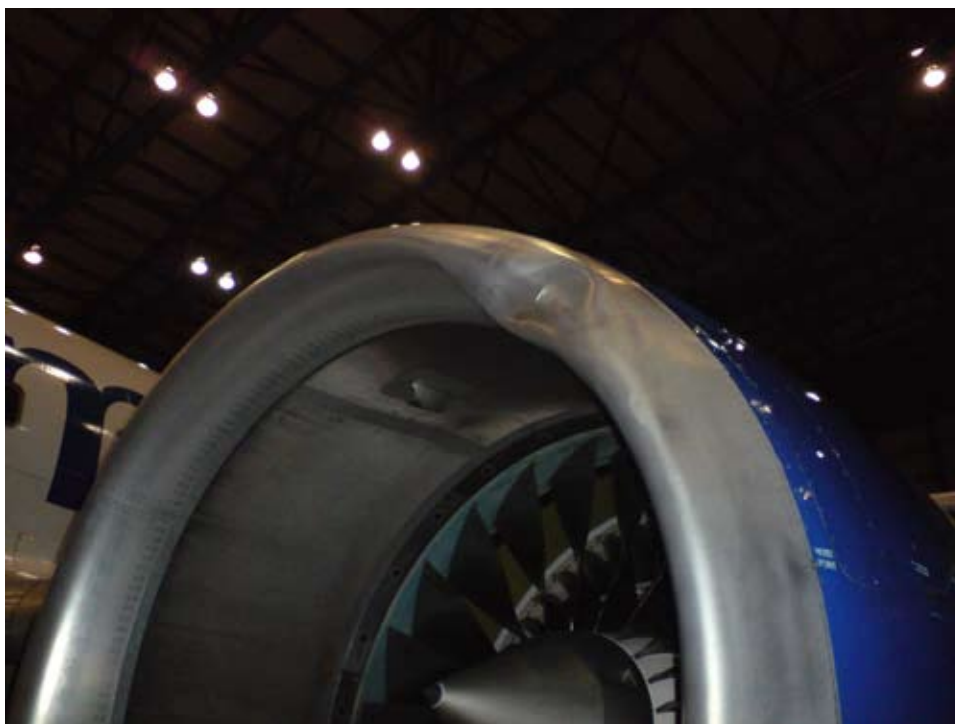
Figure 1

The pilots shut down the engines and the passengers and crew disembarked without further incident. The left engine intake cowling had impacted the outer air bridge. The Aerodrome Fire fighting and Rescue Service (AFRS) was not called and did not attend.

Maintenance personnel assessed the damage to the front upper intake lip of the intake cowl of the left engine as beyond allowable limits and replaced the cowling in accordance with the Aircraft Maintenance Manual. The engine strut, fairings, structure, mounts and fittings were also inspected but found to be undamaged.

Damage to engine cowling

The operator stated that the aircraft was fully serviceable prior to the accident. Following replacement of the damaged engine cowl, the aircraft was declared serviceable and returned to normal operations.
