AAIB Bulletin No: 4/95

Aircraft Type and Registration: VPM M16 Tandem Trainer, G-BVRD

Date & Time (UTC): 12 January 1995 at 1120 hrs

Location: Runway 36, Cranfield Airfield, Bedfordshire

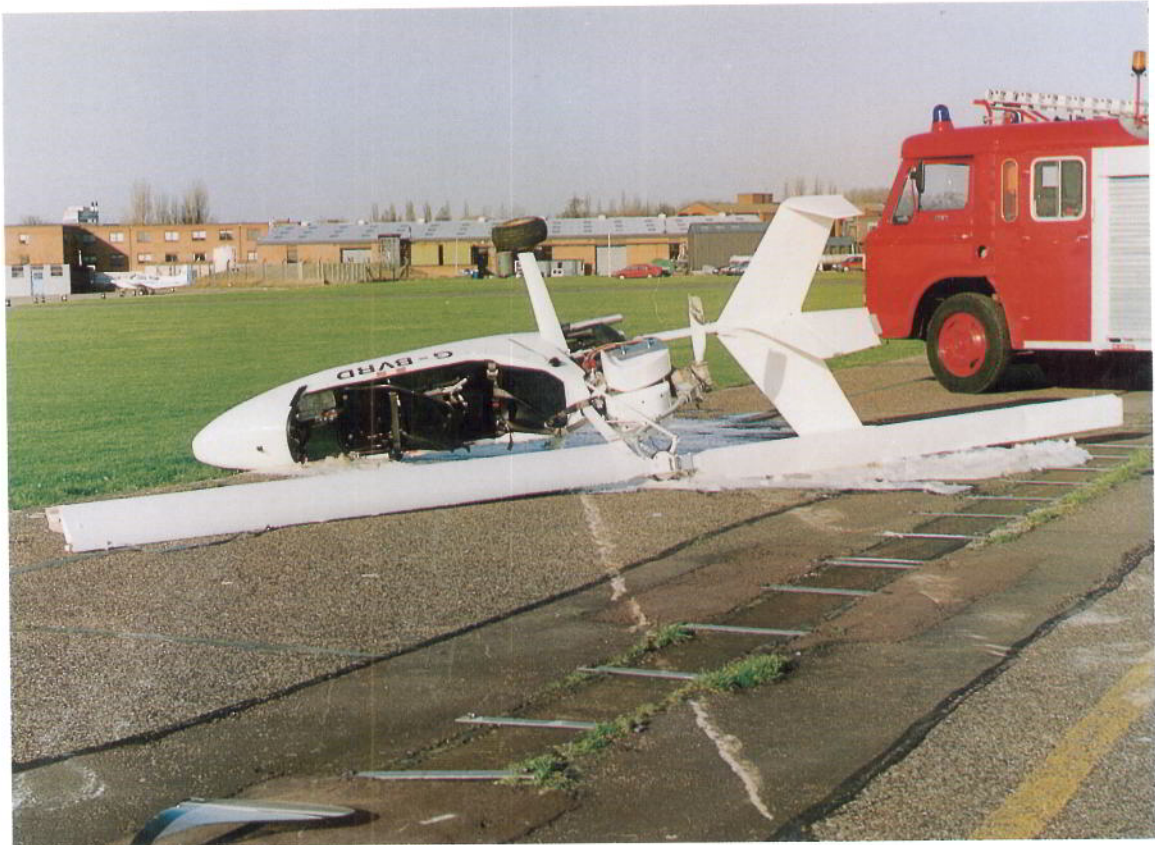
Figure 1 - VPM M16 gyroplane, G-BVRD, at Cranfield, 12 January 1995

There had been delamination towards the tip of both rotor blades (Figure 1) as they scraped along the paved surface after the impact with the runway and a length of leading edge balance mass had detached. However, the final position of the balance mass and the nature of the delaminations showed that this had occurred as the aircraft descended onto the ground. The relative lack of damage to the blades, which retained their full length, showed that the speed of the rotor at ground impact was very low and small witness marks on both rotor blades at the radius corresponding to the propeller blades showed that, before the aircraft struck the ground, the rotor had 'flapped back' sufficiently for the propeller tips to touch both blades. This degree of 'flap back' was corroborated by witness marks at the top of the rotor mast where the blade teetering mechanism had contacted the mounting plate.
