**ACCIDENT**

<b>Aircraft Type and Registration:</b>	Piper PA-28-140 Cherokee, G-AWPS	
<b>No &amp; Type of Engines:</b>	1 Lycoming O-320-E2A piston engine	
<b>Year of Manufacture:</b>	1964	
<b>Date &amp; Time (UTC):</b>	2 January 2009 at 1154 hrs	
<b>Location:</b>	Colwich Junction, near Little Haywood, Staffordshire	
<b>Type of Flight:</b>	Private	
<b>Persons on Board:</b>	Crew - 1	Passengers - 2
<b>Injuries:</b>	Crew - 1 (Fatal)	Passengers - 2 (Fatal)
<b>Nature of Damage:</b>	Aircraft destroyed, railway overhead gantry and power cables disrupted	
<b>Commander's Licence:</b>	Private Pilot's Licence (lapsed)	
<b>Commander's Age:</b>	59 years	
<b>Commander's Flying Experience:</b>	Estimated 600 hours (of which 500 were on type) Last 90 days - not known Last 28 days - not known	
<b>Information Source:</b>	AAIB Field Investigation

**Synopsis**

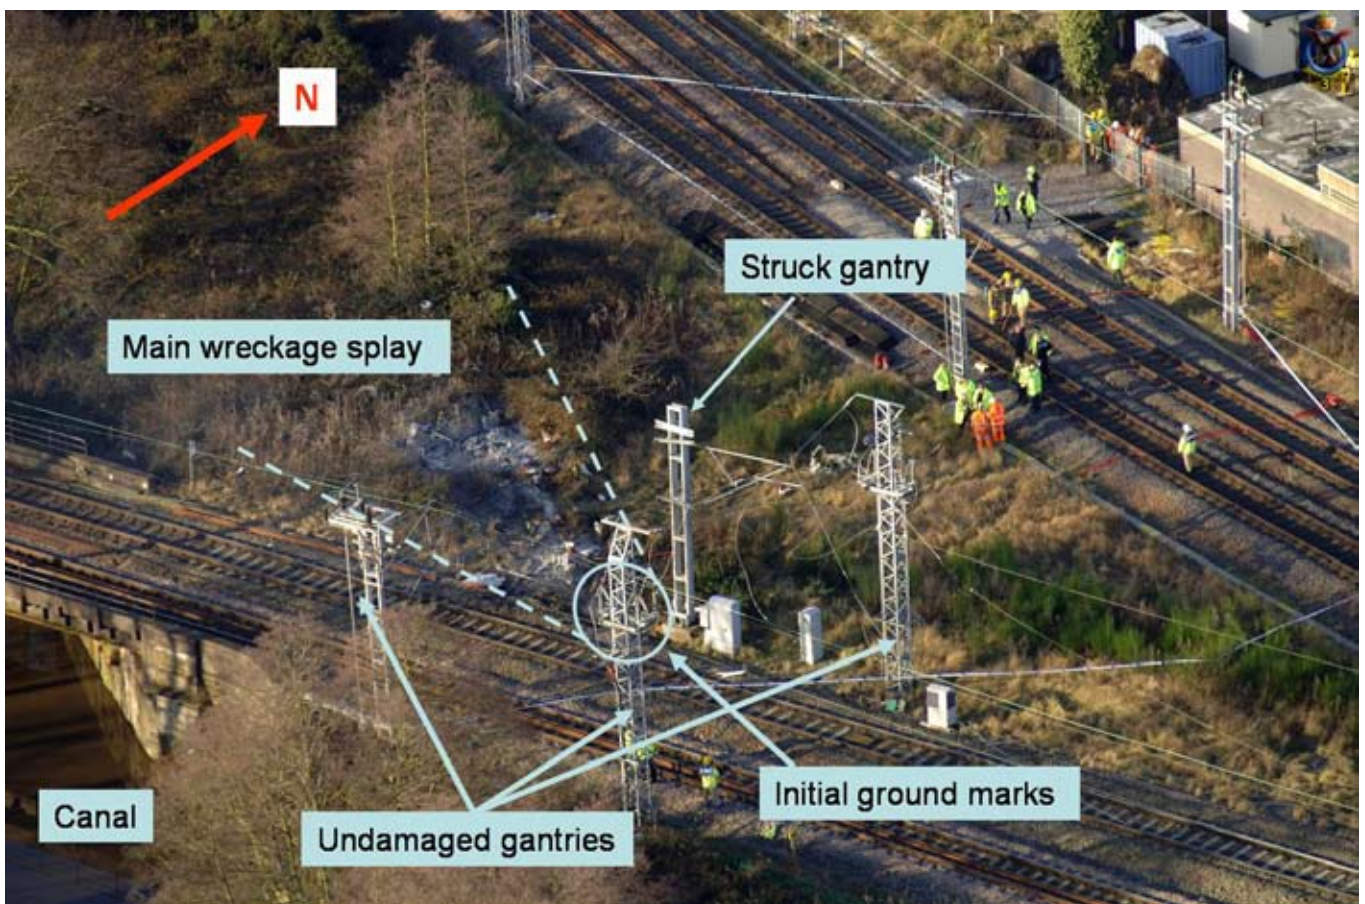
**Figure 1**

The accident site was at Colwich Junction near Little Haywood, Staffordshire. The aircraft wreckage was found between the two branches of railway track that form part of the West Coast mainline. The aircraft's initial impact (Figure 1) was with an overhead power cable gantry. This moved the gantry on its mounting plinth, disrupted the cantilever part of the gantry and failed the overhead electric power cable. The first ground marks were scrape marks on one of the railway tracks and a significant crater to the side of the track, both close to the damaged overhead gantry. Most of the fragmented wreckage was distributed in a splay in a westerly direction from these initial impact marks. Parts of the wreckage were found outside this main splay and some parts were recovered up to 60 m from

G-AWPS accident site (courtesy Central Counties Air Operations Unit)

The damage and fragmentation of the aircraft was consistent with it striking the overhead gantry, and then the ground, at high speed in a 'right wing low' attitude.

The localised damage to the overhead gantries and electrical cables, and the proximity of the initial ground marks to the struck gantry, indicate the aircraft was descending at a steep angle.

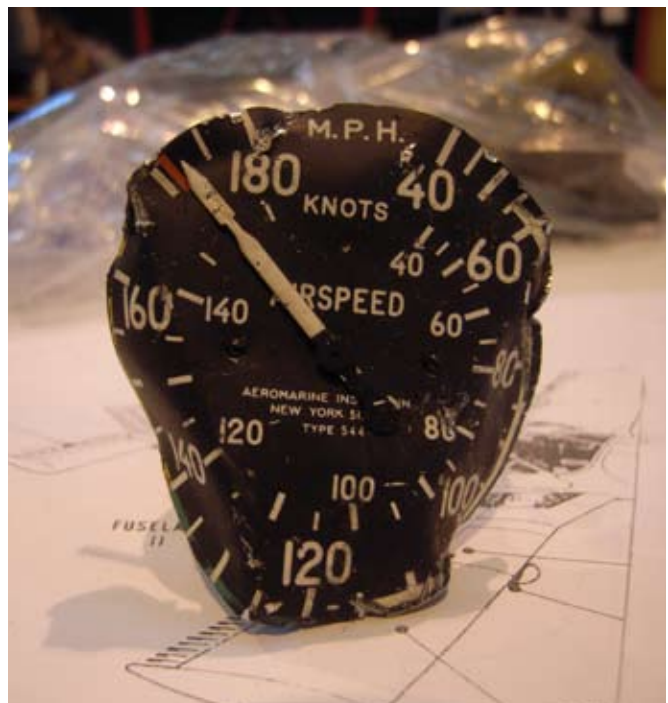
**Figure 2**

The flight instruments were destroyed apart from the face of the airspeed indicator (ASI) and the compass. The needle of the ASI was stuck at an indication of 173 mph (Figure 2).

Face of airspeed indicator (ASI)

The aircraft was intact prior to impact as all major parts were found with the wreckage. No significant pre-existing defects were found with the aircraft or its control systems. The throttle control was set to a low power setting and damage to the propeller indicates it was rotating but was at low power on impact. This is consistent with a high-speed dive with the engine running at a reduced throttle setting. The 'roaring' noise described by several witnesses and the indication on the ASI of 173 mph, which appears to be valid, are consistent with this scenario.
