SERIOUS INCIDENT

Aircraft Type and Registration:	Airbus A320-214, EI-EZV
No & Type of Engines:	2 CFM 56-5-B4/P turbofan engines
Year of Manufacture:	2003 (Serial no: 2001)
Date & Time (UTC):	16 January 2014 at 1505 hrs
Location:	London Heathrow Airport
Type of Flight:	Commercial Air Transport (Passenger)
Persons on Board:	Crew - 6 Passengers - 41
Injuries:	Crew - 4 (Minor) Passengers - None
Nature of Damage:	None reported
Commander's Licence:	Airline Transport Pilot's Licence
Commander's Age:	34 years
Commander's Flying Experience:	7,272 hours (of which 6,878 were on type) Last 90 days - 96 hours Last 28 days - 19 hours
Information Source:	Aircraft Accident Report Form submitted by the pilot

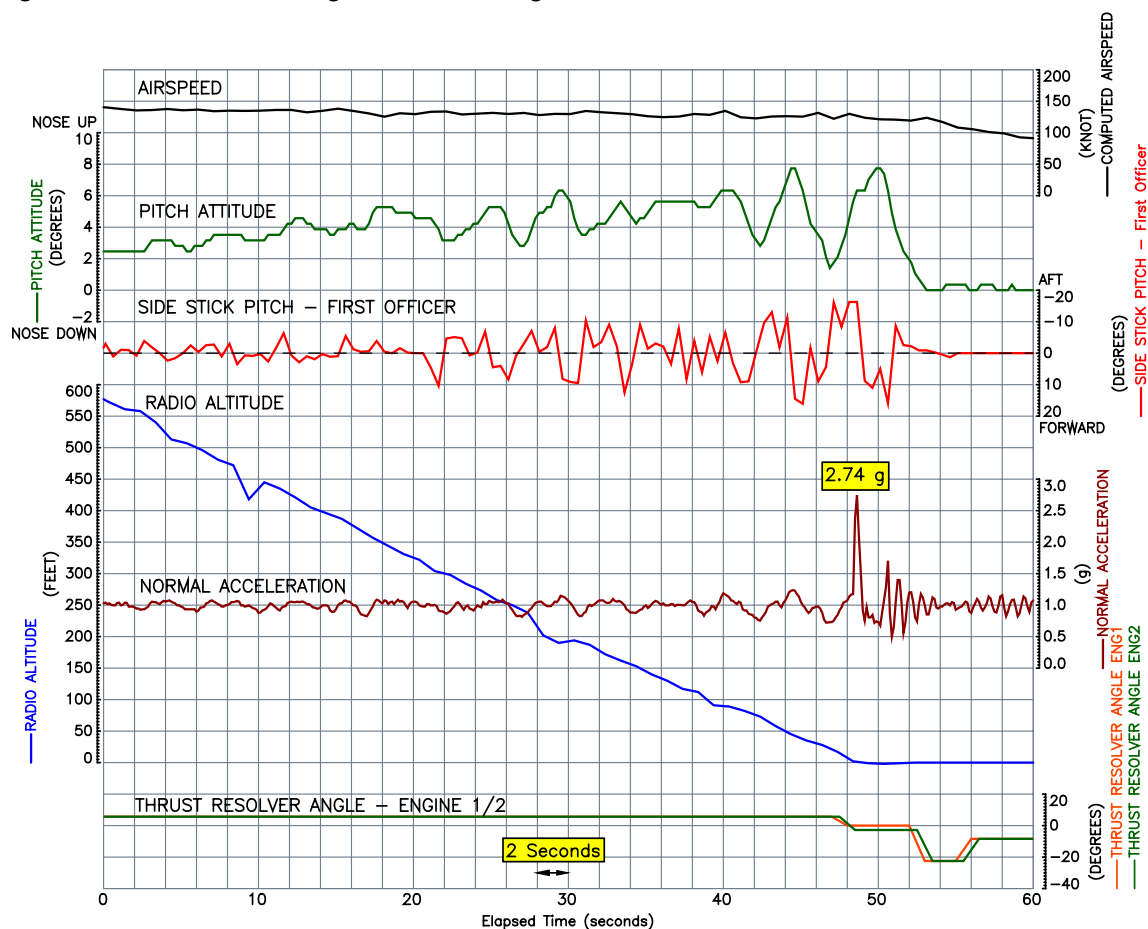
Flight data from the landing

The computed airspeed at touchdown (equivalent to groundspeed in the absence of headwind) was approximately 130 kt. The thrust levers were retarded over approximately 1.5 seconds to reach idle at touchdown. The average rate of terrain closure was 706 fpm during the descent from 500 ft radio altitude to touchdown. This approximates to the aircraft's rate of descent given the flat and level ground over which the aircraft was flying during the final approach. The ILS 27L page in the UK AIP entry for London Heathrow Airport shows that a rate of descent of 690 fpm is required to maintain the ILS glideslope at 130 kt groundspeed.

In the final 28 seconds before touchdown, the amplitude of sidestick input slowly increased but, although the pitch attitude varied, the average rate of descent remained constant. In the two seconds before touchdown, the pitch attitude changed from approximately 1.5° to 6.5° nose-up.

During the final 28 seconds of flight, the high rate at which the pitch inputs were made and reversed meant that the pitch attitude did not always change in response. The pitch inputs also had little effect on the flight path and rate of descent. The pitch attitude varied significantly during the six seconds before touchdown, including a 5° nose-up pitch change in the final two seconds. However, the final increase in pitch attitude came too late to arrest the rate of descent leading to the hard landing.

The scale for the parameter SIDE STICK PITCH – First Officer in Figure 1 is incorrectly labelled. The scale should read that positive values greater than zero indicate that the side stick has been moved forward and that negative values of less than zero indicate that the side stick has been moved aft. The revised plot has been inserted into the above report. The analysis remains unchanged.
