ACCIDENT

Aircraft Type and Registration:	Jabiru SK, G-JABA	
No & Type of Engines:	1 Jabiru Aircraft Pty 2200A piston engine	
Year of Manufacture:	2000	
Date & Time (UTC):	22 June 2010 at 1920 hrs	
Location:	1 mile west of Whiterashes Airstrip, Aberdeenshire	
Type of Flight:	Private	
Persons on Board:	Crew - 1	Passengers - None
Injuries:	Crew - None	Passengers - N/A
Nature of Damage:	Damage to nose leg, left landing gear, wing and propeller	
Commander's Licence:	Private Pilot's Licence	
Commander's Age:	55 years	
Commander's Flying Experience:	188 hours (of which 20 were on type) Last 90 days - 4 hours Last 28 days - 4 hours	
Information Source:	Aircraft Accident Report Form submitted by the pilot and further enquiries by the AAIB

Synopsis

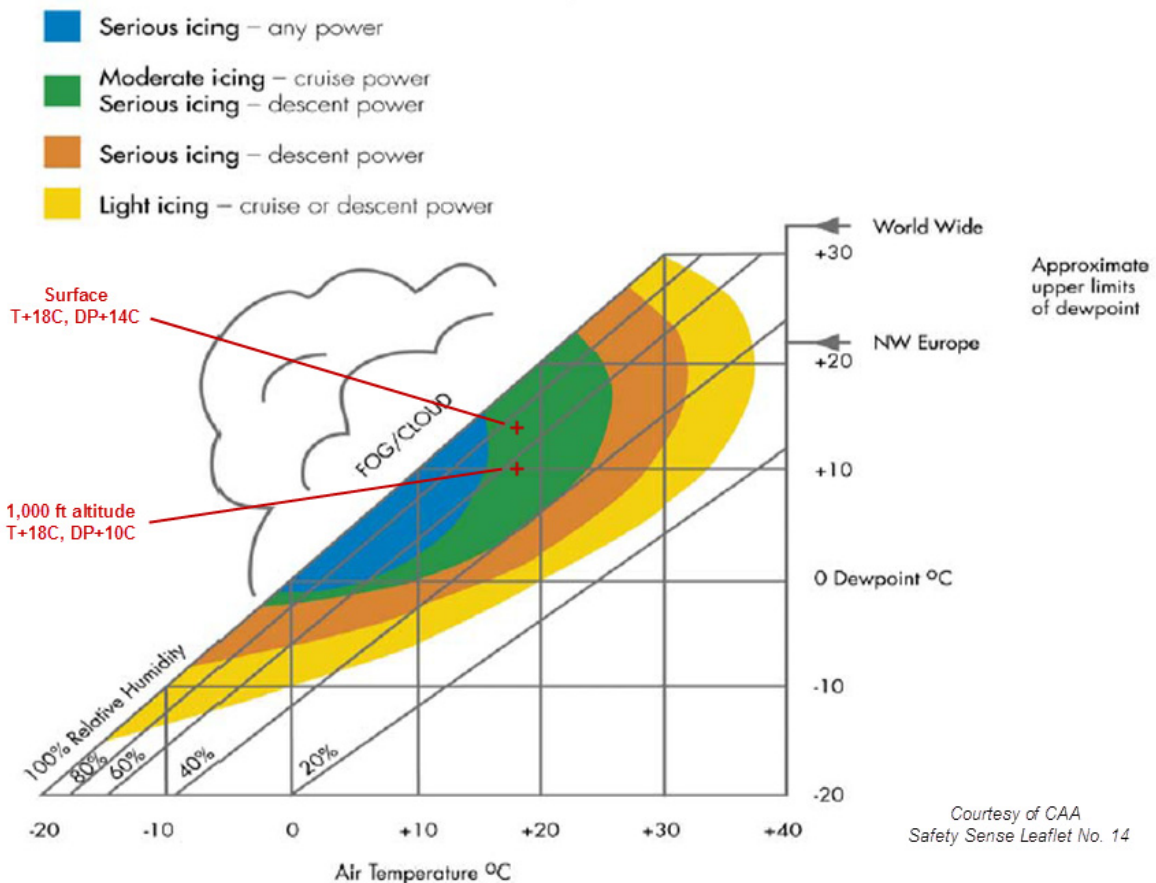
Figure 1
Carburettor icing chart

From the carburettor icing chart (Figure 1) it can be seen that the conditions at the surface and at 1,000 ft altitude were favourable for ‘moderate icing – cruise power’ and ‘serious icing – descent power’.

The prevailing meteorological conditions at the time of the accident were favourable for the formation of serious carburettor icing at descent power settings. Lack of application of carburettor heat and subsequent carburettor icing were the most likely causes of the engine failure.
