# Eurocopter AS332-L2, Super Puma, G-JSAR

<b>AAIB Bulletin No:</b> 8/2004	<b>Ref:</b> EW/C2003/02/06	<b>Category:</b> 2.1
<b>INCIDENT</b>		
<b>Aircraft Type and Registration:</b>	Eurocopter AS332-L2, Super Puma, G-JSAR	
<b>No &amp; Type of Engines:</b>	2 Turbomeca Makila 1A2 turboshaft engines	
<b>Year of Manufacture:</b>	2002	
<b>Date &amp; Time (UTC):</b>	22 February 2003	
<b>Location:</b>	1 nm north of Miller Platform, North Sea	
<b>Type of Flight:</b>	Private	
<b>Persons on Board:</b>	Crew - 2	Passengers - 2
<b>Injuries:</b>	Crew - None	Passengers - None
<b>Nature of Damage:</b>	Oil cooler drive shaft and gear wheel fractured. Bearing housing fractured	
<b>Commander's Licence:</b>	N/A	
<b>Commander's Age:</b>	N/A	
<b>Commander's Flying Experience:</b>	N/A	
<b>Information Source:</b>	AAIB Field Investigation

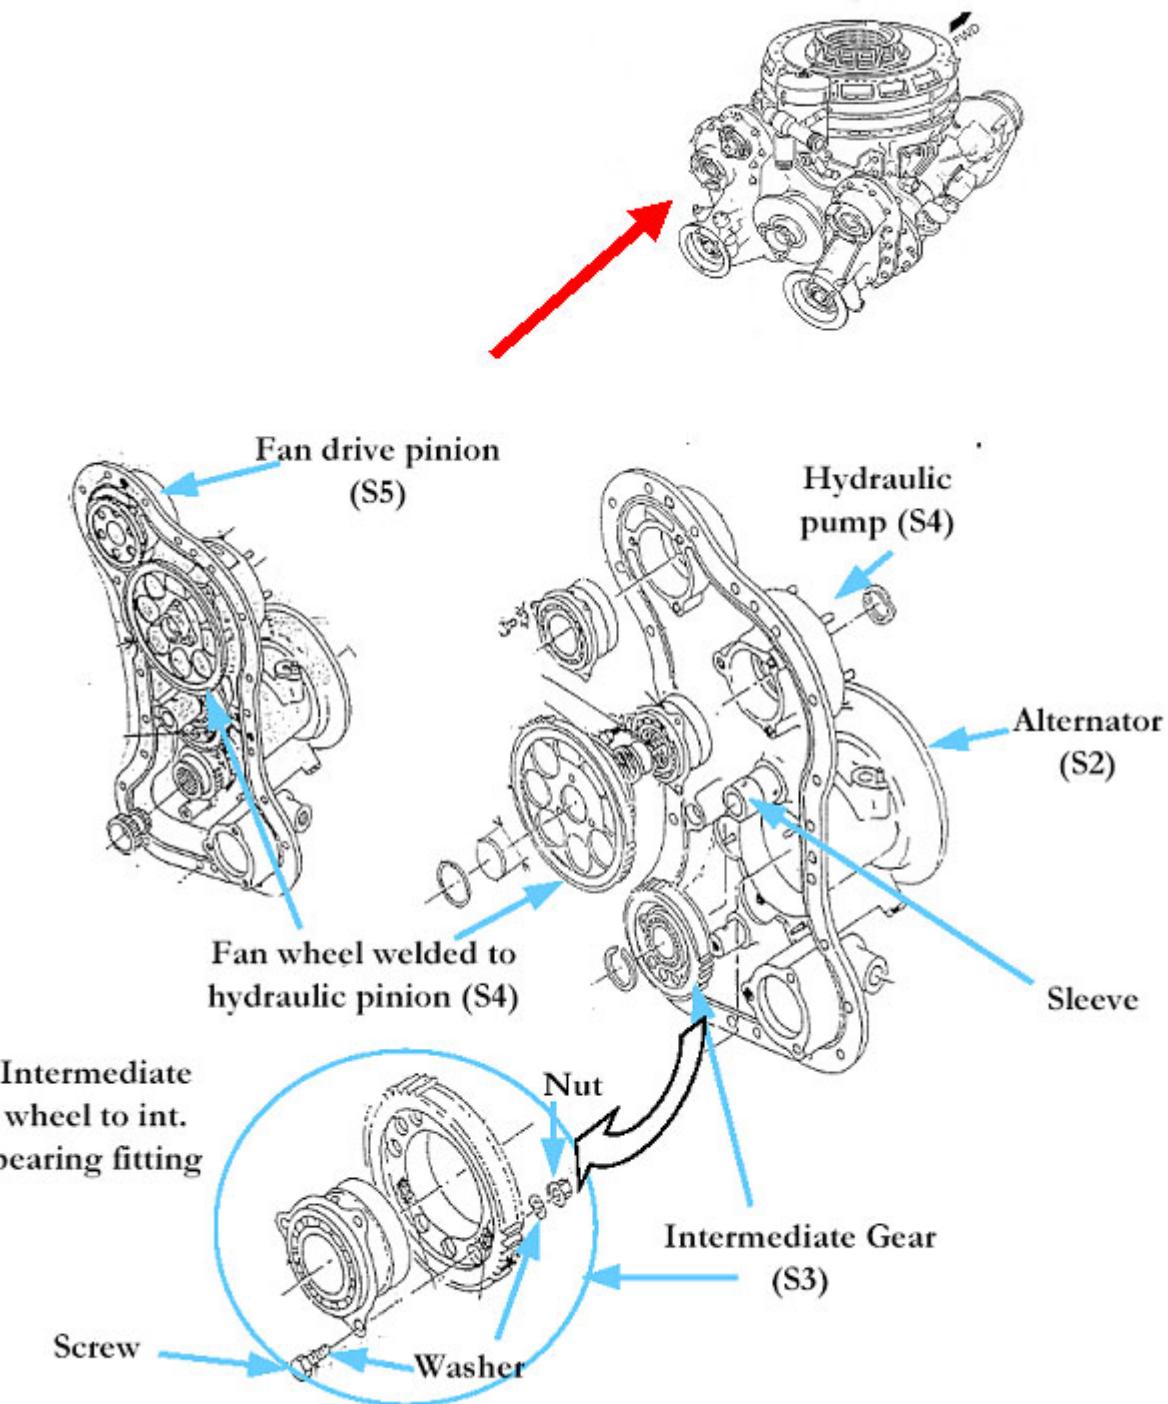
**Figure 1: Details of left hand accessory module**

chip detector and the oil cooler drive shaft had fractured at the coupling flange on the MGB output drive. A diagram of the gearbox is shown at Figure 1, with a photograph of the partially dismantled gearbox presented at Figure 2.

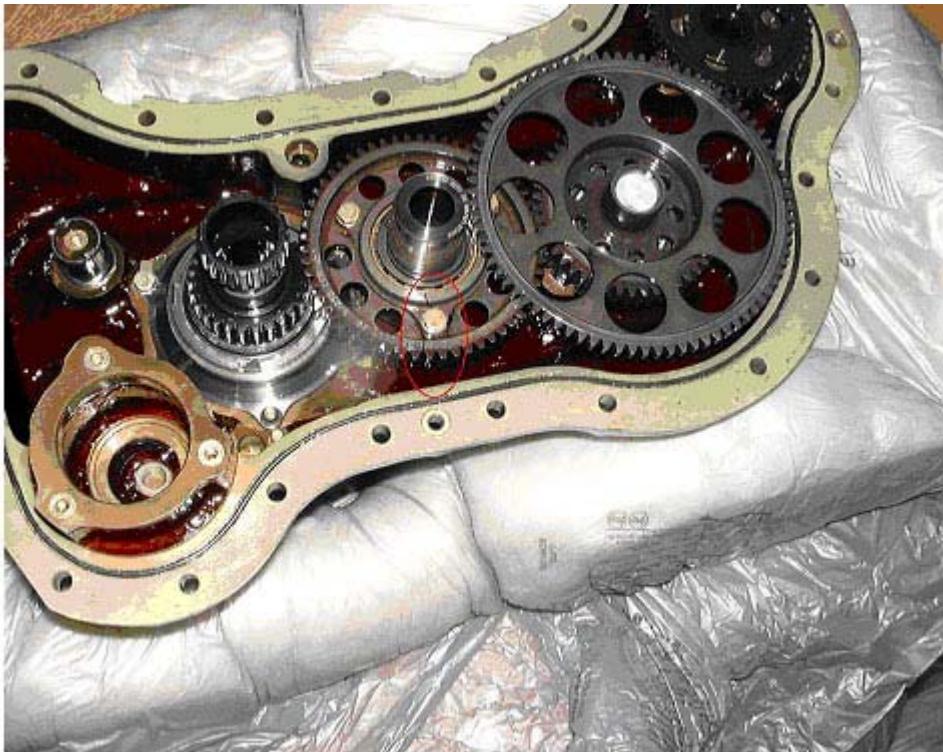
**Figure 2: LH accessory gearbox module from G-JSAR, showing cracked intermediate gear**

The left hand accessory module was removed from the MGB and an internal examination revealed that the intermediate gear wheel had fractured from the bearing at the centre to the outer edge of the gear. Its bearing housing was also fractured through one of the three attachment lugs. The remaining two attachment lug bolts were found fully torque tightened. The detached portion of the failed lug was found lying loose within the module housing.

The subsequent investigation centred on the gearbox module, as the oil cooler drive shaft failure was attributed to transient torsional loads arising from 'snatching' in the gear train.

After fitting a replacement accessory module, oil cooler and its associated drive shaft, the aircraft was returned to service. At the time of the incident the aircraft (and gearbox) had achieved a total of 175 operating hours.

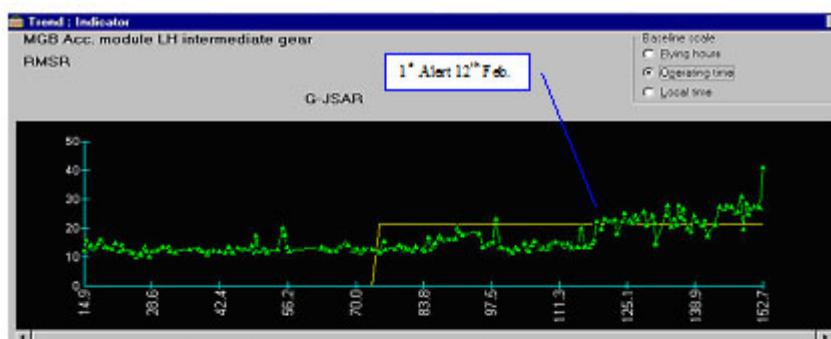
**Root Mean Square Residual (RMSR) indicator**

In this particular case, there was a EuroARMS alert generated on 12 February 2003 concerning the RMSR parameter. This is the Residual Root Mean Square of the signal and represents the residual energy after the gear teeth meshing tones have been removed. The work card associated with this alert called for an EDR to be raised with the manufacturer. This was done on the 13 February, and the manufacturer responded later the same day with the advice to continue flying but with close monitoring for a further 50 flight hours. The RMSR alert was generated on most subsequent flights, as can be seen in Figure 4.

**Figure 4 Two EuroARMS data plots, showing threshold breaches.**  
**Note that thresholds are 'learnt' over a period of approximately 50 hours following a transducer change.**

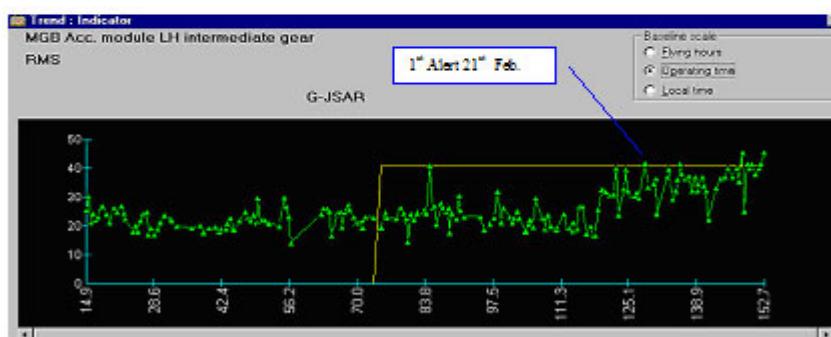
**Root Mean Square (RMS) indicator**

On 21 February the RMS parameter threshold was breached, - this is also shown in Figure 4. This is the Root Mean Square of the signal and is a measure of the total energy, the value of which will tend to increase in the event of damage to the component. The EuroARMS Training Manual notes that defect detection using this parameter occurs "at a fairly late stage" in the damage process. Following a review of the thresholds, it was decided to continue monitoring both the RMS and the RMSR parameters. The MGB chip warning and oil cooler drive shaft failure occurred on the following day, some 21 flight hours after the initial alert on 21 February. The final EuroARMS data was sampled only 2 minutes prior to the chip warning.

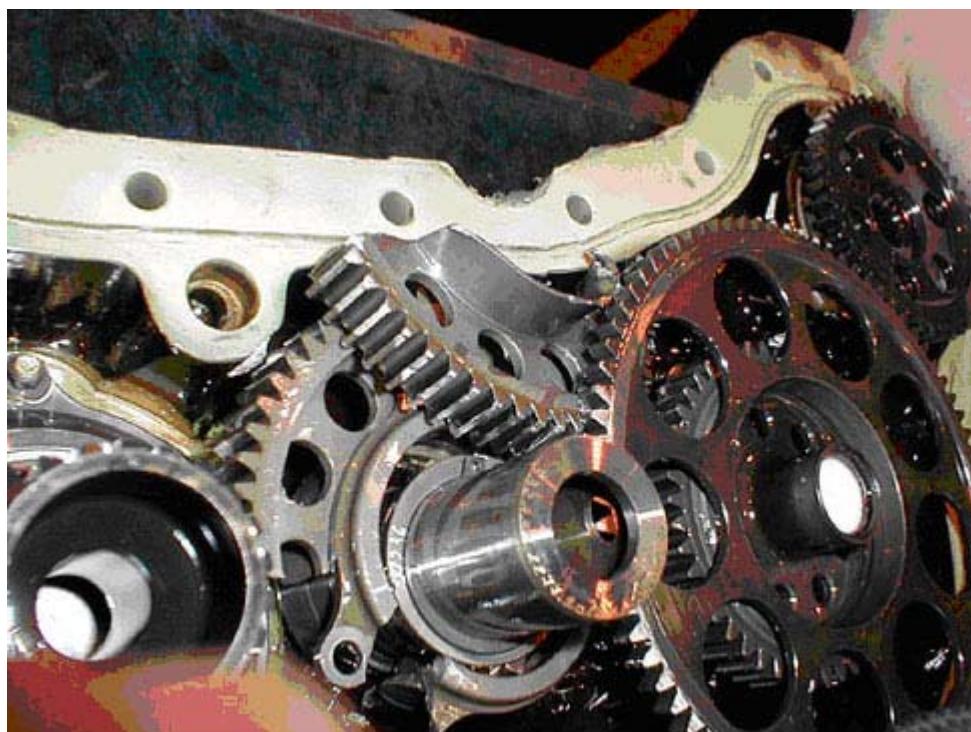
**Figure 3: Failed intermediate gear from G-PUMS**

A similar incident occurred to another operator's AS332-L2, G-PUMS, on 21 November 2002, when an amber MGB oil pressure caption illuminated when the aircraft was on the ground following flight. On the subsequent ground run, the accessory gearbox seized, followed by the shearing of the oil cooling fan drive shaft. A large amount of debris was found on the MGB magnetic plug. Investigation of the left hand accessory module revealed that the intermediate gear had fractured into two pieces. In addition, there was associated damage to the internal surfaces of the casing. A photograph of the internal components of the module is shown at Figure 3.
