ACCIDENT

Aircraft Type and Registration:	Airbus A300B4-622R(F), D-AEAP
No & Type of Engines:	2 Pratt & Whitney PW4158 turbofan engines
Year of Manufacture:	1994 (Serial no: 724)
Date & Time (UTC):	14 April 2012 at 1753 hrs
Location:	East Midlands Airport, Derby
Type of Flight:	Commercial Air Transport (Cargo)
Persons on Board:	Crew - 3 Passengers - None
Injuries:	Crew - None Passengers - N/A
Nature of Damage:	Damage to nose landing gear and minor damage to a tug
Commander's Licence:	Airline Transport Pilot's Licence
Commander's Age:	53 years
Commander's Flying Experience:	5,878 hours (of which 111 were on type) Last 90 days - 79 hours Last 28 days - 20 hours
Information Source:	AAIB Field Investigation

Synopsis

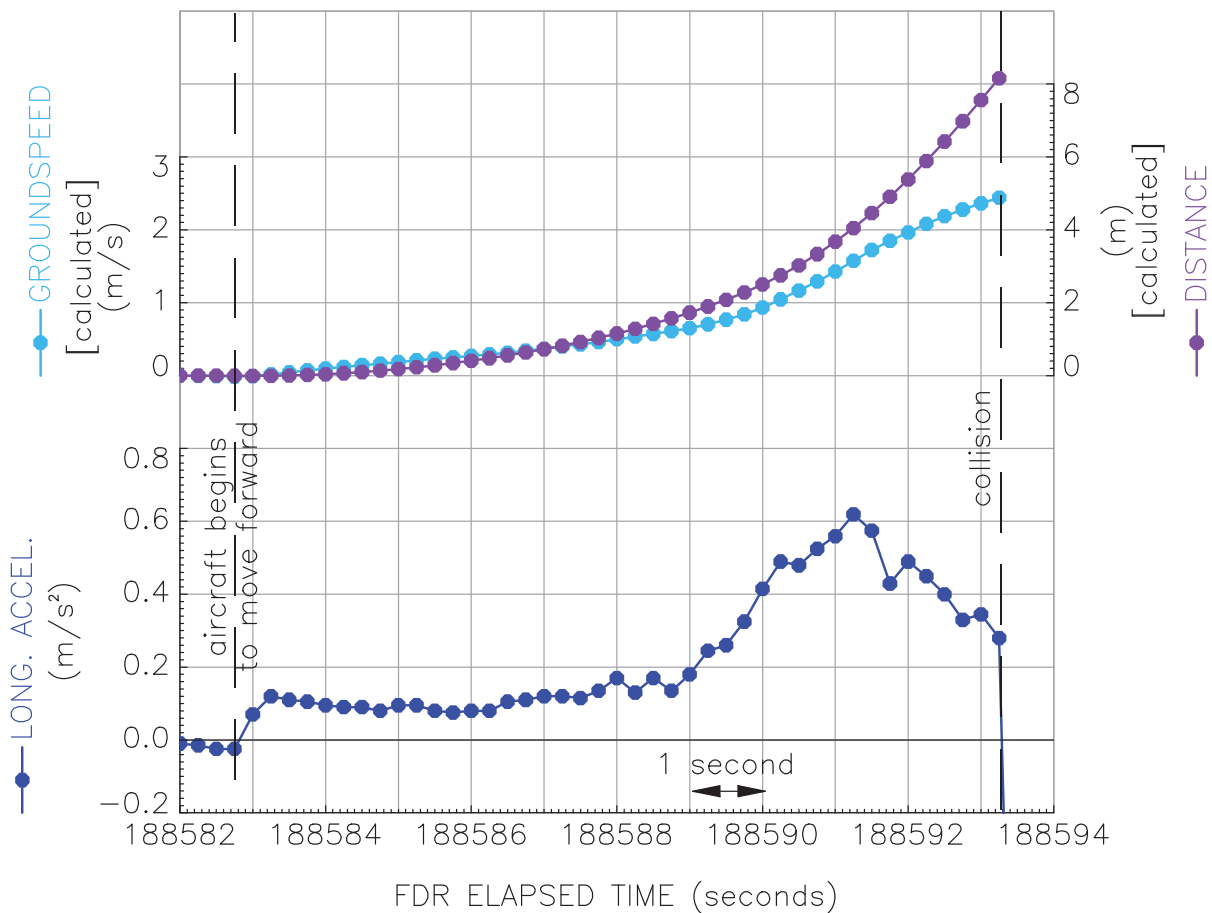
Figure 2
FDR derived groundspeed and distance

associated with the use of aircraft's brakes. However, the recording of the longitudinal acceleration enabled the calculation of the speed of the aircraft at the point of collision (2.4 m/s = 4.7 kt) and the distance travelled (8 m) (see Figure 2).

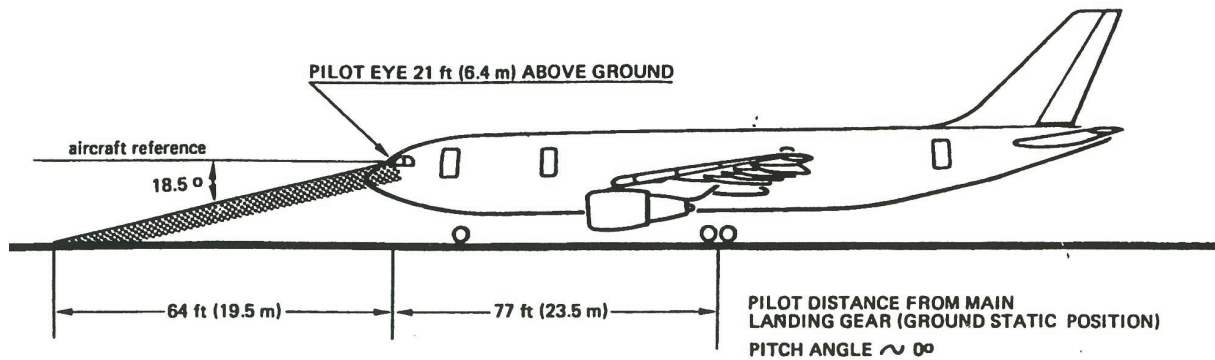
Figure 3

Field of view from pilot's seat

structure. With the pilot's seat position adjusted for flight, a 1.8 m high object (the height of the tug) becomes visible when approximately 14 m in front of the pilot.

from the flight deck indicated that it is likely that the tug and ground crew were not visible to the pilots when the aircraft started to taxi.
