No: 9/90 **Ref: EW/G90/02/03** **Category: 1a**

Aircraft Type and Registration: Avions Marcel Dassault Falcon 20, N908FR

Nature of Damage: Damage to left main landing gear, gear door and outer left wing

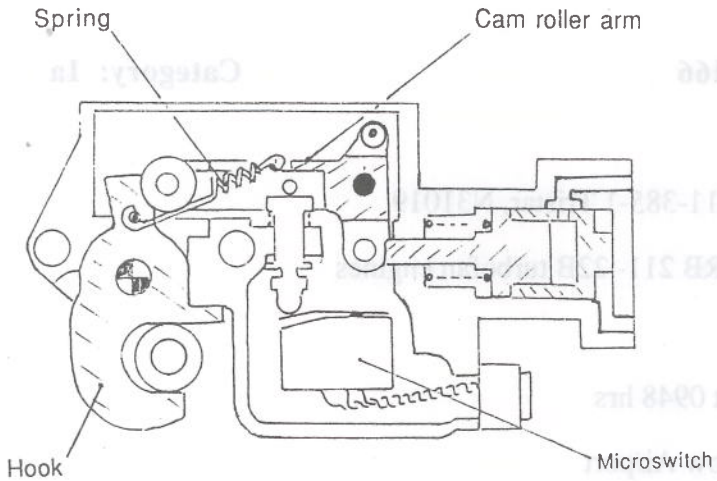
Gear up and locked

Hook held in position by cam arm

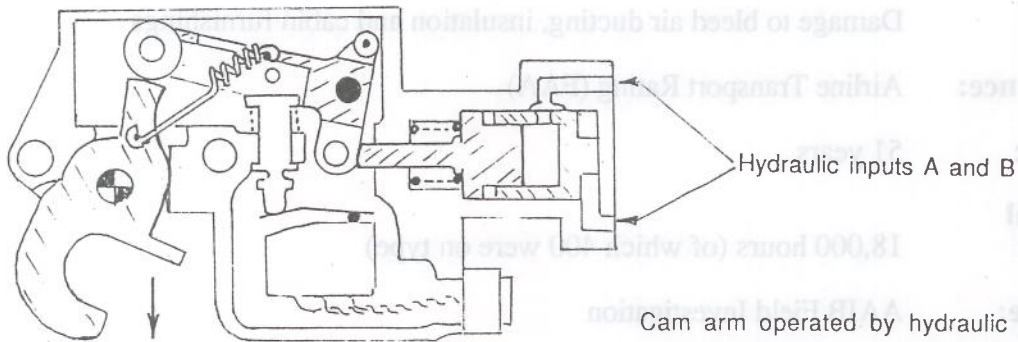
Gear unlocked

Cam arm operated by hydraulic piston or directly by the emergency release to pull hook open via the spring

Roller (Leg mounted)

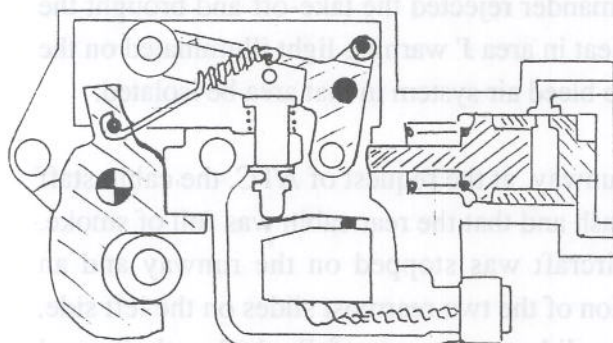
Gear 'Hung Up' configuration

1. There was a general lack of grease penetration throughout the landing gear mechanism.
2. The left landing gear leg uplock roller was found seized, due to lack of lubrication.
3. On test, a hesitation in the release of the left leg uplock was cleared following re-lubrication.
4. Beads of moisture were found present within the uplock.

With reference to the attached diagrams, the uplock hook itself for the main landing gear of this aircraft cannot be opened directly by hydraulic or mechanical means, but is solely acted upon through a tension spring connected to an unlocking arm and the uplock roller. In the absence of any relevant mechanical faults, it therefore appeared likely that high friction already present in the uplock mechanism may have been assisted by soaking to sub-zero temperatures, and the possible formation of ice, to such an extent that the tension spring was unable to move the hook to the unlock position. The profile of this hook is such that no opening motion is generated by any down-load from the roller.

Insufficient force applied by spring to overcome high friction generated by siezed roller and stiff hook when operated hydraulically or manually

Although it was recorded in the aircraft documentation that lubrication of the landing gear system was last carried out in early December 1989, between January 1990 and the time of the incident three washes of the landing gear had been completed. Since this event, the operating company have increased the frequency of landing gear lubrication to 150/165 hour periods and required that this lubrication requirement is certified by a Certificating Engineer.
