No: 1/92 **Ref:** EW/C91/9/4 **Category:** 2c

Aircraft Type and Registration: Enstrom 280FX, G-BSIE

Nature of Damage: Tail rotor gearbox and spindle broken,
minor damage to tail rotor and guard

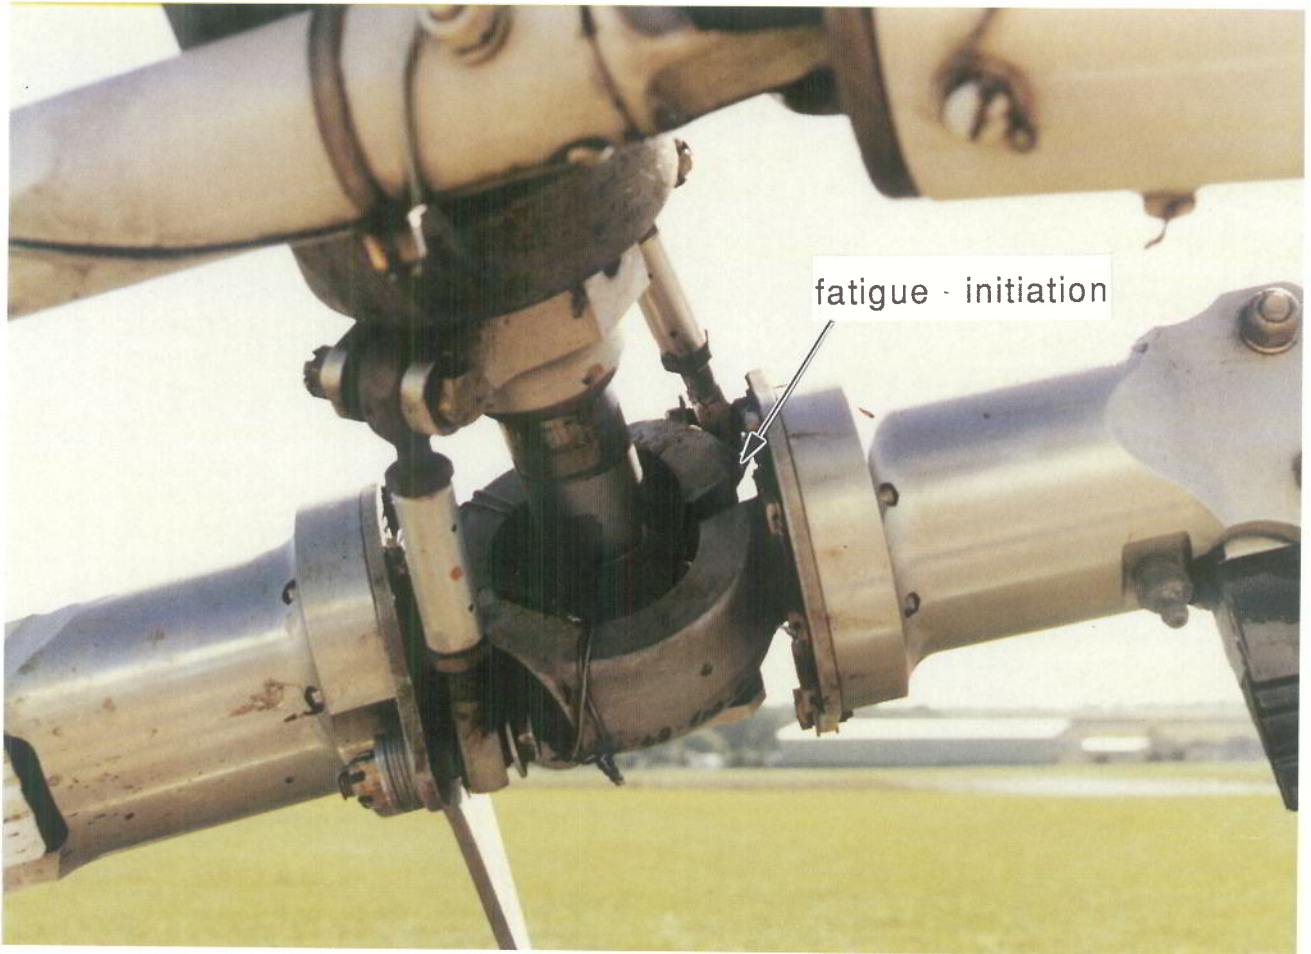
Subsequent examination also revealed that the tail rotor spindle, part number 28-150064-11, had fractured across one of the teeter bearing housings (see photo). This had not, surprisingly, led to liberation of the entire tail rotor assembly but meant that the blades were no longer co-axial and must

therefore have generated substantial out-of-balance forces. Visual inspection showed clear evidence of fatigue damage involved with the fracture and it is considered that this was the primary failure which led to a secondary failure of the gearbox. The broken items were removed and submitted for metallurgical examination.

The metallurgist's report confirmed the presence of long-term fatigue damage in the fractured spindle. Indeed, the failure was almost entirely in fatigue with very little static overload. One side of the bearing housing had failed in long-term fatigue occurring over millions of cycles whilst the other had failed over a shorter term involving hundreds, possibly thousands, of cycles. Thus the fatigue initiation had occurred early in the life of the part and progression was probably associated with tail rotor RPM frequency on one side of the housing before additional loads transferred to the other side of the housing and caused this to fail in fatigue at a higher rate more closely associated with flight cycles. This implies that a crack existed on both sides of the spindle fitting over a considerable number of flight cycles. The part was original-build on G-BSIE and had only accrued some 285 flying hours. The cause of the primary fatigue initiation was considered to be "stress-raisers" caused by surface discontinuities in the as-forged and descaled surface and/or flaking caused by a poor shot-peening process. The metallurgical report also confirmed that the gearbox case fracture was a secondary event following on from the spindle failure.

check had been performed by his maintenance organisation at about the time of the last 100-hour check, 81 hours previously. The metallurgical examination found no evidence of penetrant or developer either in the crack or around the area. In addition it was recognised that the initiation point of this particular fatigue failure was such that it would have been difficult to detect by visual examination and may have been obscured by excess grease from the pitch bearings. Developing cracks could also be hidden by the teeter bearing cap locking wires.

G-BSIE - view showing inboard face of fractured tail-rotor spindle

"The Civil Aviation Authority should urgently consider making Enstrom Service Bulletin 0077 mandatory as an interim measure. Compliance requires a visual inspection (described in the SB) before further flight and on a repeat daily basis. The authority should also emphasise the necessity to inspect under the bearing cap locking wires which could obscure indications of a crack."

On 8 October, the CAA issued Emergency Airworthiness Directive 001-10-91. This called for an immediate, once-off, visual inspection of the affected tail rotor spindles by qualified personnel and advised that a further Directive was likely to be issued following discussions with the manufacturer and the FAA.

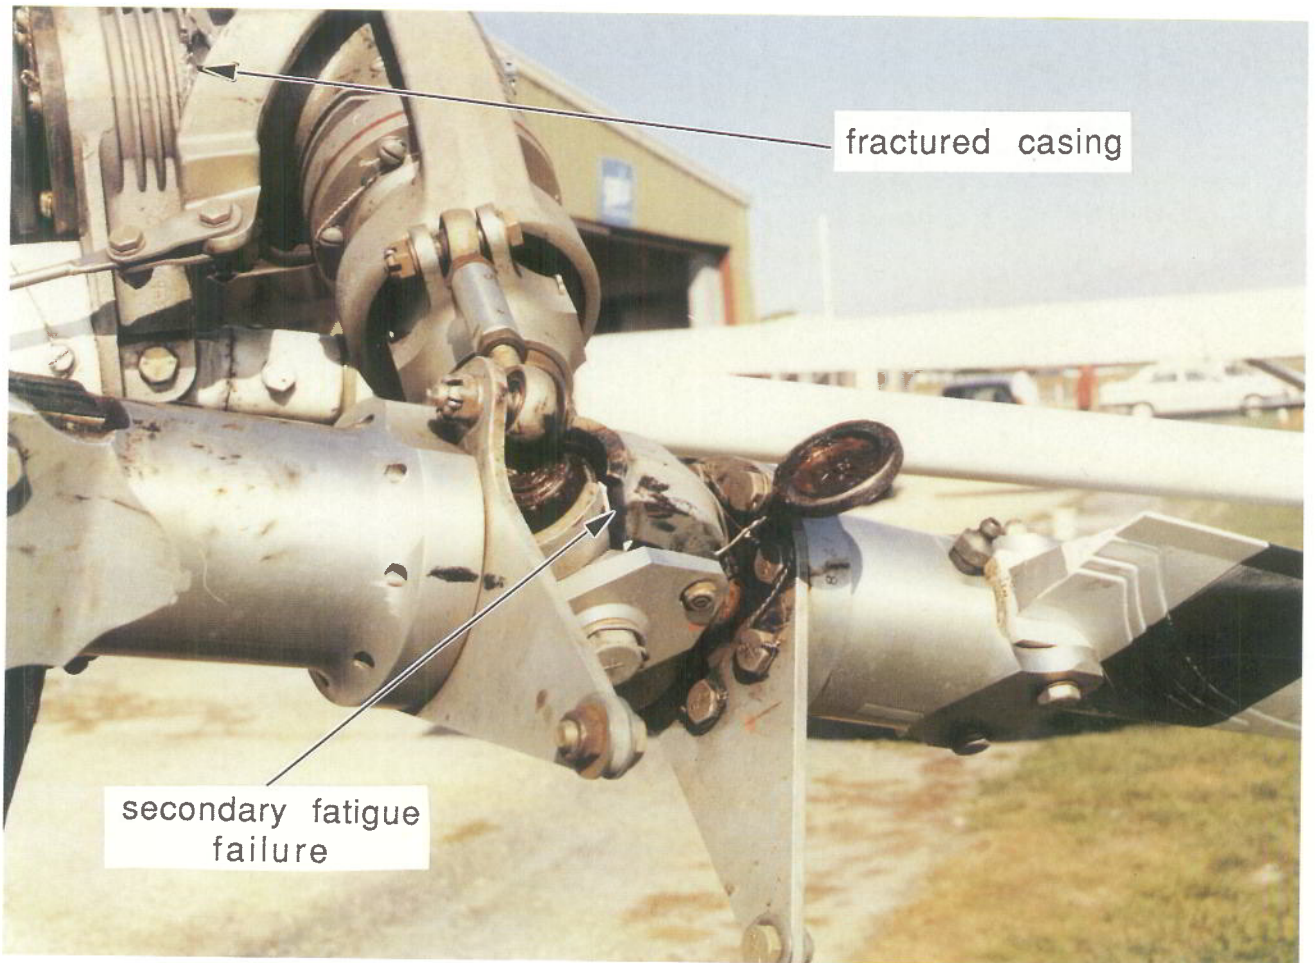
G-BSIE - view showing fractured tail-rotor gearbox casing
